December 2023
FL979A-F
NHTSA #23V-467
Transport Canada #2023-372
SECOND REVISED NOTICE

Subject: Freightliner eCascadia e-Axle Ring Gear

Models Affected: Specific model years 2023-2024 Freightliner eCascadia vehicles manufactured between January 19, 2023, through April 13, 2023.

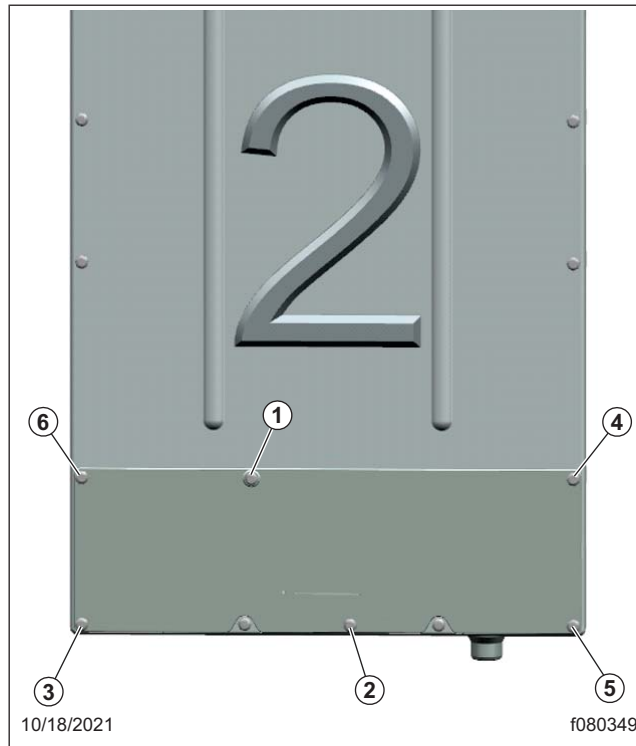
Fig. 10, Inverter Access Cover Tightening Sequence

58. Install the inverter access cover and tighten all the fasteners 44 lbf-in (497 N-cm) in the sequence shown in **Fig. 10**. For detailed instructions, see **Section 08.02, Subject 050** of the *eCascadia Workshop Manual*.
