November 2023
FL979A-F
NHTSA #23V-467
Transport Canada #2023-372

Subject: Freightliner eCascadia e-Axle Ring Gear

Models Affected: Specific model years 2023-2024 Freightliner eCascadia vehicles manufactured between January 19, 2023, through April 13, 2023.

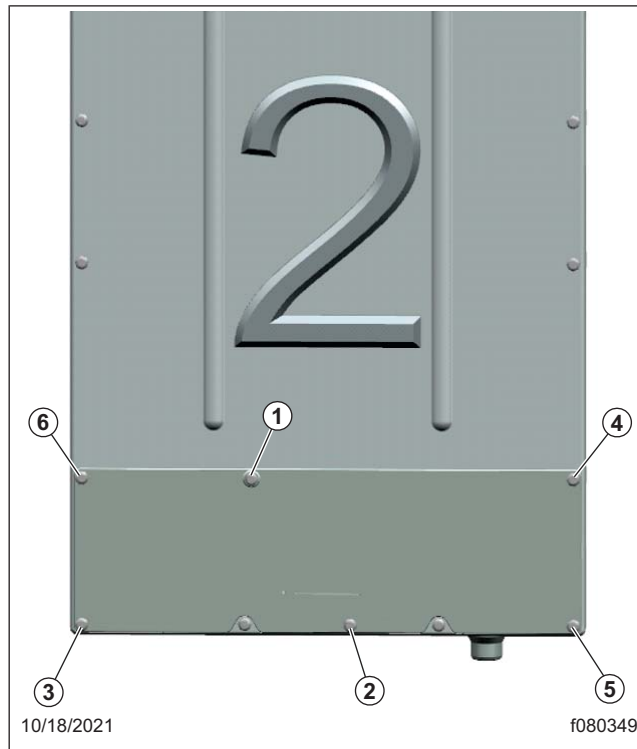
58. Install the inverter access cover and tighten all fasteners 44 lbf·in (497 N·cm) in the sequence shown in [Fig. 10](#). See [Section 08.02, Subject 050](#) of the *eCascadia Workshop Manual* for detailed instructions.

Fig. 10, Inverter Access Cover Tightening Sequence
