Ford Motor Company
PO Box 1904
Dearborn, Michigan 48121

**SUBJECT: NEW VEHICLE DEMONSTRATION / DELIVERY HOLD
Compliance Recall 23C25 - *Supplement #2***
Certain 2023 Model Year Super Duty and Escape Vehicles
Instrument Panel Cluster Replacement

- **Technical Instructions:** 2023 Super Duty Instrument Panel Cluster (IPC) installation.
- **Additional Repair:** Updated guidelines.
- **Labor Allowances:** Adding IPC programming time.
- **Parts Requirements / Ordering Information:** IPC part number updated to RC3Z-10849-R for 2023 Super duty.

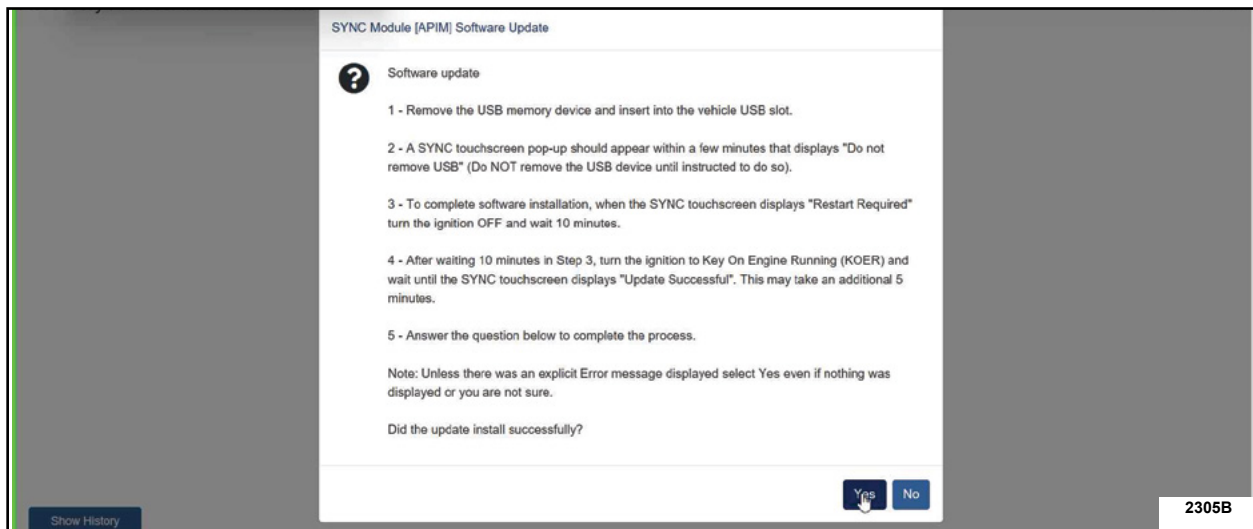
FIGURE 2

29. Select Toolbox tab.
30. From the list on the LH side of the screen, select the APIM.
31. From the list on the RH side of the screen, select APIM - Accessory Protocol Interface Module [APIM] Software Update.
32. Click RUN. Follow all on-screen instructions carefully.
33. Return the USB thumb drive to the FDRS and follow the on-screen prompts carefully until the following screen is reached. See Figure 2.
