**SUBJECT:** **NEW VEHICLE DEMONSTRATION / DELIVERY HOLD**

**Safety Recall 23S64 - Supplement #4**

Certain 2017-2022 Model Year EcoSport, 2016-2018, Focus, and 2017-2018 Fiesta Vehicles Equipped with a 1.0L EcoBoost engine and automatic transmission  
Engine Oil Pump Belt and Tensioner Replacement – Final Repair

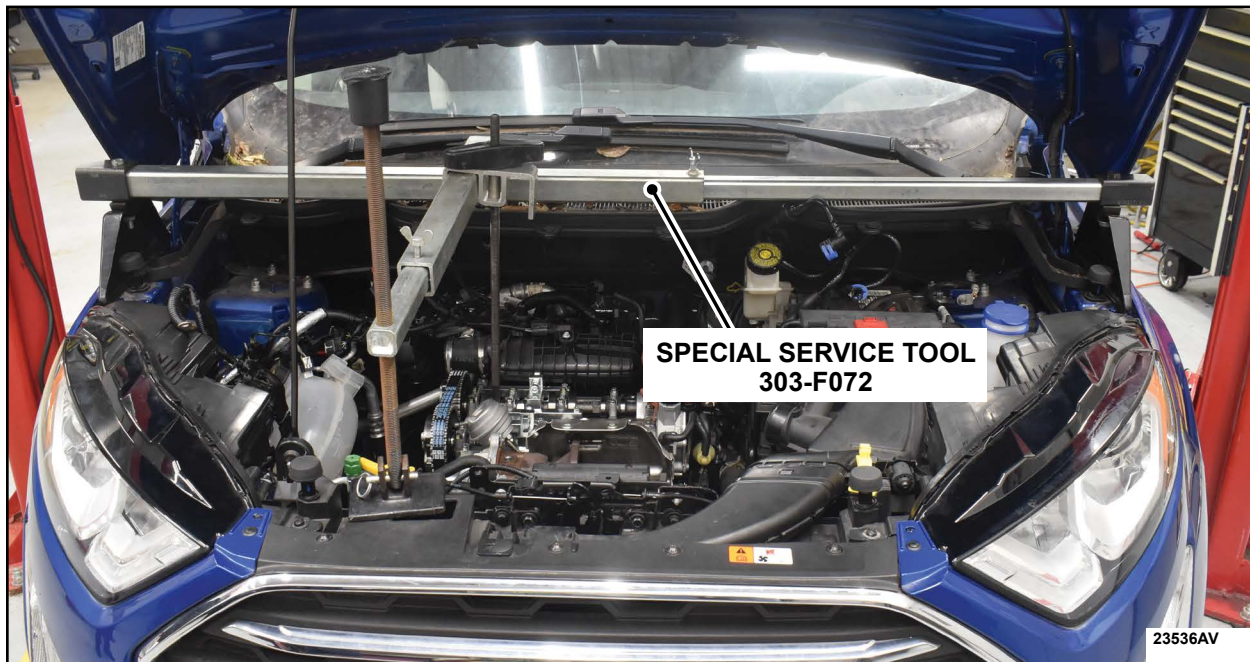
FIGURE 8

14. Install Special Service Tool 303-F072 Support Bar, Engine. Set up the engine support bar over the engine timing belt, as shown in Figure 8.

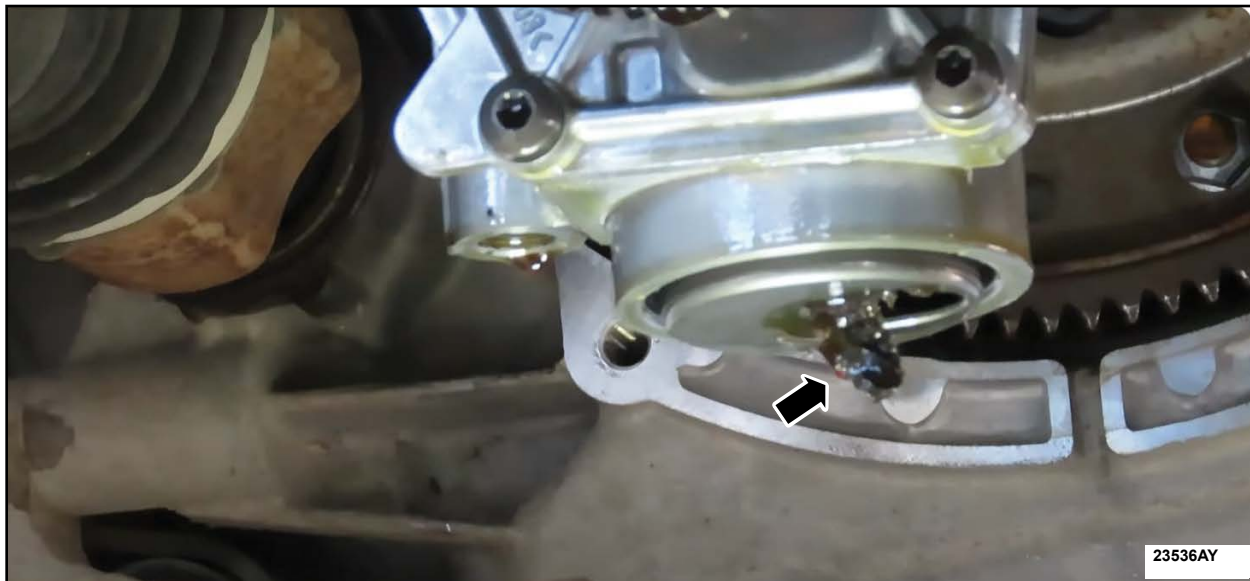
**FIGURE 24**

31. Using a suitable tool and brake clean, clean the oil pump sump screen of any debris or belt material. See Figure 24.

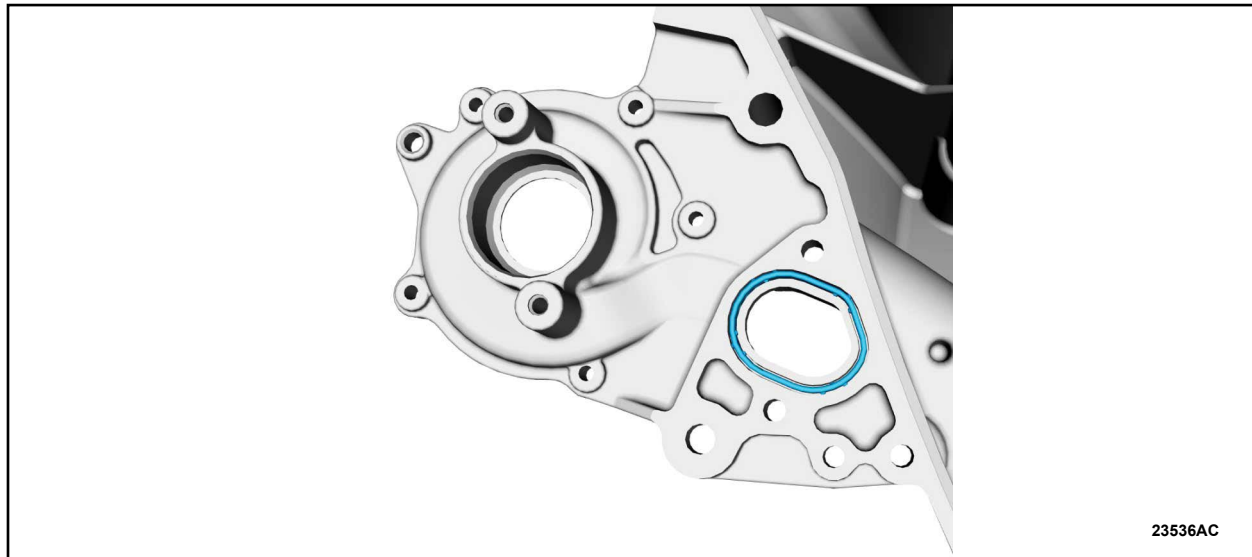
**FIGURE 33**

40. Install a new gasket. See Figure 33.

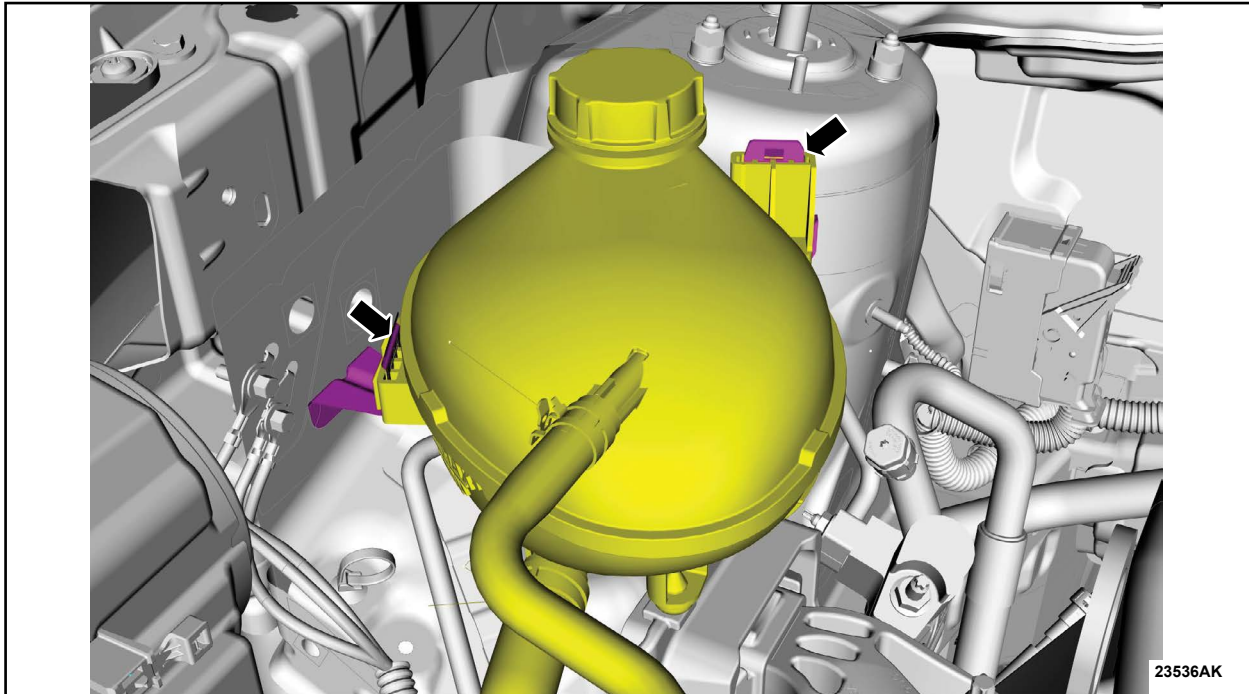
**FIGURE 41**

49. Install the degas bottle onto the tabs. See Figure 41.
