**SUBJECT:** **NEW VEHICLE DEMONSTRATION / DELIVERY HOLD**

**Safety Recall 23S64 - Supplement #3**

Certain 2018-2022 Model Year EcoSport, 2016-2018, Focus, and 2017-2021 Fiesta Vehicles Equipped with a 1.0L EcoBoost engine and automatic transmission.  
Engine Oil Pump Belt and Tensioner Replacement – Final Repair

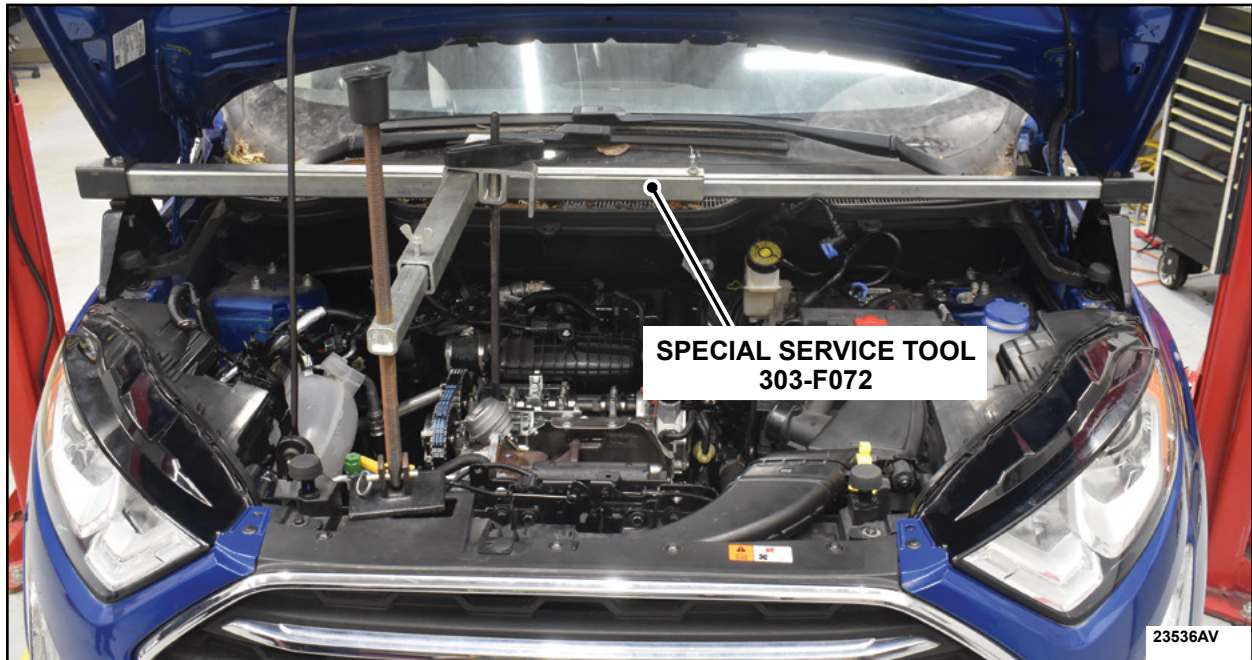
FIGURE 8

14. Install Special Service Tool 303-F072 Support Bar, Engine. Set up the engine support bar over the engine timing belt, as shown in Figure 8.

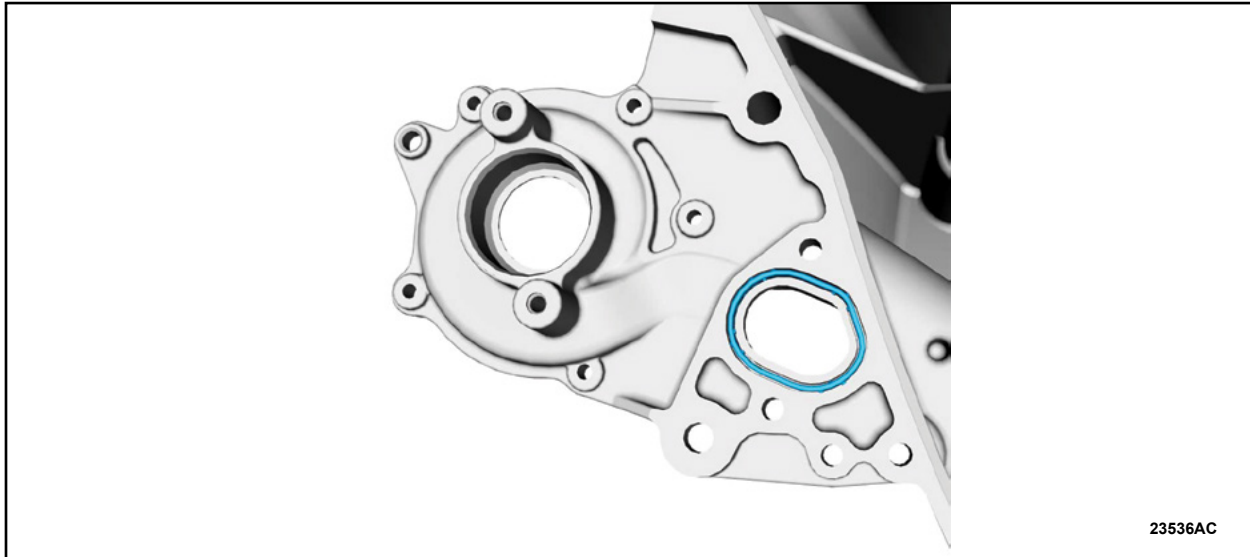
**FIGURE 33**

40. Install a new gasket. See Figure 33.

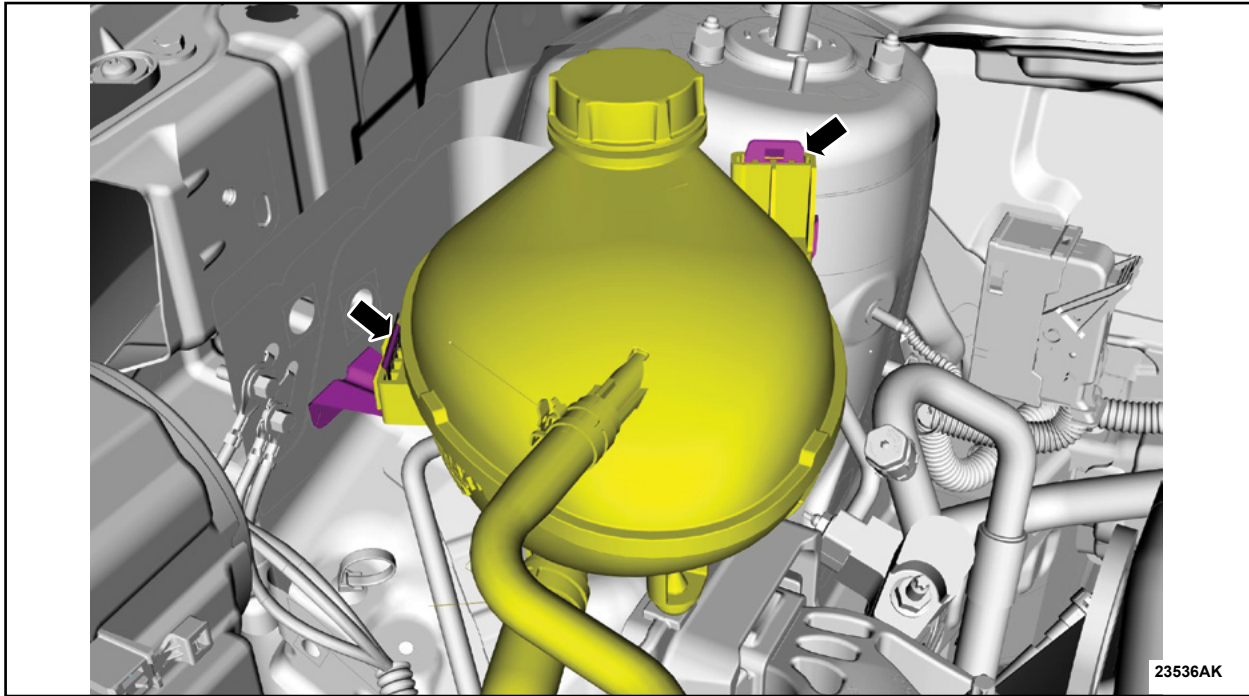
**FIGURE 41**

49. Install the degas bottle onto the tabs. See Figure 41.
