Product Safety Recall

N232396500 ABS Module Reprogramming

Release Date: January 2023

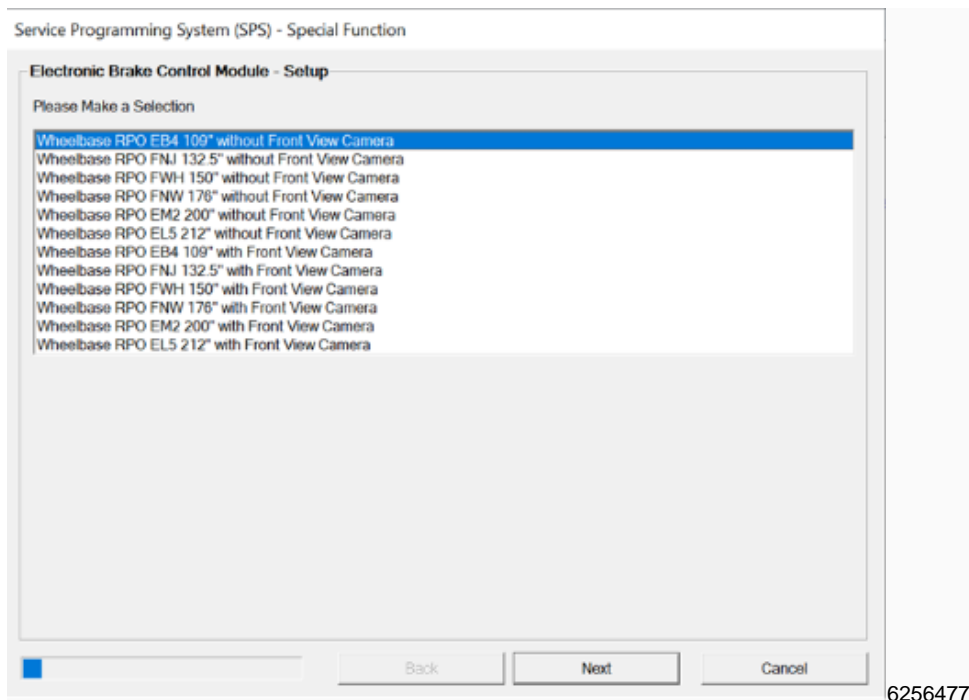
1. Reprogram the anti-lock brake control module. Refer to *Anti-Lock Brake Control Module: Programming and Setup* in SI.

Important: During the Anti-Lock Brake Control Module Setup, IVH will need to be used to determine which wheelbase selection is needed - Either EM2 or EL5 (200" or 212" wheelbase).
