Product Safety Recall

N232396500 ABS Module Reprogramming

Correction	Dealers will recalibrate the ABS module so the ESC system will function properly with the affected vehicles' wheelbases.

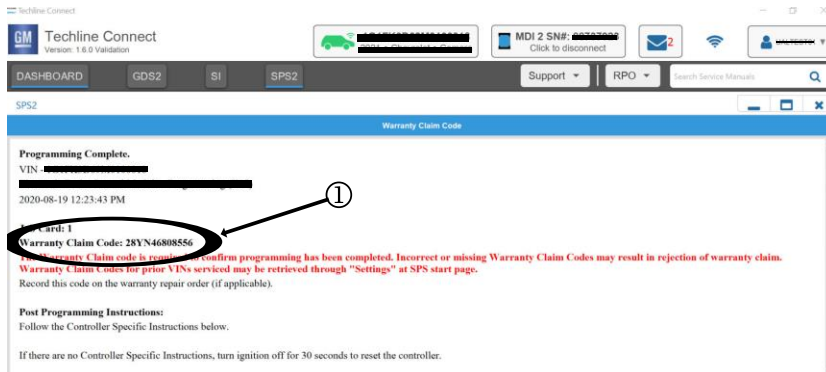
5644478

- 1.1. On the Select Controller screen, select “Anti-Lock Brake Control Module” and select “Setup” for “Select Function Sequence” in Techline connect and follow on screen instructions.

Note: The screenshot above is an example of module programming and may not be indicative of the specific module that is being programmed. Module selection and VIN information have been blacked out.
