Safety Recall

Code: 97ZZ

Subject	High Voltage (HV) Battery Management Control Module Software															
Release Date	March 29, 2023															
Affected Vehicles

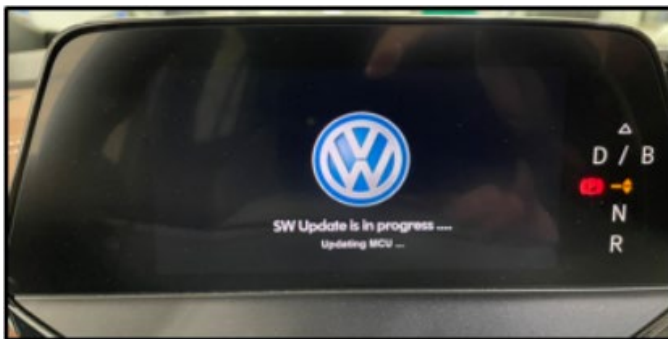
- The update will start on its own after about two minutes.
- During the update, the instrument cluster display will change multiple times.

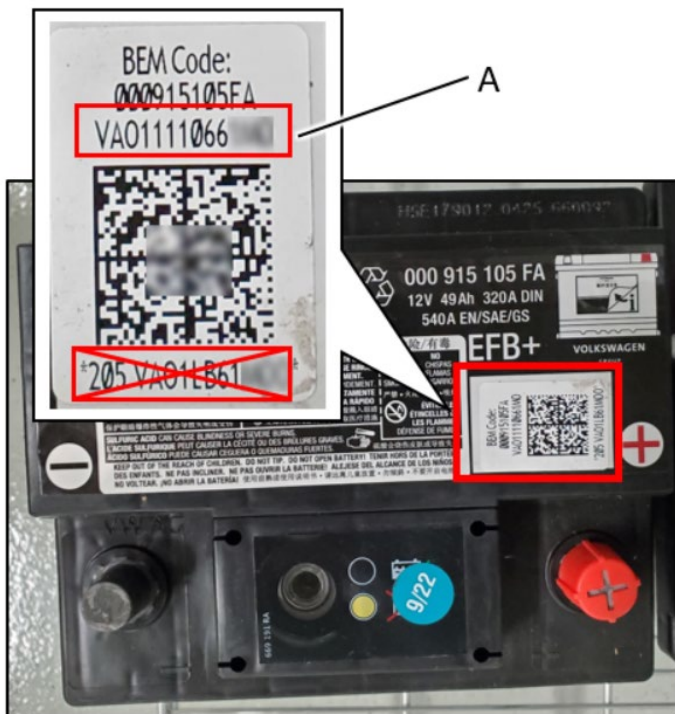
- When installing the 12V battery, record the following from both the NEW and the OLD 12V batteries:
 - Serial number <A>
 - Battery capacity
 - Battery manufacturer
- This will be required later when performing the 12V battery replacement test plan.

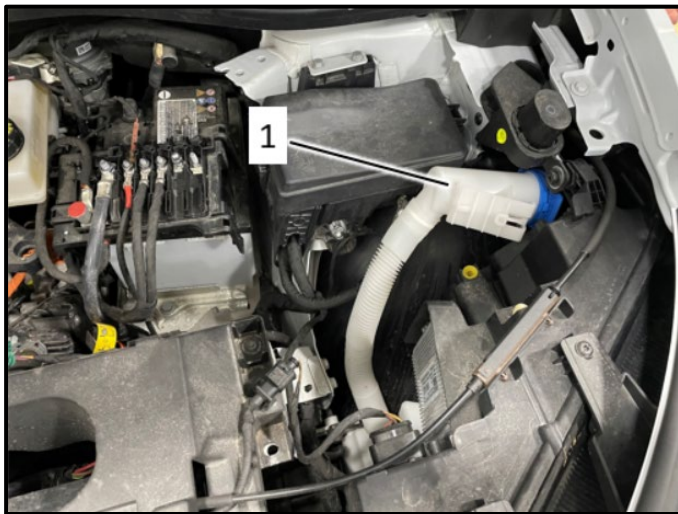
- The washer fluid filler neck will have to be unclipped and moved to the side.

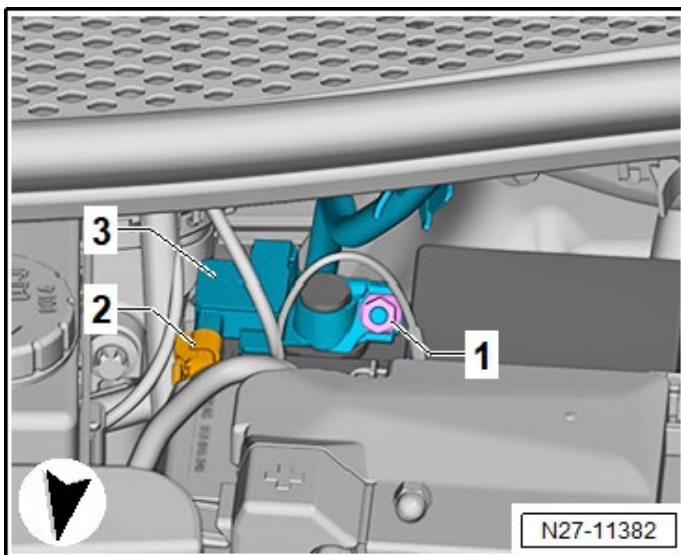
- Open the negative terminal cover above the battery monitoring control module <3>.
- Loosen the nut <1> several turns and remove the battery monitoring control module <3> from the battery negative terminal.
- Disconnect the connector <2> from the Battery Monitoring Control Module -J367-.
- Wait 1 minute.
- Check the voltage of the 12V vehicle electrical system using a commercially available voltmeter.
- The voltage must be 0V.

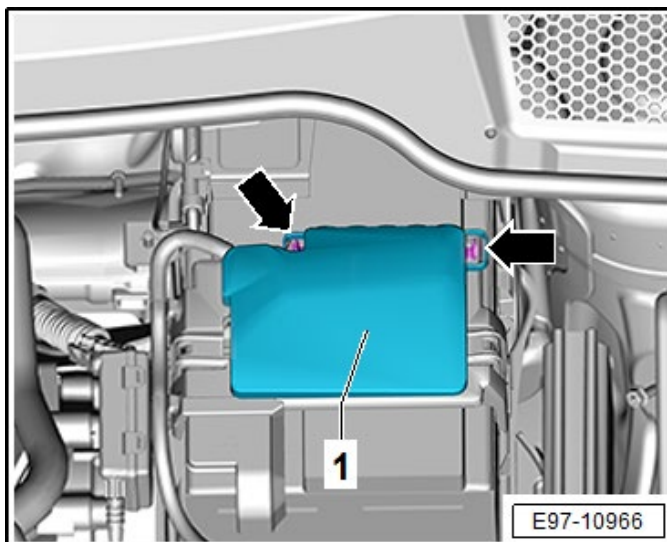
- Release the hooks <arrows>.
- Remove the cover <1>.

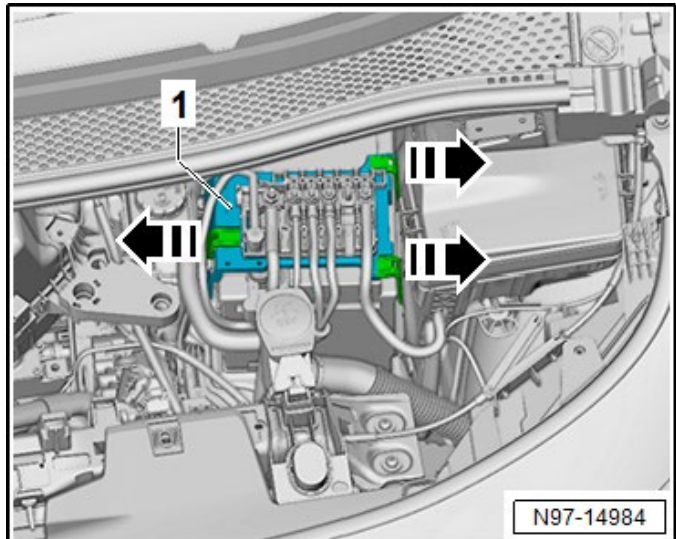
- Release the retaining straps for the bracket for fuse panel A <1> in the direction of <arrow>.
- Remove the bracket for fuse panel A <1> and move it to the side with the wires still connected.

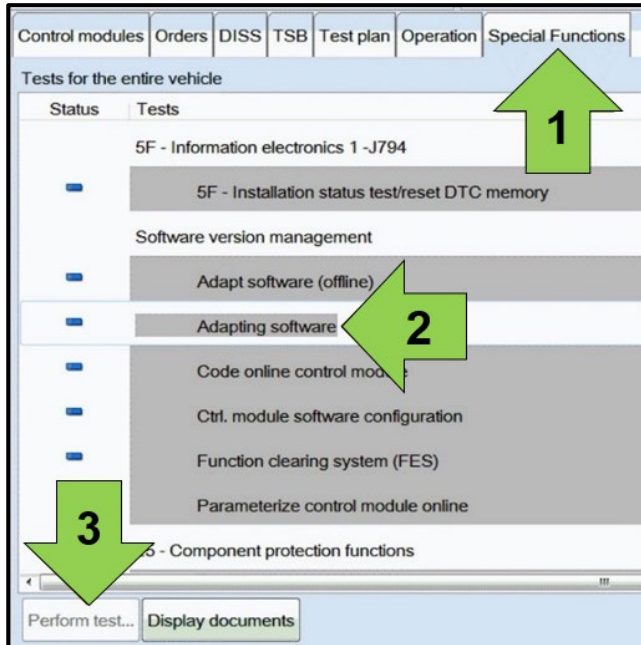
- Once the GFF scan is complete, select “Special functions” <arrow 1>, then “Adapting software” <arrow 2>, then select “Perform test” <arrow 3>.

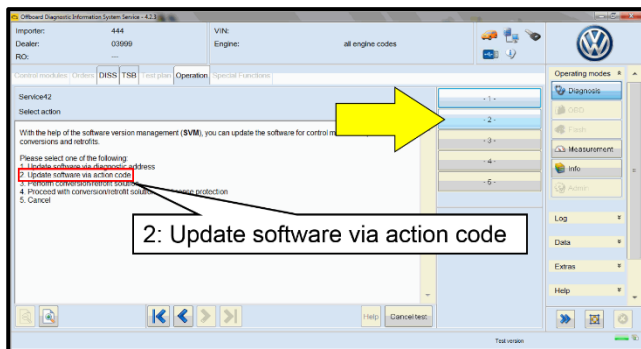
- Select the correct option to “Update software via action code”.

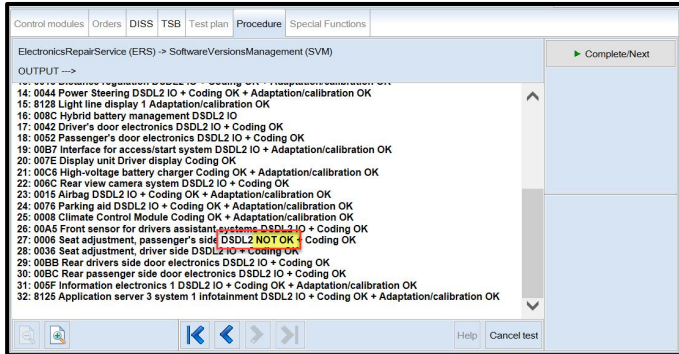
- Pay attention to the status report of the control module updates.
- Any module stating NOT OK will have to be updated again.
- Selecting “Complete/Next” will begin another attempt to update the control module.
- It may take more than one attempt to update every control module.

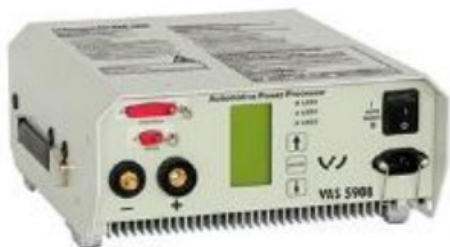
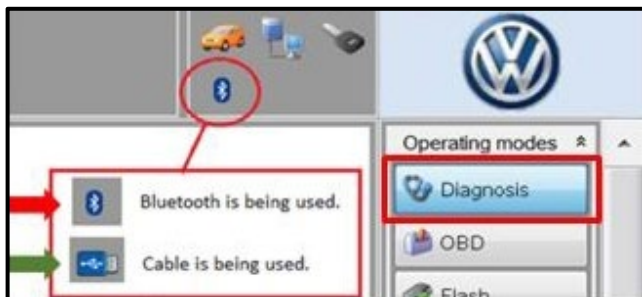
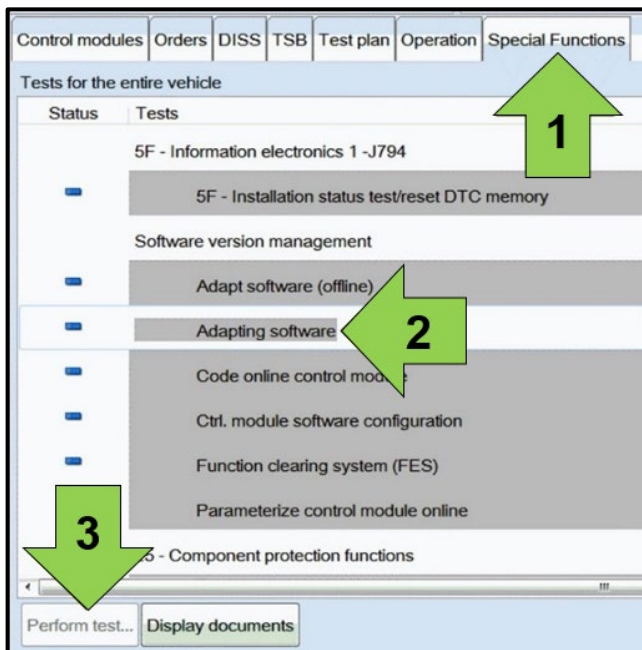
Step 5 – Perform Software Configuration via SVM

- Turn battery charger OFF, then back ON.
- Connect battery charger.
- Turn the hazards on.
- Confirm that scan tool is communicating with the diagnostic head by USB <Green Arrow>.
 - If the Bluetooth symbol is shown <Red Arrow> then disconnect the diagnostic head from the vehicle and reconnect the USB cable to the diagnostic head and then reattach to the vehicle.
- Upon ODIS startup, verify the “Diagnosis” operating mode is selected <as shown>.
- Once the GFF scan is complete, select “Special functions” <arrow 1>, then “Adapting software” <arrow 2>, then select “Perform test” <arrow 3>.

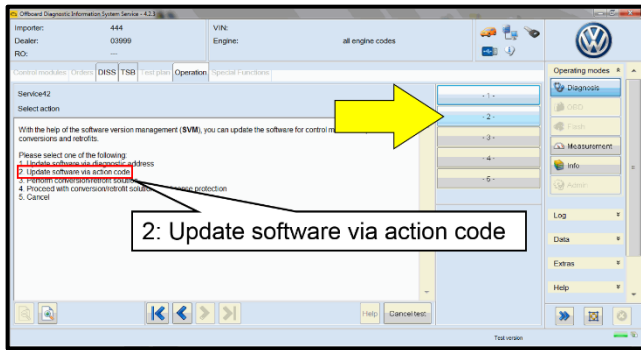
- Select the correct option to “Update software via action code”.

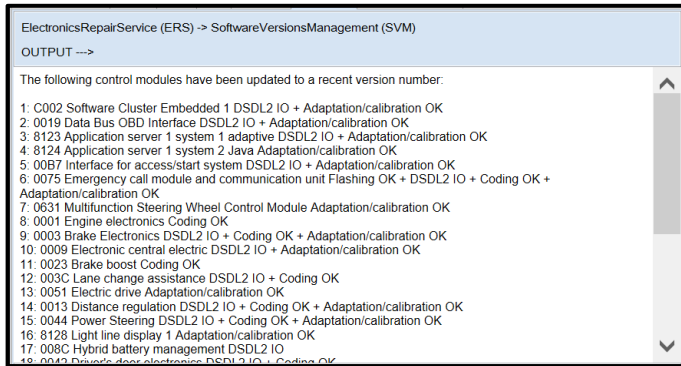
SVM code
S313

- Select “Accept” <arrow> and follow the on screen prompts.
- Pay attention to the status report of the control module updates.
- Any module stating NOT OK will have to be updated again.
- Selecting “Complete/Next” will begin another attempt to update the control module.
- Do not end the diagnostic session.

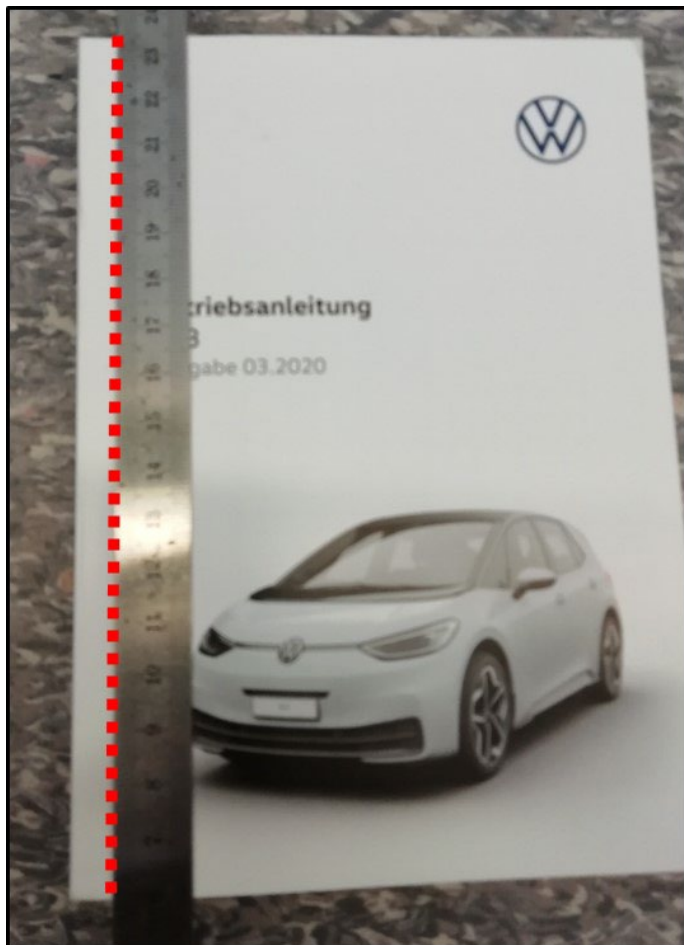
- On the first page (inside) of the owner's manual enclosed in the vehicle there is the vehicle data sticker and information on PDI and date of delivery/registration.
- To ensure this information is not lost to the customer, cut out the first page of the owner's manual with a sharp knife, as shown in the illustration <red dotted line>.
- We recommend the use of a steel ruler or another suitable implement to guide the knife and ensure a straight cutting line.
- Include the cut-out page in the new owner’s manual.
