GROUP	MODEL
Safety Recall Campaign	2015-2019MY Soul EV (PS EV)
NUMBER	DATE
SC267 (Rev 3, 09/12/2023)	August 2023

HIGH-VOLTAGE BATTERY PACK AND BATTERY MANAGEMENT SYSTEM (SC267)

HV BATTERY PACK AND BATTERY MANAGEMENT SYSTEM (SC267)**ECU Upgrade Procedure:**

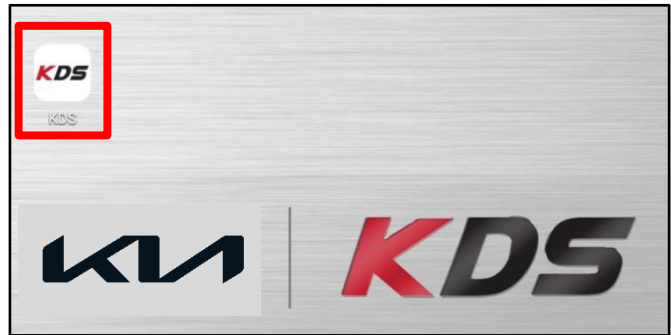
- With the ignition ON, turn ON the KDS tablet. Select 'KDS' from the home screen.

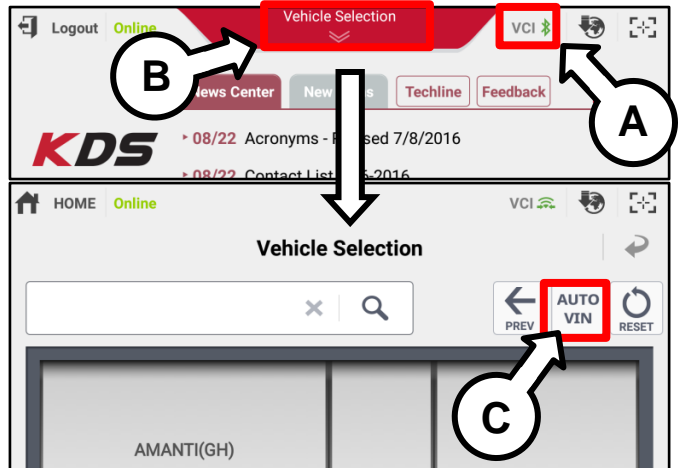
- Confirm communication with VCI (A) and then configure the vehicle (B) using the 'AUTO VIN' (C) feature.

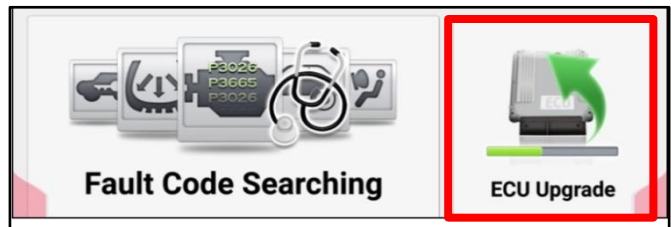
- Select 'ECU Upgrade'.

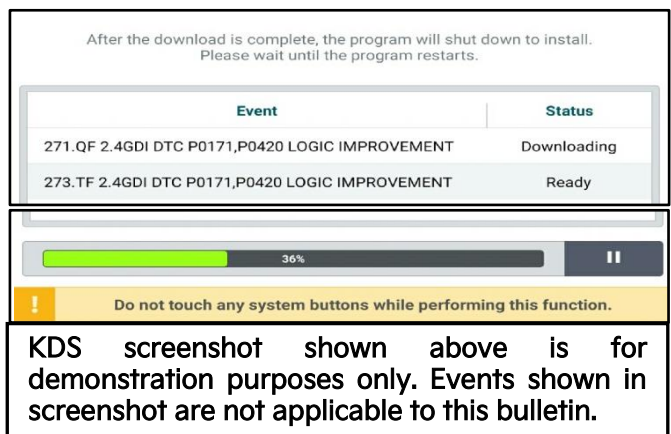
- The KDS will check the server for recently uploaded Events and then automatically download Upgrade Event #697.

The vehicle must be identified in Vehicle Selection to download an Event for that vehicle.

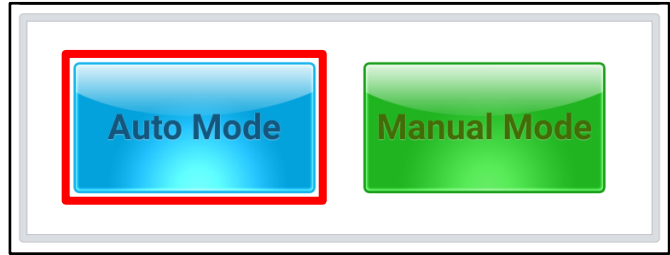
6a. Select 'Auto Mode'. (18-19MY)

Do NOT attempt to perform a Manual Mode upgrade UNLESS Auto Mode fails. Always follow the instructions given on the KDS in either Auto or Manual mode.

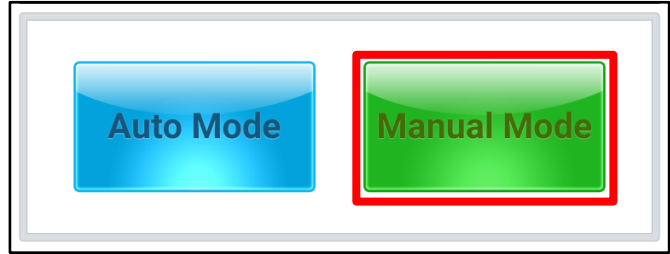
6b. Select 'Manual Mode' (15-17MY) ONLY

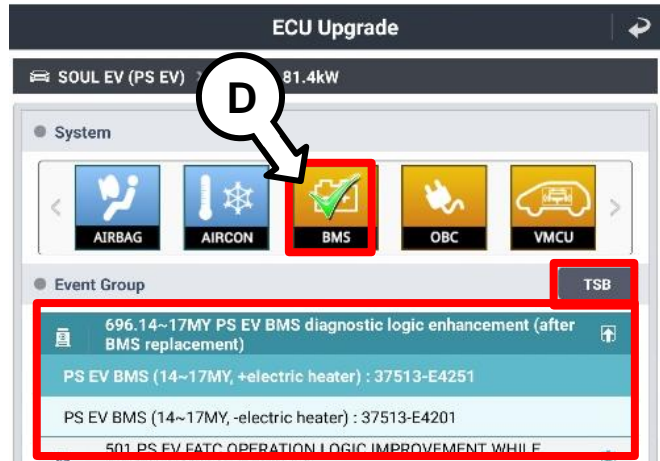
7. Select 'BMS' system and confirm the applicable Event #696 or #697.

Note: Event #696 for 15-17MY PS EV will not appear in the upgrade events list as it needs to be performed in 'Manual Mode' only.

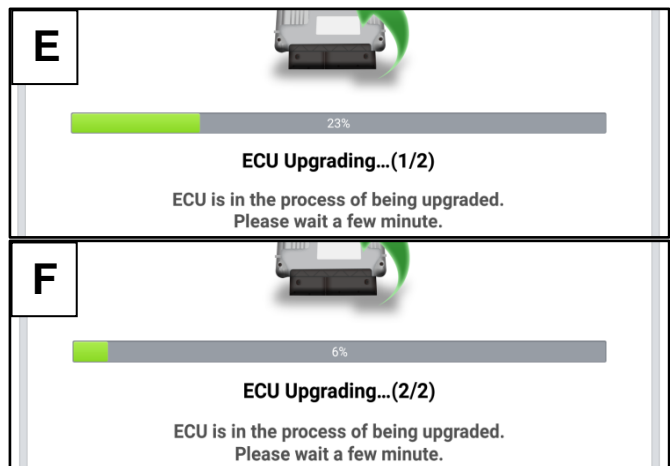
8. The ECU upgrade will begin and the progress of the upgrade will appear on the bar graph. Upgrade part (1/2) (E) will download the upgrade event to the VCI-II. Upgrade part (2/2) (F) will upgrade the ECU.

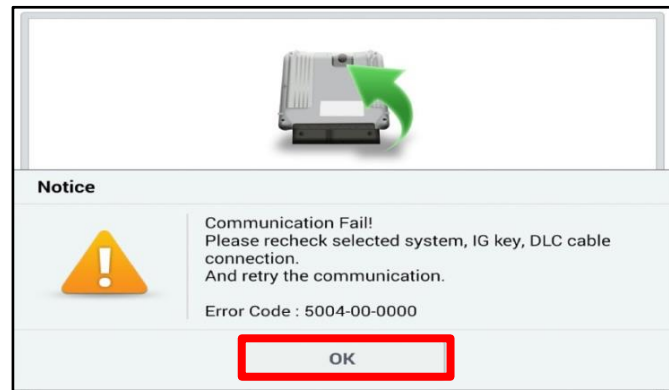
9. If a "Communication Fail" screen appears, verify that the VCI-II and KDS are communicating properly. Select 'OK' and restart the from step 4.

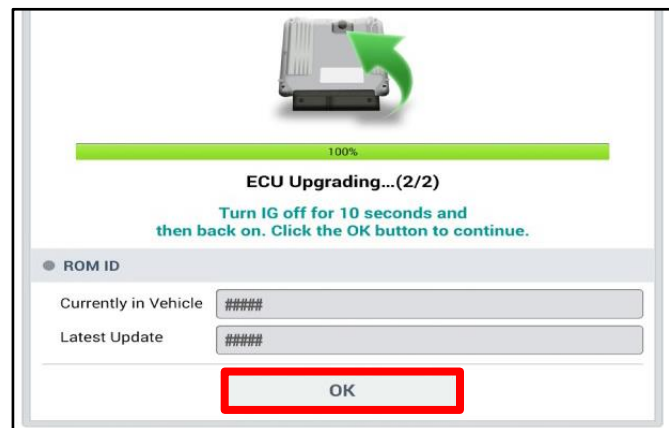
10. When instructed on the KDS, turn the ignition OFF for ten (10) seconds then back on. Select 'OK' to continue.

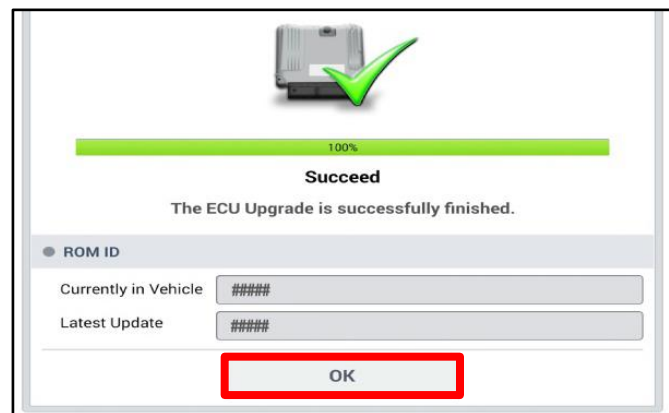
11. Once the upgrade is complete, select 'OK' to finalize the procedure.

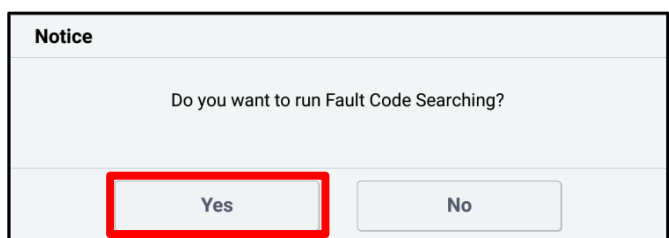
12. When prompted, select 'YES' to check for Diagnostic Trouble Codes (DTC) and erase any DTCs stored such as EPS, ESC, and TPMS that may have been set during the upgrade.

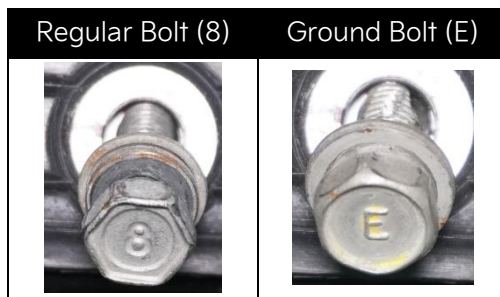
1. Remove the BPA upper case (A) by referring to "EV Battery System → High Voltage Battery System → Case → Repair procedures (Removal)" in the applicable Shop Manual on KGIS. Refer to KGIS for bolt/nut torque specs.

Mark the six (6) 'ground' bolts and their location to prevent mixing with regular bolt prior to reassembly.

Ground Bolt (E): 6 ea.

Regular Bolt (8): 35 ea.

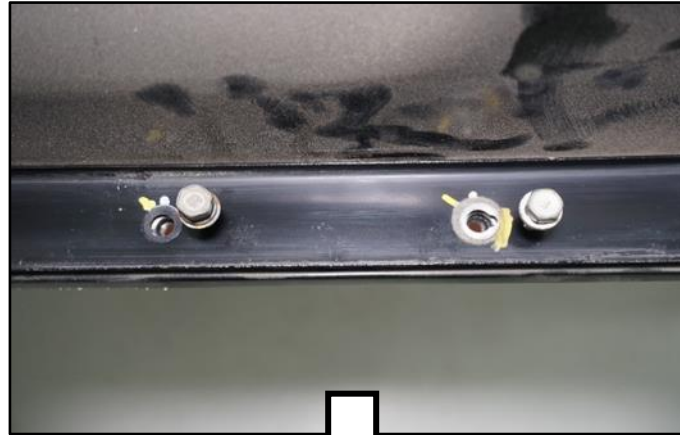
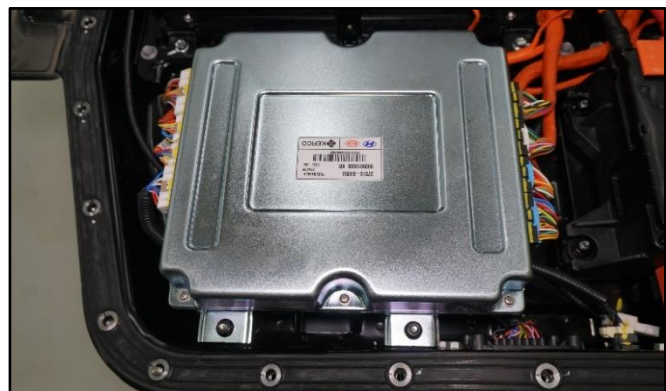
2. Replace the BMS ECU by referring to "EV Battery System → High Voltage Battery Control System → Battery Management System (BMS) ECU → Repair procedures (Removal)" in the applicable Shop Manual on KGIS.
3. Proceed to page 10 to replace the Voltage & Temperature Sensor Wiring Harness (VTSWH).

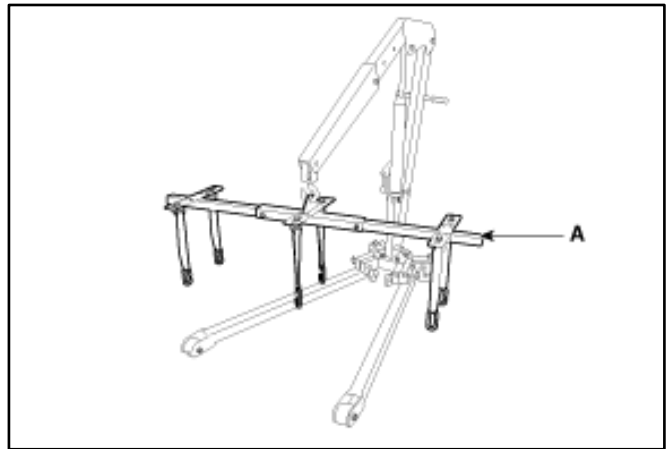
Note: SST OK375 E4300 and crane jack are required.

2. Place the battery on a clean and flat bench surface area.

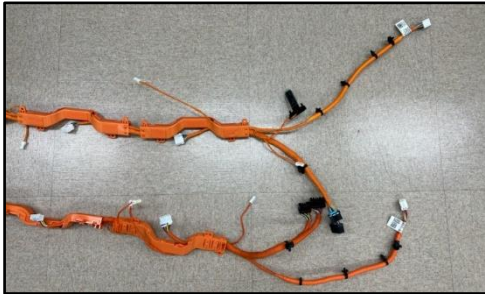
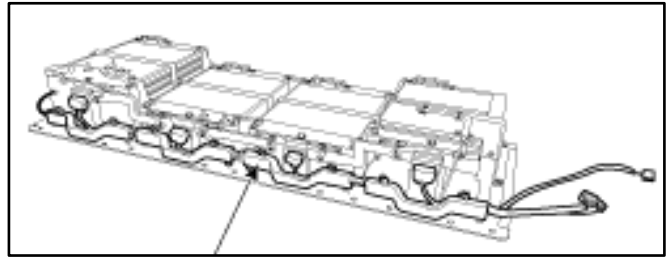
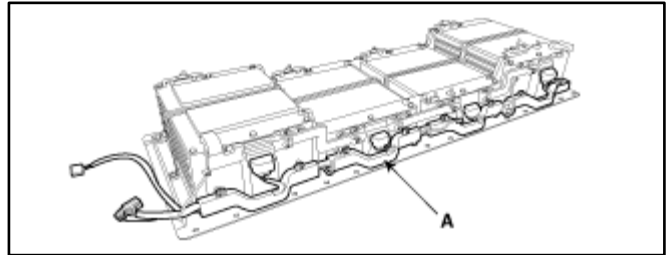
- Replace the two voltage temperature sensor wire harnesses (VTSWH) with the new parts.

Note: The new harness is different for the removed harness when compared side by side.

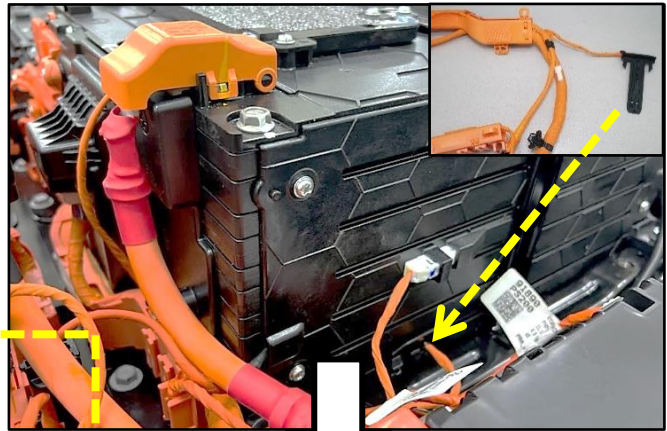
- During re-assembly, insert the battery temperature sensor into the battery pack lower side area shown.

Connect the outside temperature sensor connector where shown.

Note: Some vehicles may have a remaining temperature sensor connector hole. If so, disregard, no need to connect to it.

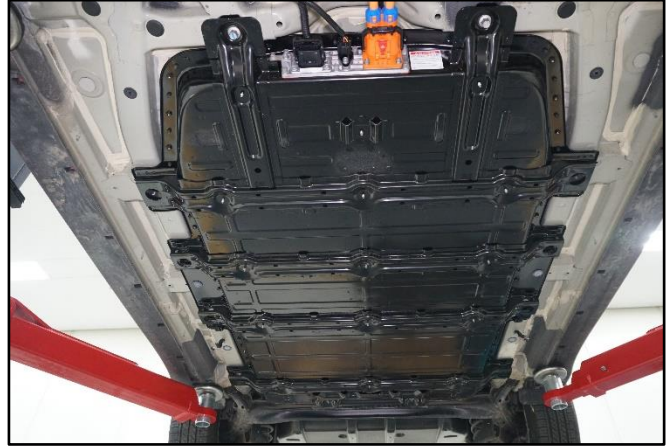
15-17MY ONLY new **BPA** is equipped with an "old" type harness. Be sure to swap/install the "new" type harness.

Note: SST OK375 E4300 BPA lifting jig and crane jack (A) are required.

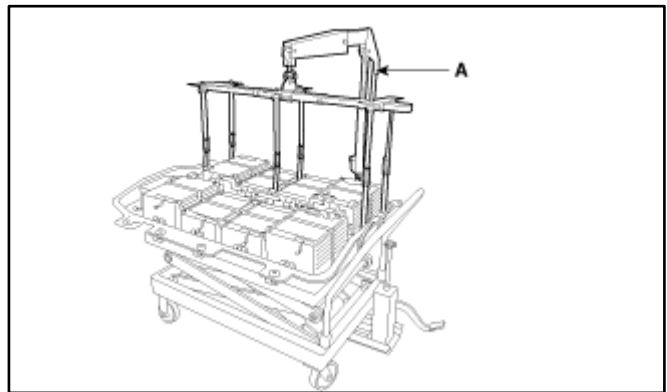
Place the removed BPA on a clean flat surface. Dealer should follow the process included in TSB ELE044 and obtain TL PWA.

Note: The battery pack assembly (BPA) consists of two (2) (left and right) battery packs.

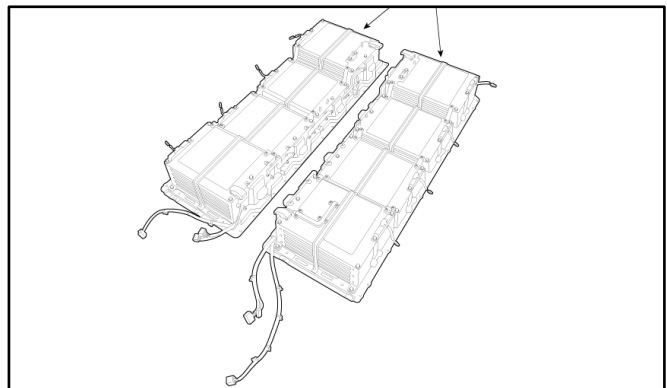
18-19MY ONLY new **BPA** is equipped with the "new" type harness. There is no need to swap.
