**Safety Recall 5823D – 2022-2023 CX-30 and 2023 CX-50 Brake Pedal Travel May Increase**

## Repair Procedure – Brake Pedal Travel May Increase Safety Recall 5823D

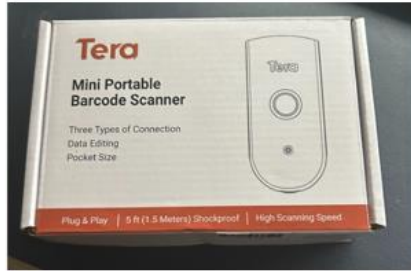
**Use the Scan Tool with the black cable only, please do not use the “Bluetooth” dongle in the SST Scan Tool box as it does not work (red X in the box photo).**

**EY-015P. ONLY USE THE USB CABLE. DO NOT USE THE USB DONGLE TO SCAN**

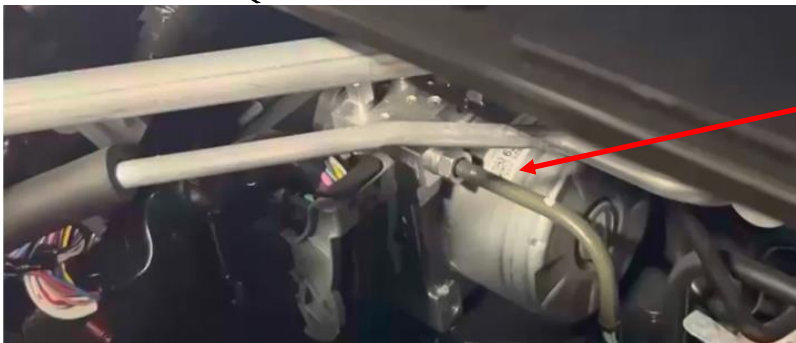
3. With the hood raised, place the Laptop on the Engine Cover with the USB Scan Tool Connected. Locate the ABS Unit (DSC HCU) under the rear LH side engine bay. You will need to scan the QR Code on the ABS Unit.

4. Place the cursor in the “ABS HCU SERIAL NUMBER” Field. Using the Barcode Scanner, Press and Hold the Orange button and scan the QR Code on the ABS Unit (DSC HCU). [Click Here to see a VIDEO on how to scan the QR Code “Video to Scan QR Code. This VIDEO is also available in MGSS under the 5823D Documents.](#)
