GROUP	MODEL
Safety Recall Campaign	2023MY Multiple Models Listed on Page 9.
NUMBER	DATE
SC270 (Rev 1, 08/07/2023)	May 2023

CLUSTER DISPLAY LOGIC IMPROVEMENT (SC270)

This bulletin provides the procedure to inspect and, if necessary, upgrade the software logic of the cluster (CLU) system on certain 2023MY vehicles listed in the table on page 9, which may exhibit cluster booting errors. Such booting errors can cause the instrument cluster screen to become blank resulting in the driver's inability to see the telltales and indicators required by certain Federal Motor Vehicle Safety Standards (FMVSS). As a result, the subject vehicles fail to comply with the visibility and illumination requirements of FMVSS No. 101, "Controls and Displays", and other illumination requirements of FMVSS No. 138, "Tire Pressure Monitoring Systems" and FMVSS No. 208, "Occupant Crash Protection". The failure to illuminate certain telltales and indicators may increase the risk of a crash. Follow the procedure outlined in this publication to apply the improved logic to the 'Cluster' system using the KDS ECU Upgrade function as described in this bulletin. For confirmation that the latest reflash has been appli

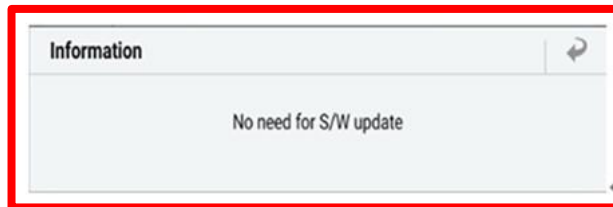
Note: Some of the affected vehicles included in the VIN list may NOT REQUIRE the S/W upgrade. If so, only claim the 'Cluster Display Inspection' Op Code if the message below (or similar) is displayed during the software upgrade procedure on KDS.

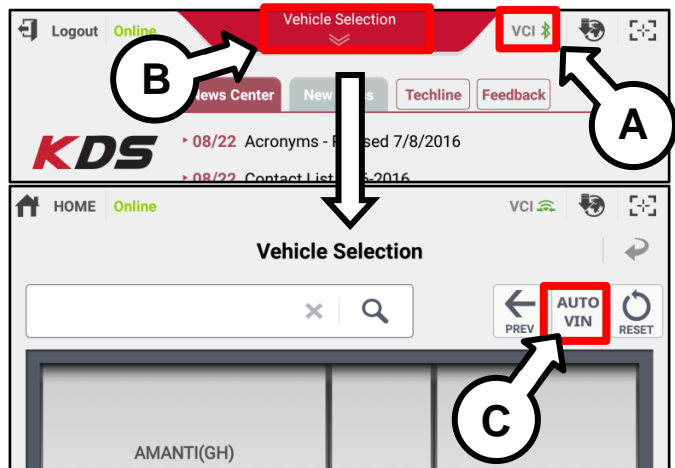
3. Confirm communication with VCI (A) and then configure the vehicle (B) using the 'AUTO VIN' (C) feature.

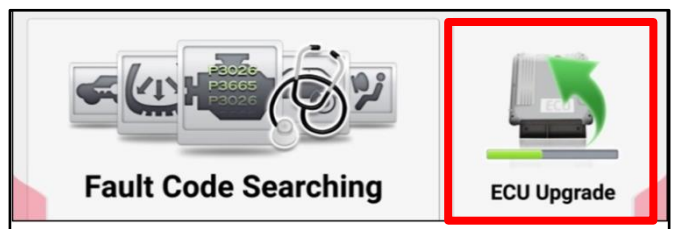
4. Select 'ECU Upgrade'.

- The KDS will check the server for recently uploaded Events and then automatically download Upgrade Event #668, 670, 672, 673, or 675.

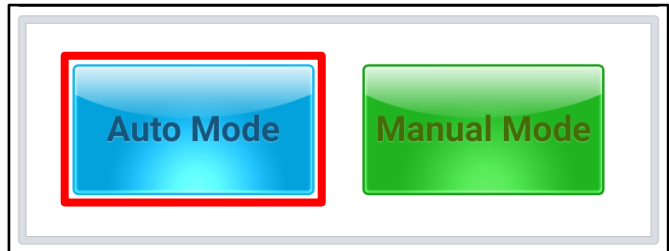
- Select Auto Mode.

- Select the CLU system under the System selection menu. Touch ID Check (D) and confirm that the latest update is available.

Select Upgrade Event:
#688, 670, 672, 673, or 675 and select 'Upgrade' to continue.

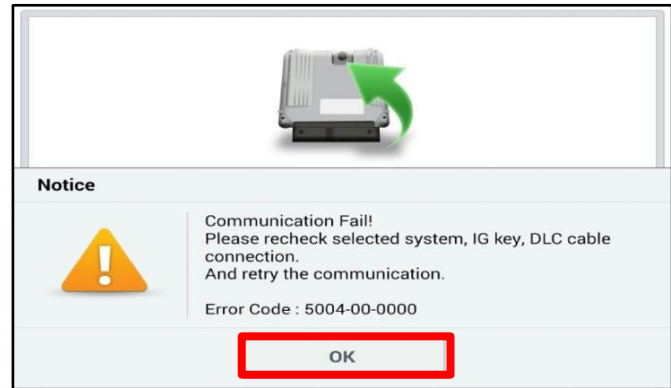
9. If a "Communication Fail" screen appears, verify that the VCI-II and KDS are communicating properly. Select 'OK' and restart the from step 4.

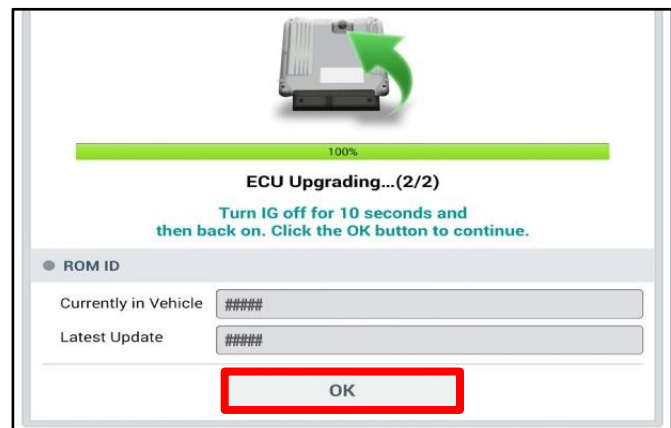
10. When instructed on the KDS, turn the ignition OFF for ten (10) seconds then back on. Select 'OK' to continue.

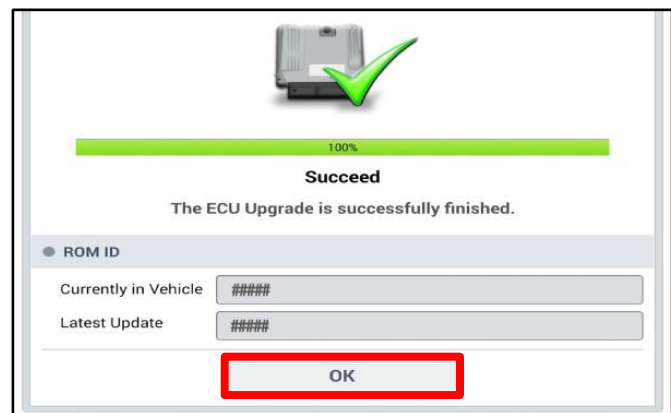
11. Once the upgrade is complete, select 'OK' to finalize the procedure.

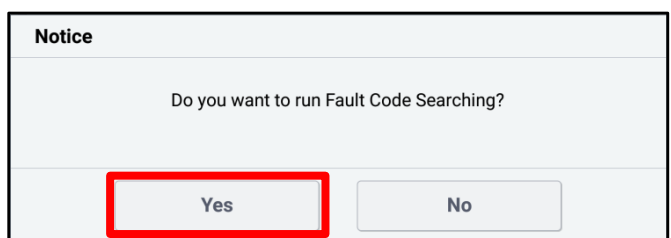
12. When prompted, select 'YES' to check for Diagnostic Trouble Codes (DTC) and erase any DTCs stored such as EPS, ESC, and TPMS that may have been set during the upgrade.
