# ***SAFETY RECALL BULLETIN***

SUBJECT: <b>ALLIANCE IN-VEHICLE INFOTAINMENT (A-IVI) OPERATION FAILURE – SAFETY RECALL CAMPAIGN</b>			No: <b>SR-23-001</b>
			DATE: <b>June 2023</b>
			MODEL: <b>See Below</b>
<b>CIRCULATE TO:</b>	<input checked="" type="checkbox"/> GENERAL MANAGER	<input checked="" type="checkbox"/> PARTS MANAGER	<input checked="" type="checkbox"/> TECHNICIAN
<input checked="" type="checkbox"/> SERVICE ADVISOR	<input checked="" type="checkbox"/> SERVICE MANAGER	<input checked="" type="checkbox"/> WARRANTY PROCESSOR	<input checked="" type="checkbox"/> SALES MANAGER

This Campaign Bulletin provides instructions to reprogram the In-Vehicle Infotainment (IVI) system with modified software.

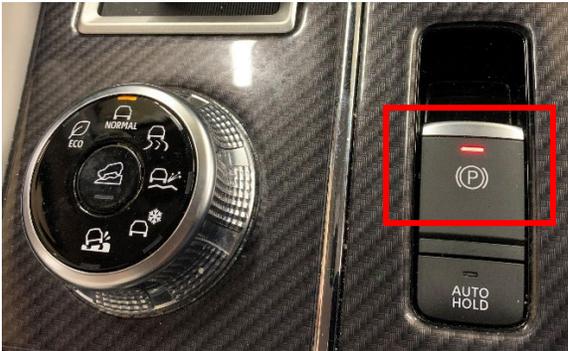
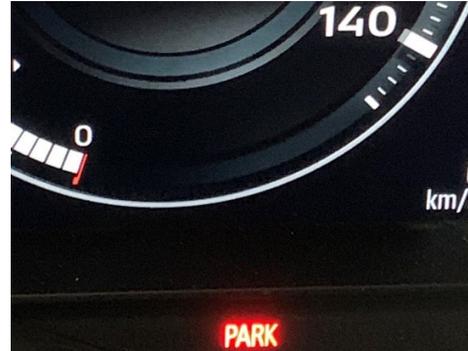
- a. Turn the engine on (set Outlander Plug-in Hybrid to "READY") and engage the parking brake. Make sure the "P" in the cluster and Parking Brake Indicator illuminates.

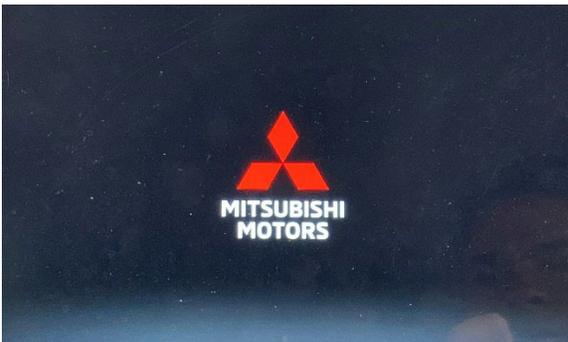
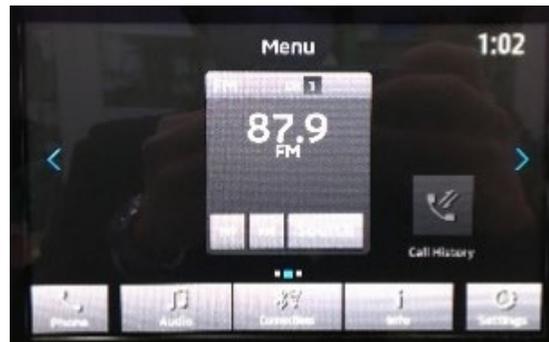
- b. The vehicle must remain idling with the parking brake ON. Never move the vehicle during software update.
- c. The IVI display may display the Mitsubishi Logo followed by the menu.  
**(Please note it may take approximately 1 minute after the power switch is turned on for the menu to display.)**

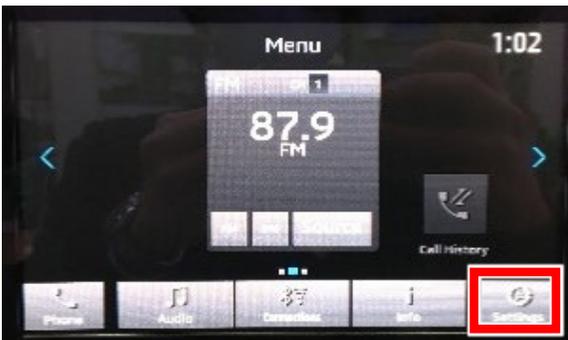
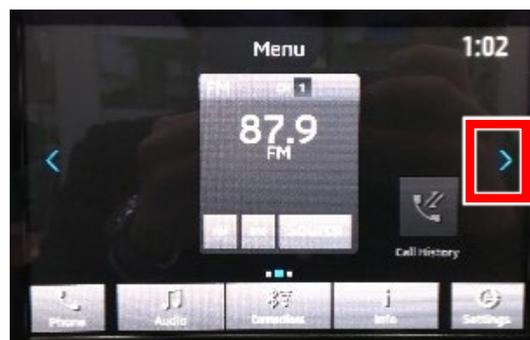
- a. Go to "Settings", then arrow right ">".

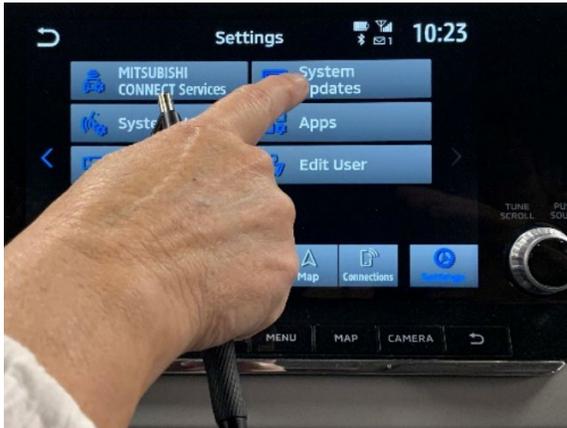
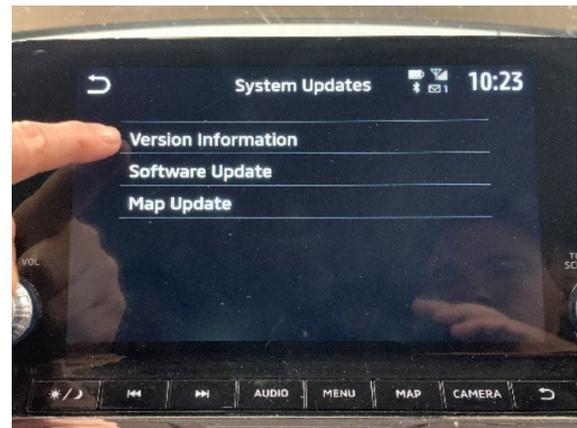
b. Go to "System Updates", then "Version Information".

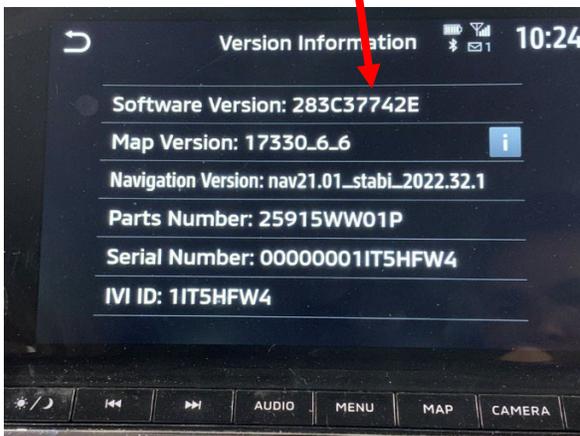
Update not Necessary

c. Check "Software Version" and determine whether updating is necessary.

Necessity of update	Software Version	Work
Required (Before counter measures)	283C35272E	Proceed to update # 3
	283C35682E	
	283C35812E	
	283C36752E	
	283C36042E	
	283C36292E	
	283C36972E	
283C37542E		
Not required (Counter measures done)	<b>283C37742E</b>	Work done

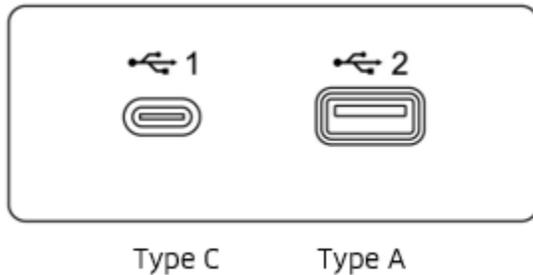
- a. Check if a device is connected to the USB port (Type: A, C) on the instrument panel, and if it is connected, inform the customer and remove it.

- The USB port on the back of the floor console is for charging use only (not connected to the navigation system), so there is no need to remove it.
- b. Check the navigation, and if route guidance is in progress, end the guidance.
  - c. Switch off the A/C system and Audio system while updating.

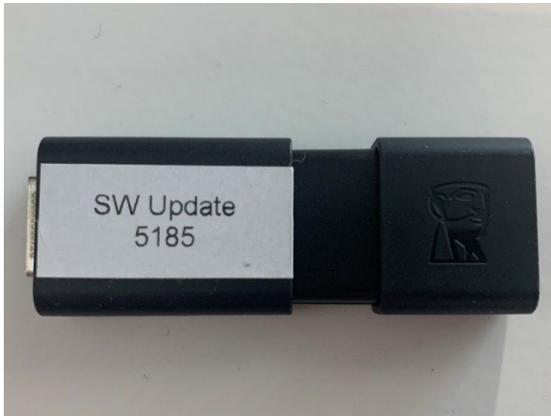
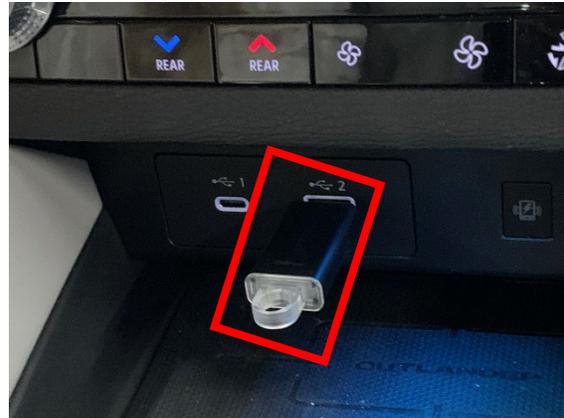
- a. Insert the USB drive for updating into the USB port (right side) on the instrument panel.

**PLEASE ONLY USE THE USB DRIVE LABELED  
"SW UPDATE 5185" WHEN PERFORMING THIS RECALL**

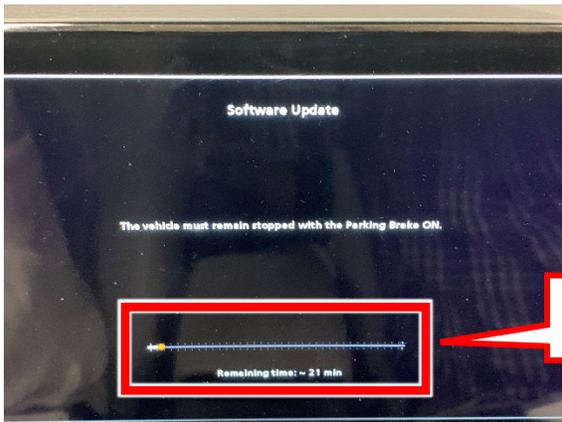
Remaining time is displayed

- The screen will switch to the "Software Update" screen and the update will automatically start.
- It takes about 20-24 minutes to complete the update.
- The time remaining until the update is completed will be displayed on the screen.

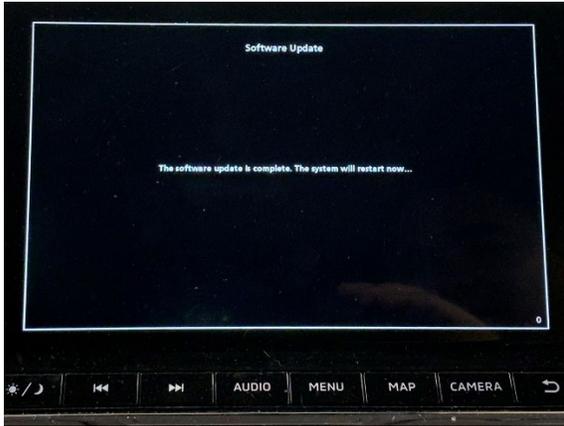
- When the update reaches 100%, the following message will appear.  
"The software update is complete. The system will restart now..."

**NOTE: Leave the USB drive in place at least 1 minute to complete the update process.**

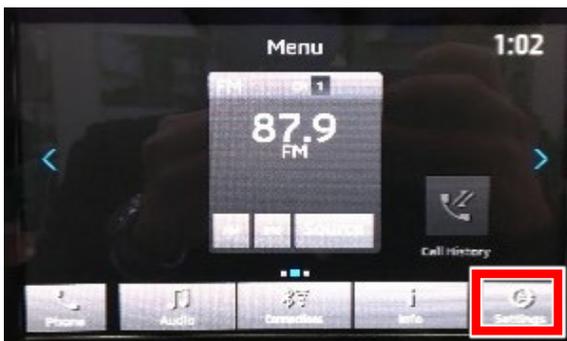
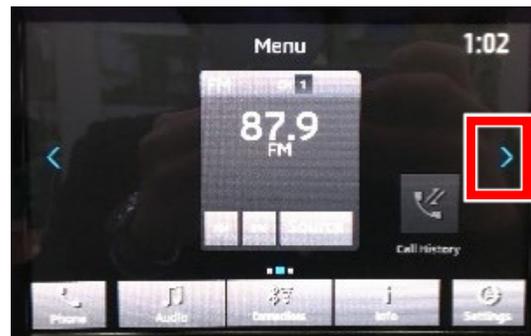
- a. Make sure that the software version is now "**283C37742E**".
- The smartphone link navigation clock is reset, but the correct time is displayed when GPS is received.
  - Go to "Settings", then arrow right ">".

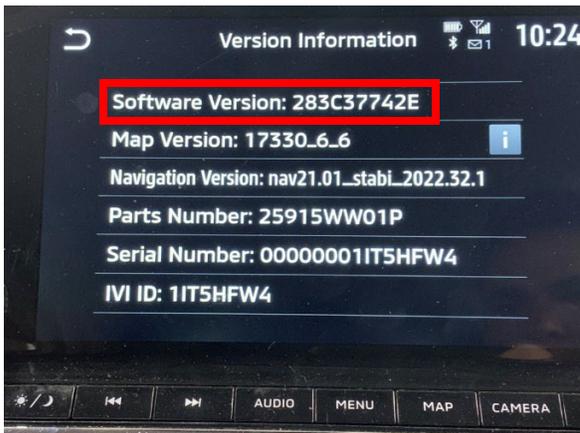
- Verify software version is "**283C37742E**".

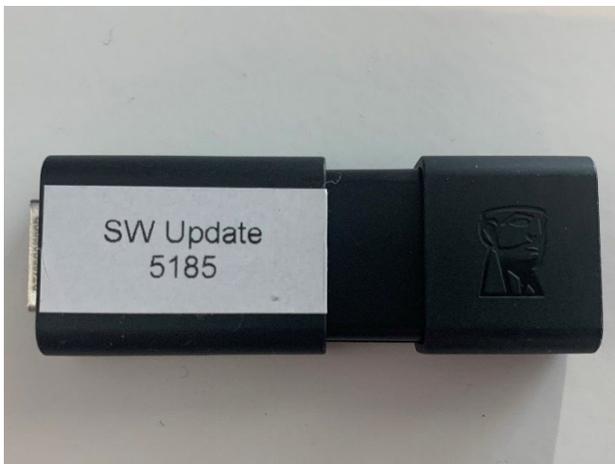
**Two USB drives containing the updated software will be sent to each dealer (Attention: Service Manager) via FedEx. Each USB drive will be labeled "SW Update 5185", as shown below:**

**PLEASE ONLY USE THE USB DRIVE LABELED SW UPDATE 5185 WHEN PERFORMING THIS RECALL**
