June 16, 2023

## Safety Recall: 2018–23 Odyssey Install FAKRA Service Cables at MOST Bus Network

## FAKRA CONNECTOR HOUSING DISASSEMBLY/FAKRA SPLICE REPAIR SERVICE CABLE ASSEMBLY PROCEDURE

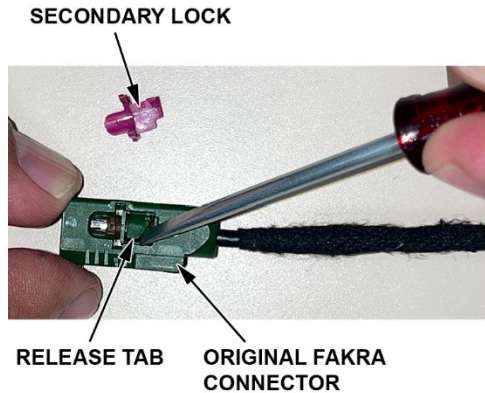
1. Use a small screwdriver, remove the secondary lock, then release the tab as shown.

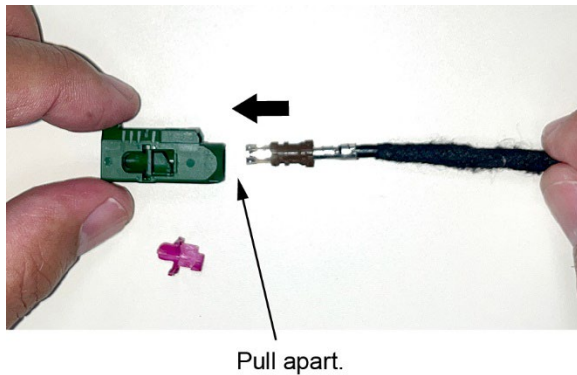
2. Pull to remove the housing form the vehicle harness. Then, **discard** the housing and lock.

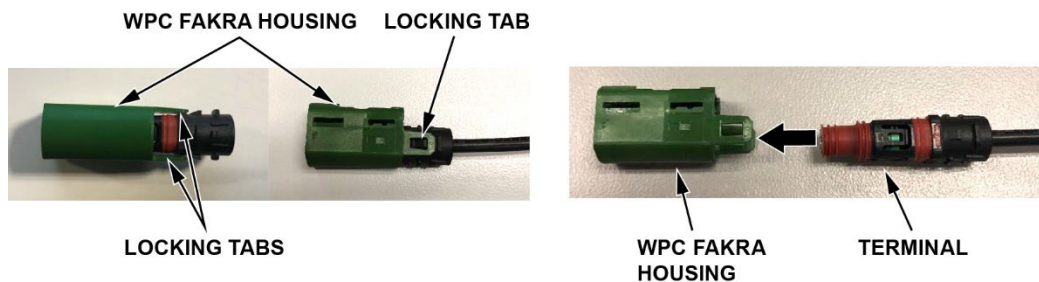
1. Release the two locking tabs on the WPC FAKRA Service Housing and remove the housing from the terminal.

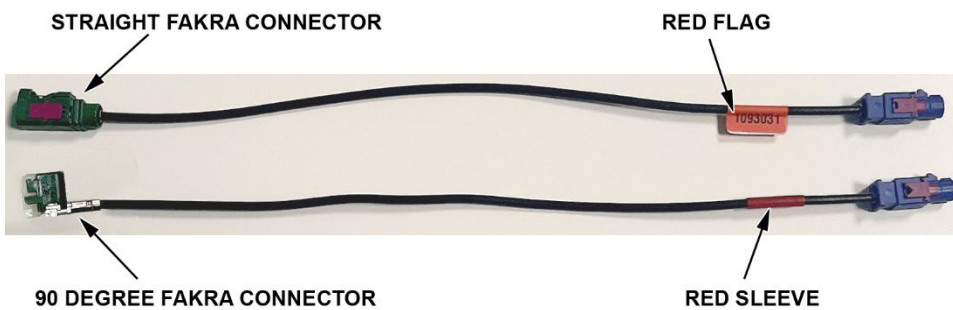
- The splice box arrow must always point in the direction of either the red flag label or red sleeve on the FAKRA splice repair service cable.
- If the splice box is installed **incorrectly**, the repair will fail; MOST ring failure conditions will still occur.

- See the above section **FAKRA CONNECTOR HOUSING DISASSEMBLY/FAKRA SPLICE REPAIR SERVICE CABLE ASSEMBLY PROCEDURE SECTION** for detailed instructions.
- **The splice box arrow must always point in the direction of the red flag label or red sleeve on the FAKRA splice repair service cable.**
- If any of the lock tabs break during installation, the splice box halve(s) must be replaced.
- If the splice box is installed **incorrectly**, the repair **will fail**; MOST Ring failure conditions will still occur.

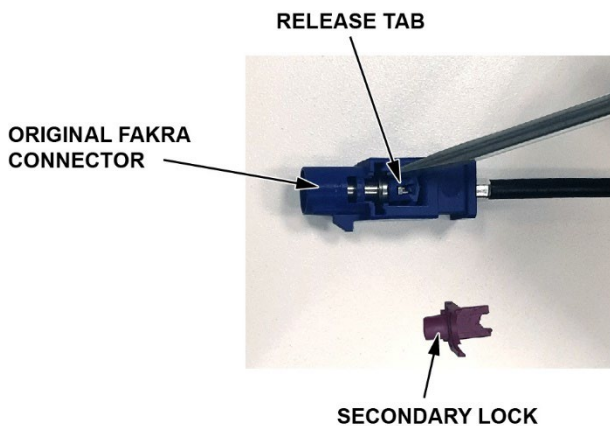
2. Use a small screwdriver to remove the secondary lock and then, release the tab.

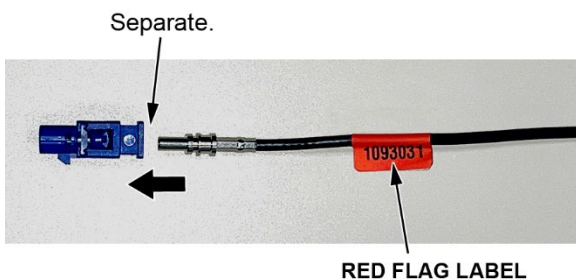
3. Pull to remove the housing from the cable and then discard the housing and secondary lock tab from the FAKRA splice repair service cable.

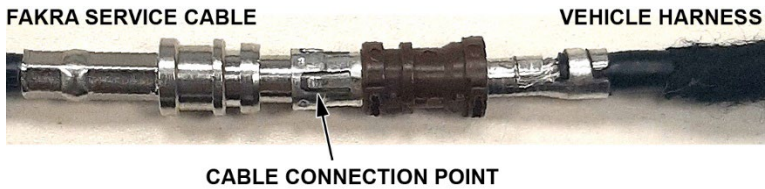
4. Connect the appropriate color FAKRA splice repair service cable to the vehicle harness.

NOTE: Always disassemble the connectors one at a time to avoid swapping the green and red wires.

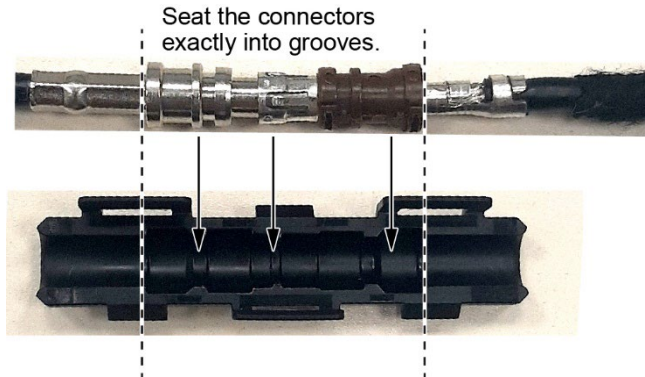
5. Attach the splice box halves to the cable connection as shown.

6. When mating the two splice box halves, **make sure** that all **6 lock tabs** are fully engaged. You may hear a click when installing the two halves.

- The splice box arrow must always point in the direction of the red flag label or red sleeve on the FAKRA splice repair service cable.
- If any of the lock tabs break during installation, the splice box half(s) must be replaced.
- If the splice box is installed **incorrectly**, the repair will fail; MOST ring failure conditions will still occur.

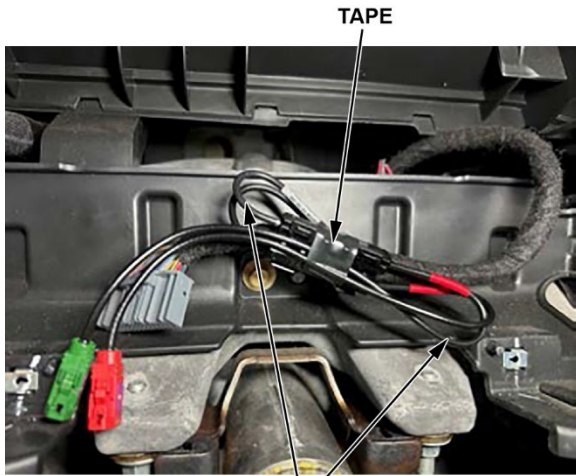
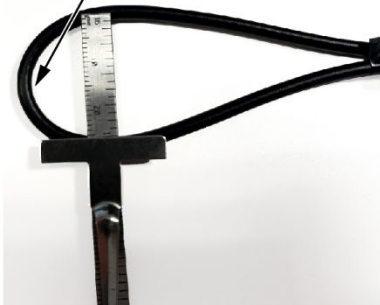
**CORRECT** ✓

8. Once the FAKRA splice repair service cables and splice boxes have been attached to the cable connection, tape the splice boxes and FAKRA service cables to the appropriate component harness.

Keep smooth curves with a radius bend greater than 25 mm.

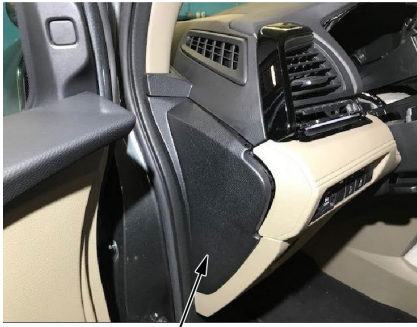
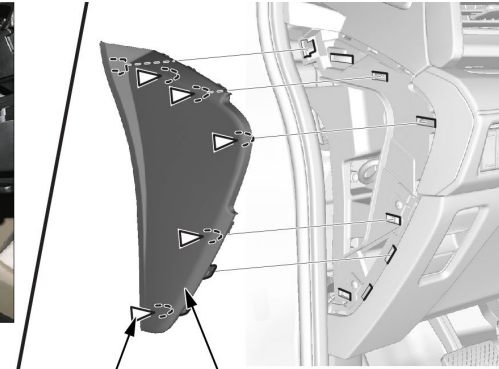
1. Remove side cover.

CLIPS (5)  
DASHBOARD  
SIDE COVER

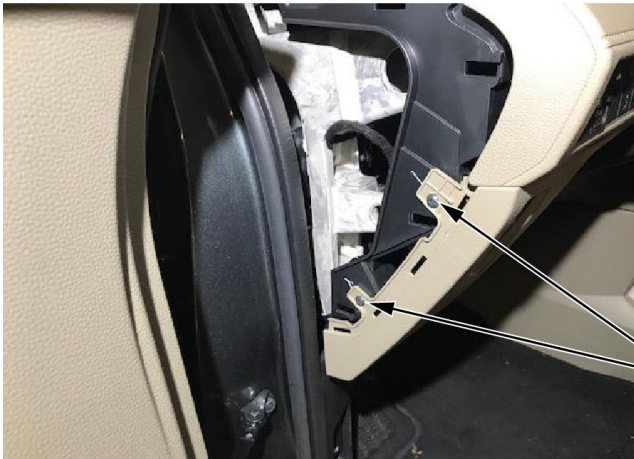
SCREWS

2. Remove the two screws.

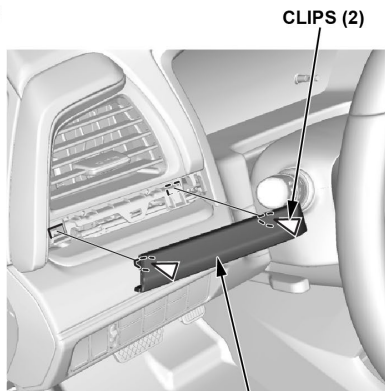
3. Remove the lower vent covers.

CLIPS (2)  
LOWER VENT COVER

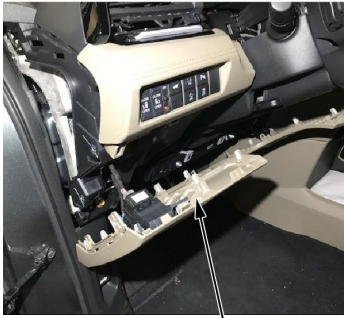
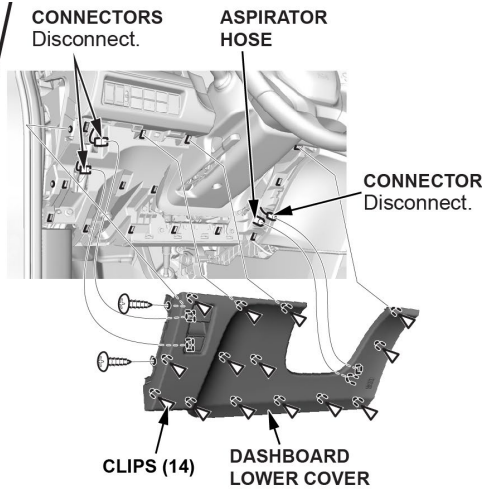
LOWER DASH PANEL

4. Remove the lower dash panel.

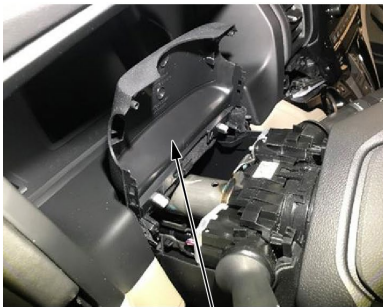
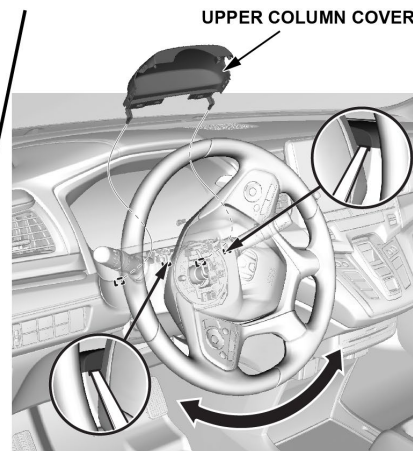
UPPER COLUMN COVER

5. Loosen the upper column cover.

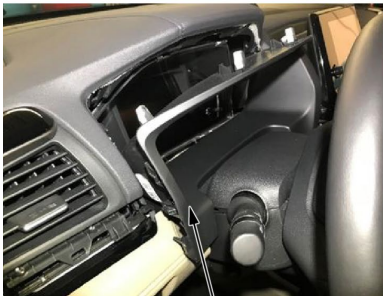
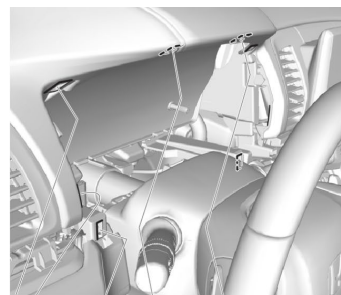
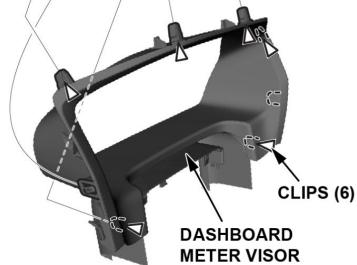
DASHBOARD  
METER VISOR

6. Disengage the clips around the meter bezel. Then remove the meter bezel and upper column cover as one piece.

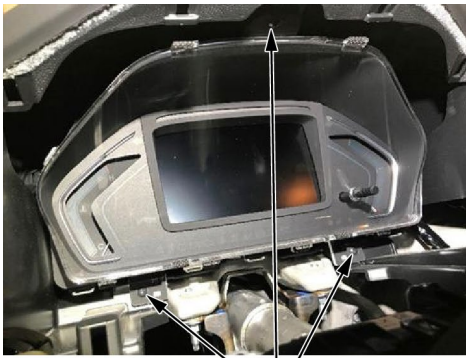
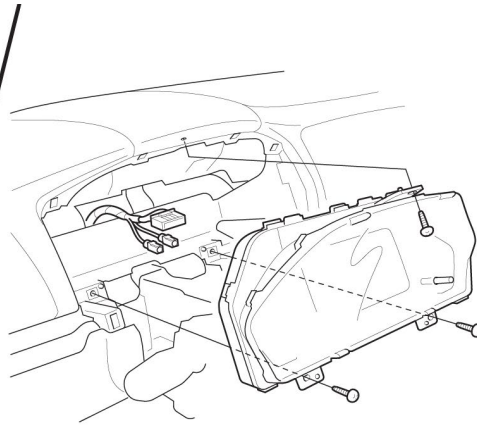
SCREWS

7. Remove the three screws holding the gauge control module.

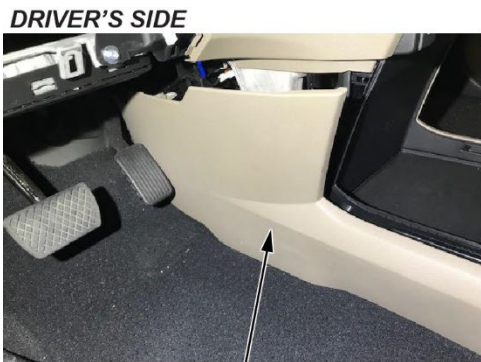
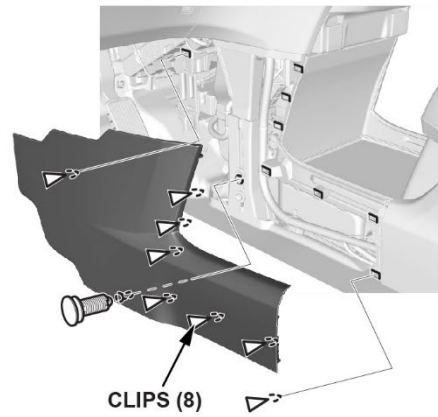
DRIVER LOWER  
CONSOLE PANEL

8. Remove the driver's side lower console panel.

CLIPS (8)

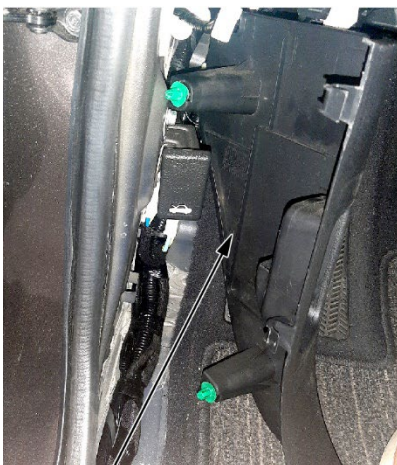
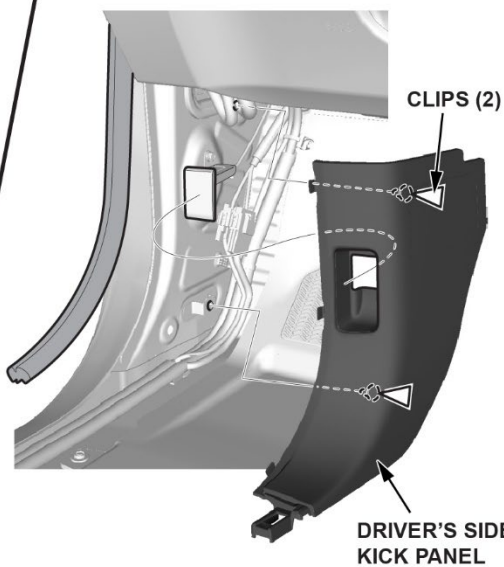
DRIVER'S SIDE  
KICK PANEL

9. Remove the driver's side kick panel.

CLIPS (2)

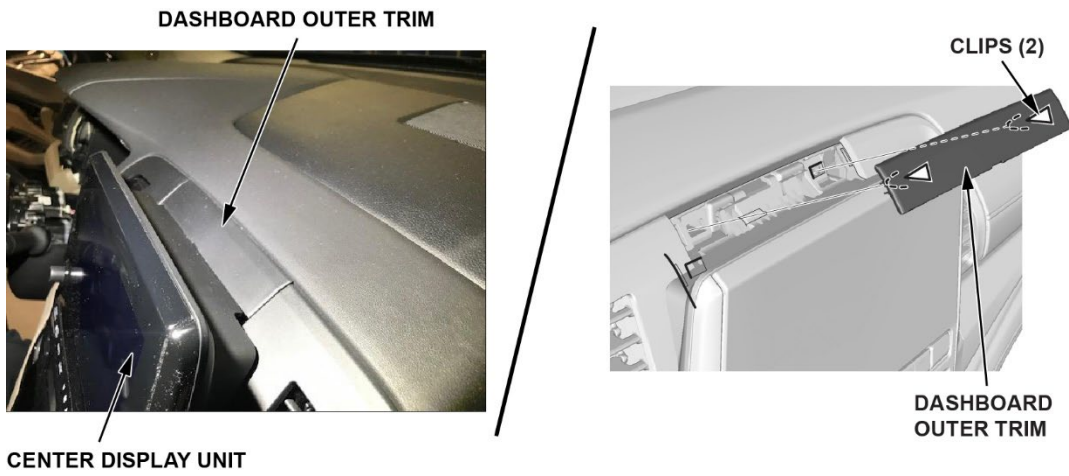
10. Remove the cover above the center display unit.

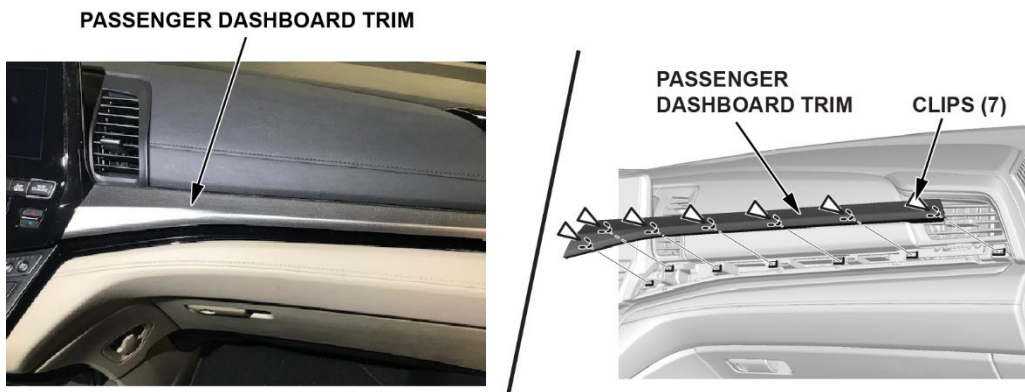
11. Remove the center dash trim.

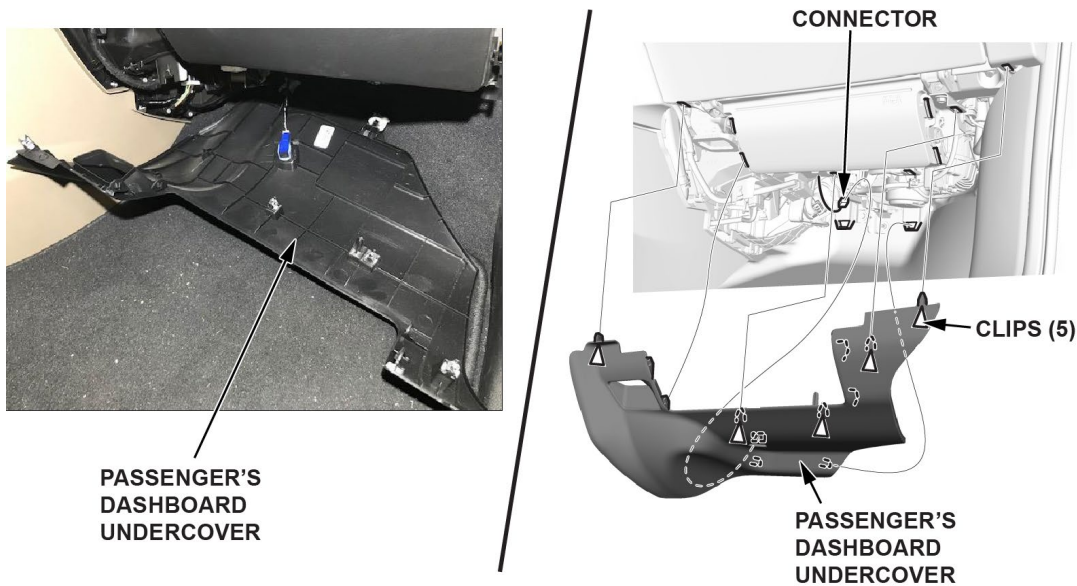
12. Remove the passenger side lower panel.

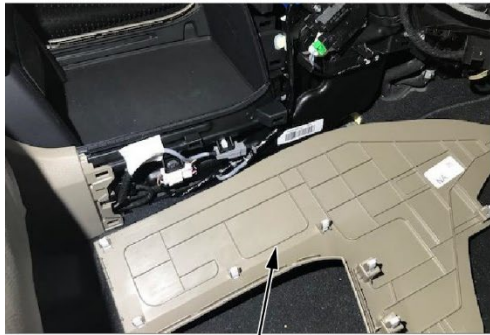
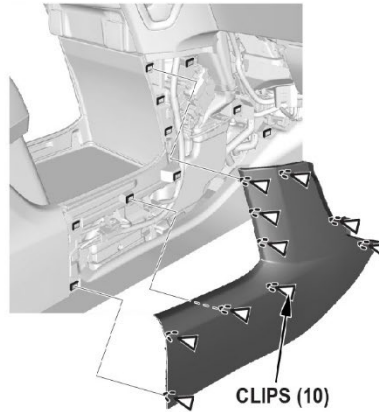
**PASSENGER LOWER  
CONSOLE PANEL**

13. Remove the passenger lower console panel.

**PASSENGER'S SIDE**

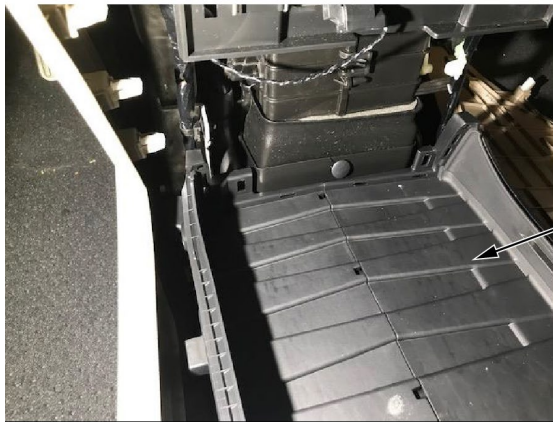
**RUBBER  
LINER**

14. Remove the rubber liner and pull back the lower console cover.

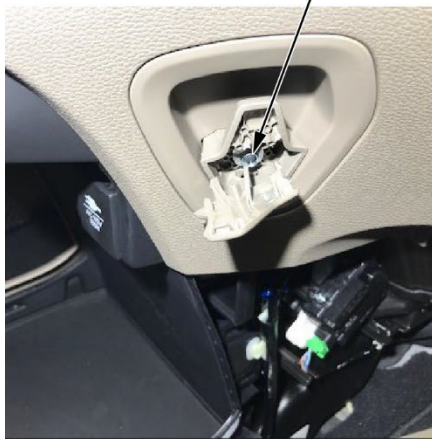
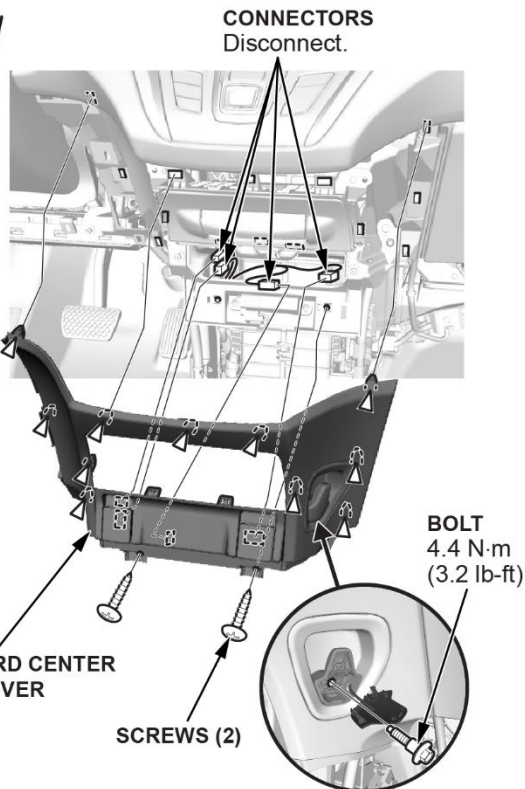
**BOLT**

15. Remove the dashboard center lower cover and bolt as well as any connectors.

**CONNECTORS  
Disconnect.**

**BOLT  
4.4 N-m  
(3.2 lb-ft)**

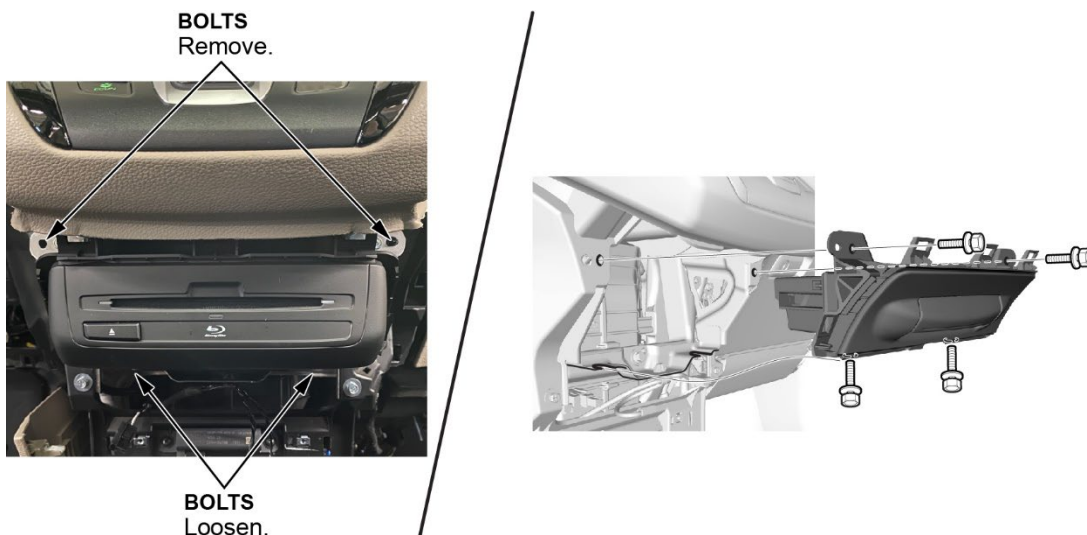
16. On the DVD player or center pocket, remove the two upper bolts; loosen the two lower bolts.

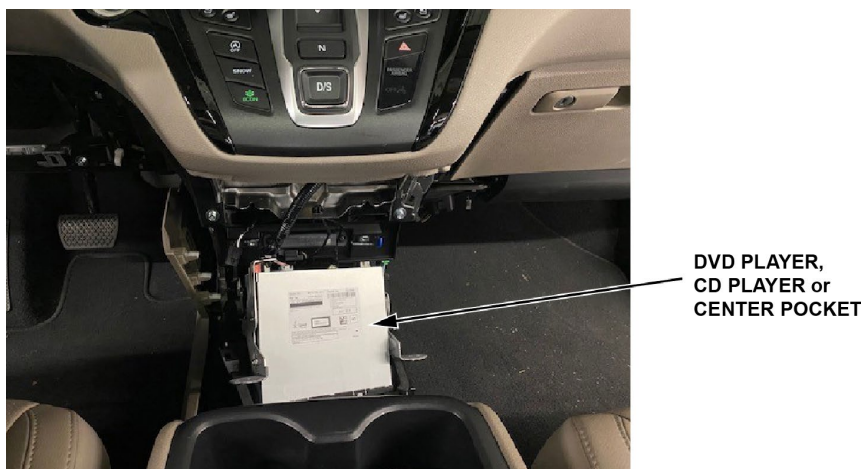
17. Remove the DVD player or center pocket to gain access to the two 8 mm bolts holding the Infotainment Control Unit.

20. While looking upward from underneath (where the DVD player, CD player, or center pocket was located) loosen the two 8 mm bolts holding the infotainment unit, then remove the unit.

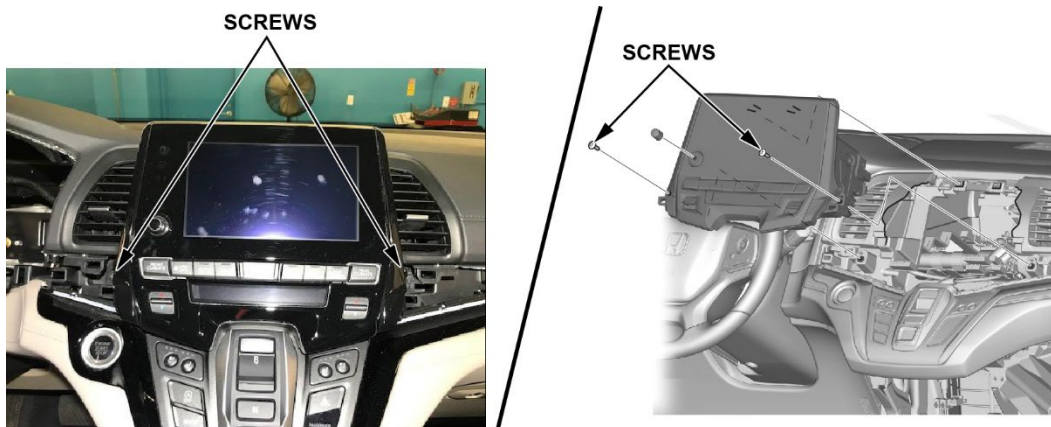
18. Remove the screws.

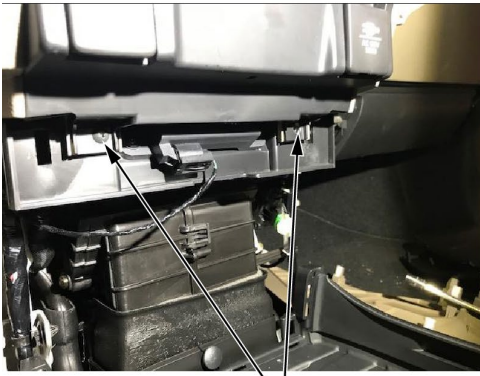
**SCREWS**

19. Remove the two screws from the dashboard center pocket, then pull back the panel.

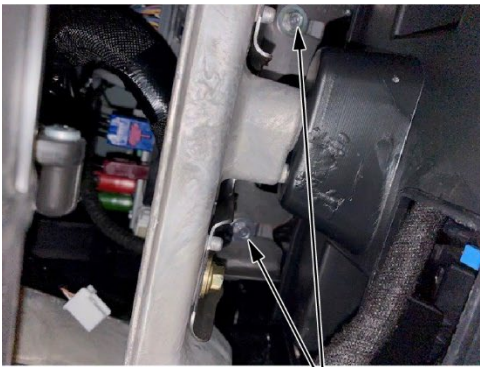
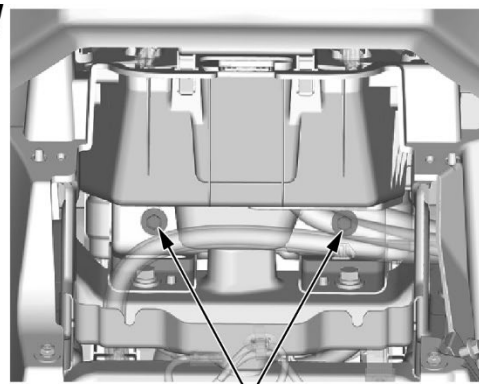
**BOLTS**  
4.4 N·m  
(3.2 lb-ft)

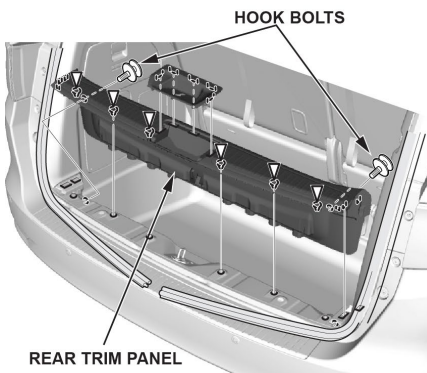
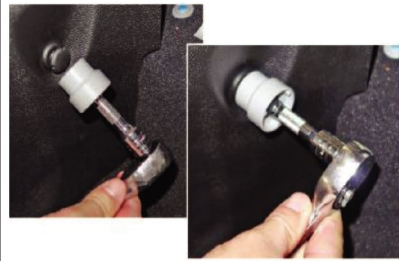
**HOOK BOLTS**

21. In the rear cargo area, remove the rear trim panel. On the right rear quarter panel, remove the hook bolts. If needed, use Cargo Cap Screw Socket (T/N 07AAA-SEPA100) to loosen the bolts.

**REAR TRIM PANEL**

If necessary, use Special Tool 07AAA-SEPA100 to loosen the hook bolts.

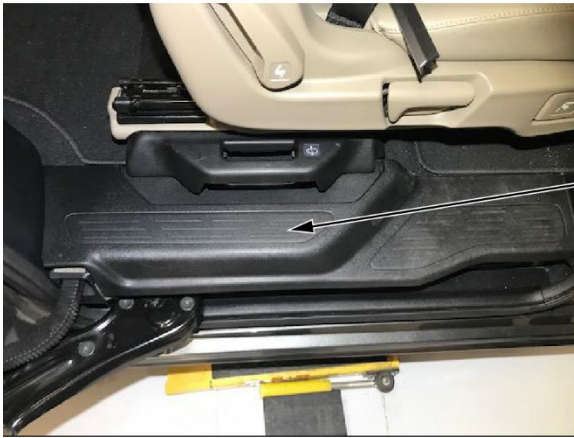
LOWER PASSENGER  
SLIDING DOOR TRIM

22. Remove the lower passenger sliding door trim.

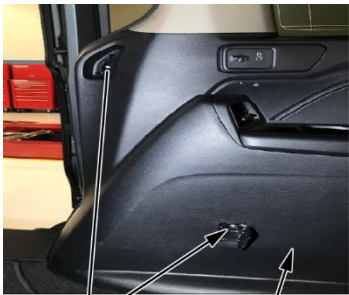
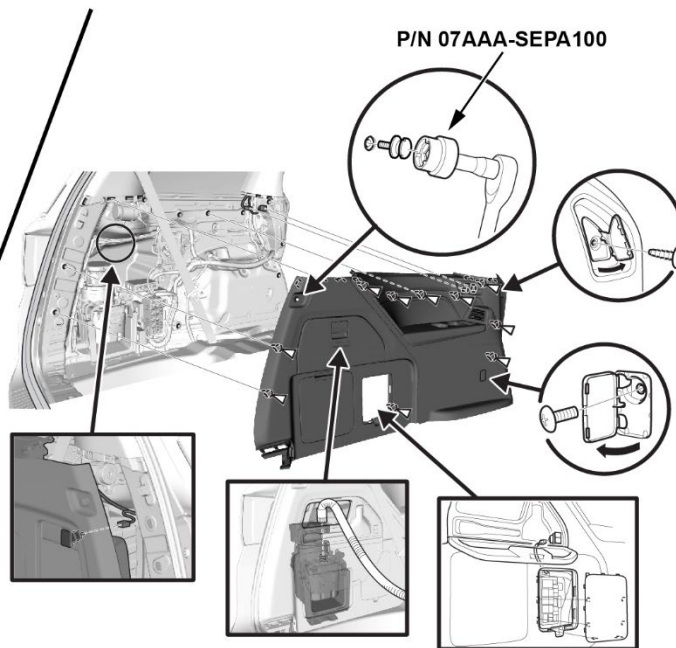
SCREWS  
PASSENGER SIDE  
INNER REAR  
QUARTER PANEL

23. Remove the covers then remove the two screws from the passenger side inner rear quarter panel.

- Only the driver side rear quarter panel from the service manual is **shown below**.
- All callouts on the service manual image **apply** to the passenger side rear quarter panel.

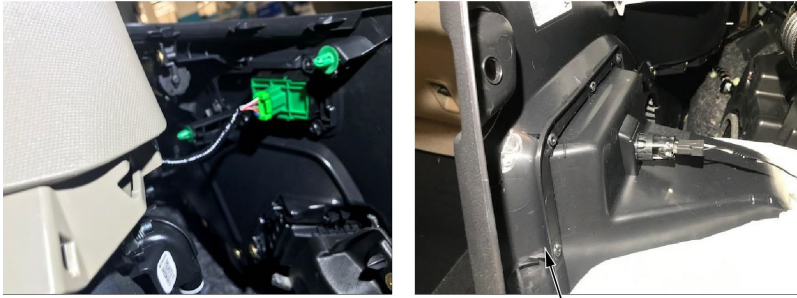
RIGHT QUARTER INNER PANEL

24. Remove the right quarter inner panel and the connectors.

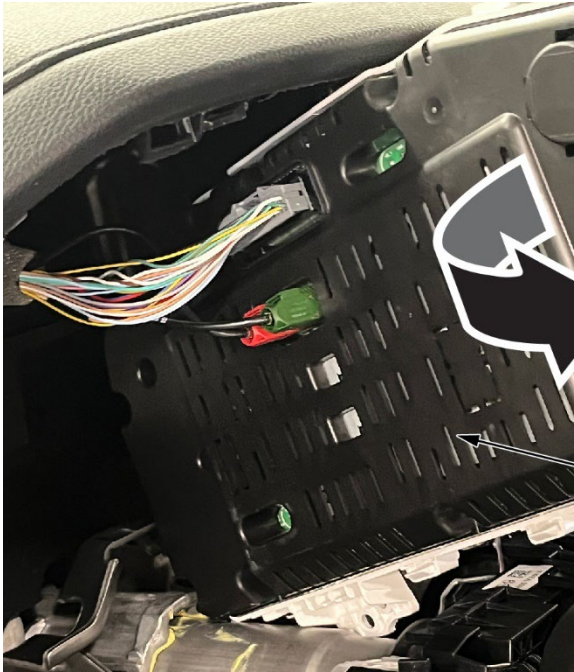
**MODULE**  
Turn over.

1. Turn the gauge control module to access the rear connectors.

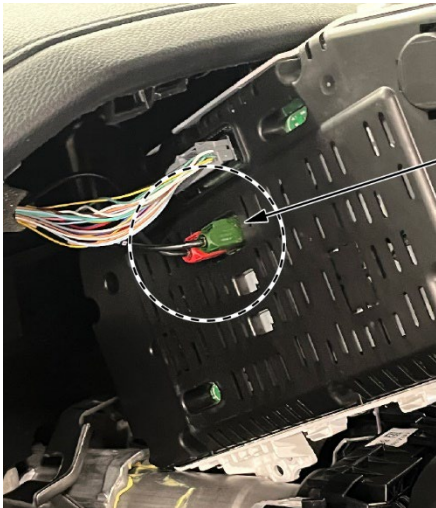
**FAKRA CONNECTORS**  
Disconnect.

2. Disconnect the FAKRA connectors and any other related connectors at the gauge control module.

**NOTE:** Disassemble the connectors one at a time to avoid swapping the green and red wires.

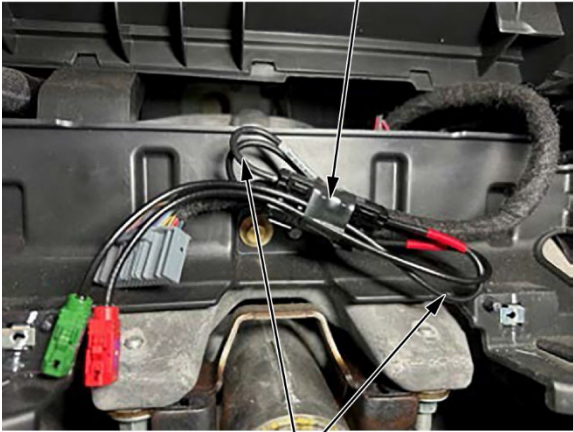
4. Tape both splice boxes and cables to the gauge control module harness.

Attach fakra service cables and splice boxes to the appropriate component harness with tape to prevent any rattles.

Keep smooth curves with a radius bend greater than 25 mm.

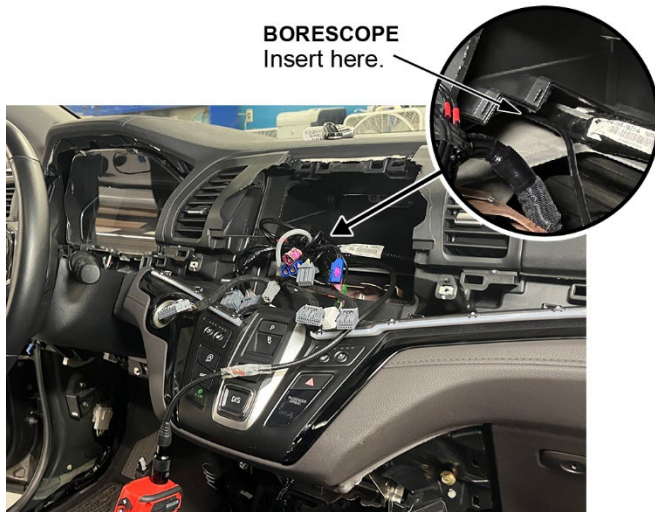
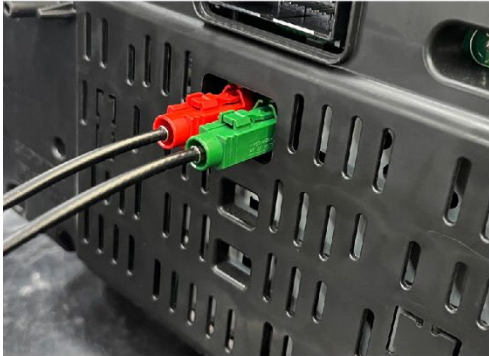
**CORRECT** ✓

7. Using the digital borescope (T/N BK5600DUAL55) or a commercially available borescope with multiple view angles, inspect the cable routing at the back of the gauge control module as shown below to make sure the cables are routed straight and not sideloaded. Adjust gauge control module harness as needed to achieve proper cable routing.

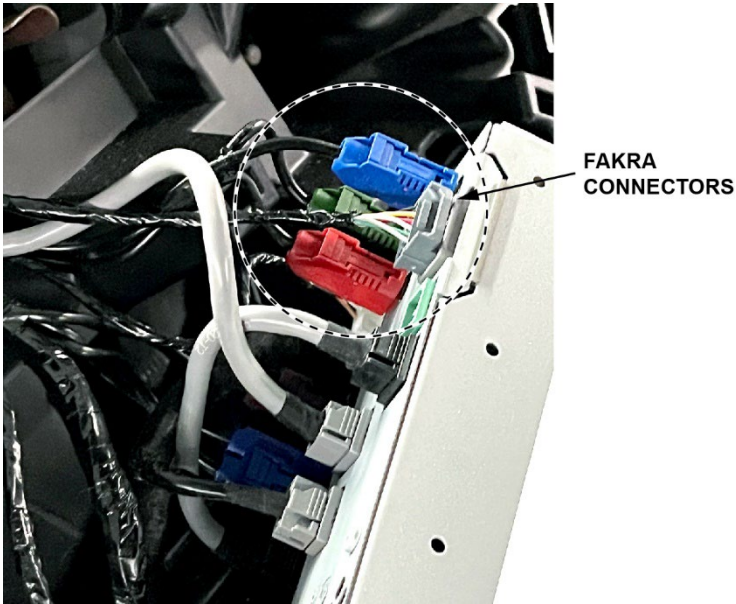
1. Disconnect the red and green FAKRA connectors and any other related connectors at the Infotainment Control Unit.

NOTE: Disassemble the connectors one at a time to avoid swapping the green and red wires.

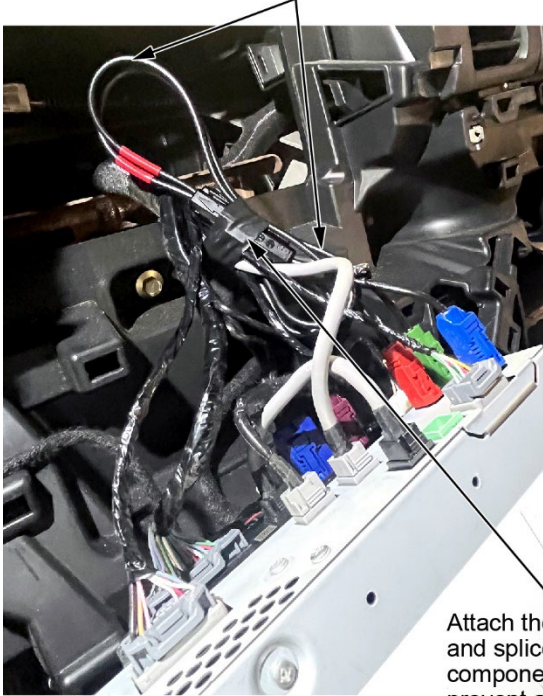
3. Tape both splice boxes and cables to the Infotainment Control Unit Harness.

Keep smooth curves with radius bend greater than 25 mm.

Attach the fakra service cables and splice boxes to the appropriate component harness with tape to prevent any rattles.

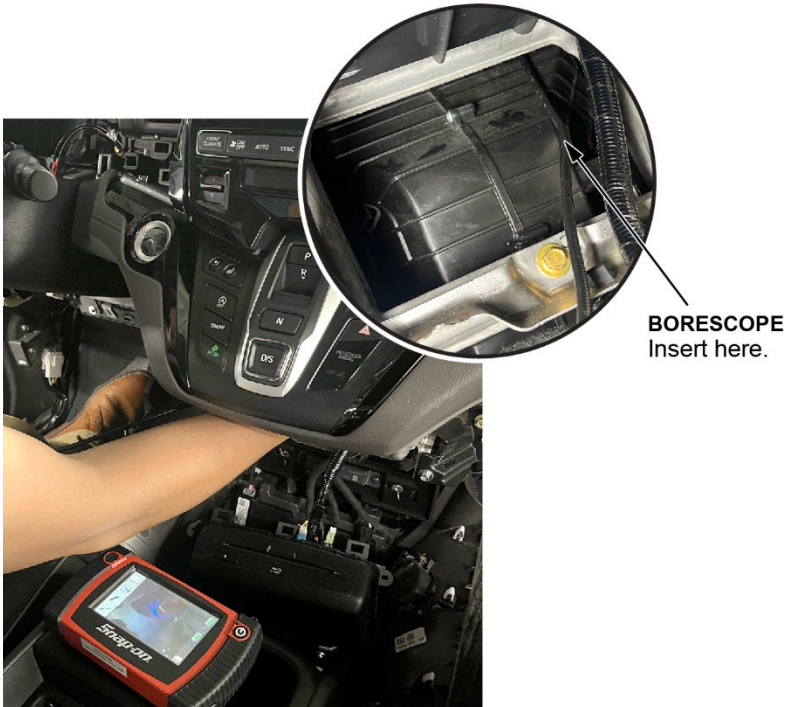
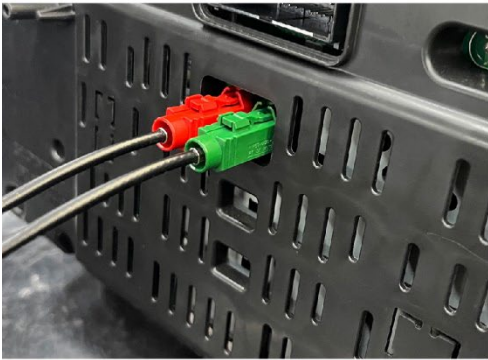
**CORRECT** ✓

6. Using the digital borescope (T/N BK5600DUAL55) or a commercially available borescope with multiple view angles, inspect the cable routing at the back of the gauge control module as shown below to make sure the cables are routed straight and not sideloaded. Adjust gauge control module harness as needed to achieve proper cable routing.

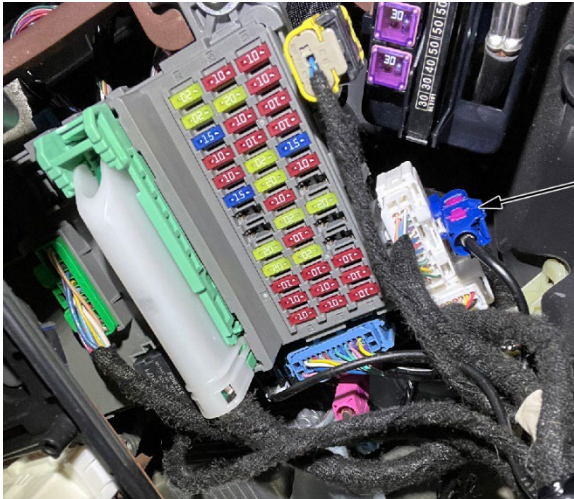
FAKRA  
CONNECTOR

1. Disconnect the blue FAKRA connector at the driver's kick panel.

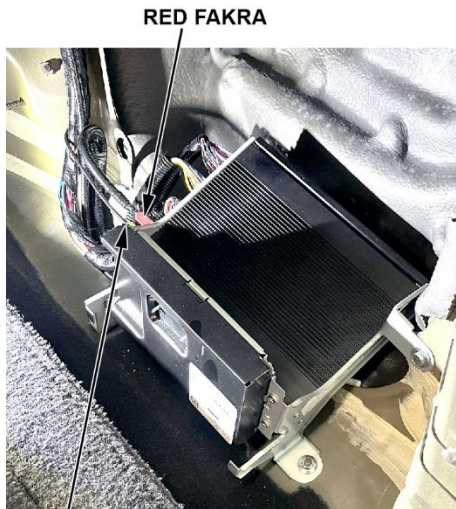
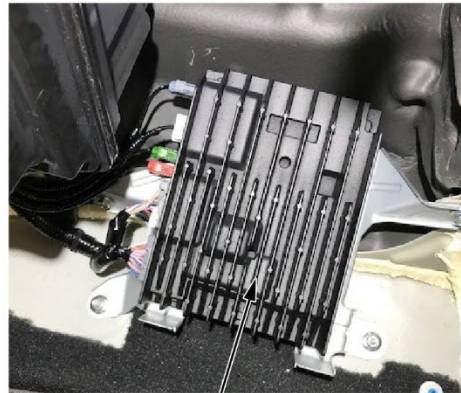
1. Disconnect the red and green FAKRA connectors at the amplifier.

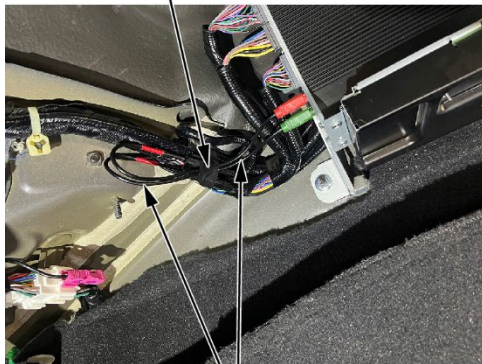
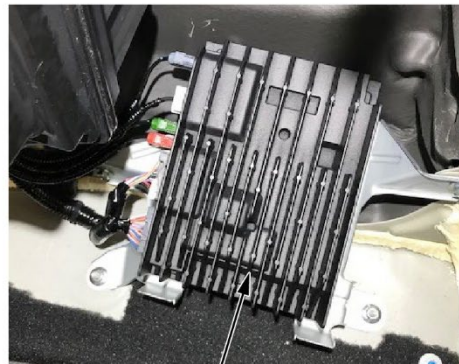
3. Tape both splice boxes and cables to the amplifier, or tuner-amplifier harness.

Attach the fakra service cables and splice boxes to the appropriate component harness with tape to prevent any rattles.
