Compliance Recall

Code: 93S7

Subject	Rearview Camera Image Delayed or Not Displayed				
Document History	Date		Summary		
	08/18/2023		Original publication		
Affected Vehicles	Country	Beginning Model Year	Ending Model Year	Vehicle	Vehicle Count
	USA	2022	2022	ID4	4
	<p>Check Campaigns/Actions screen in ELSA on the day of repair to verify that a VIN qualifies for repair under this action. ELSA is the <u>only</u> valid campaign inquiry & verification source.</p> <ul style="list-style-type: none"> ✓ Campaign status must show "open." ✓ If ELSA shows other open action(s), inform your customer so that the work can also be completed at the same time the vehicle is in the workshop for this campaign. 				
Problem Description	<p>Vehicles included in this recall have received a replacement infotainment central control unit that contained software that was not released for the U.S. market. Because of this, it is possible for the rearview camera image to be delayed or deactivated when the vehicle is put into reverse. A rearview camera screen that displays no image reduces the driver's information about what is behind the vehicle, increasing the risk of a crash.</p>

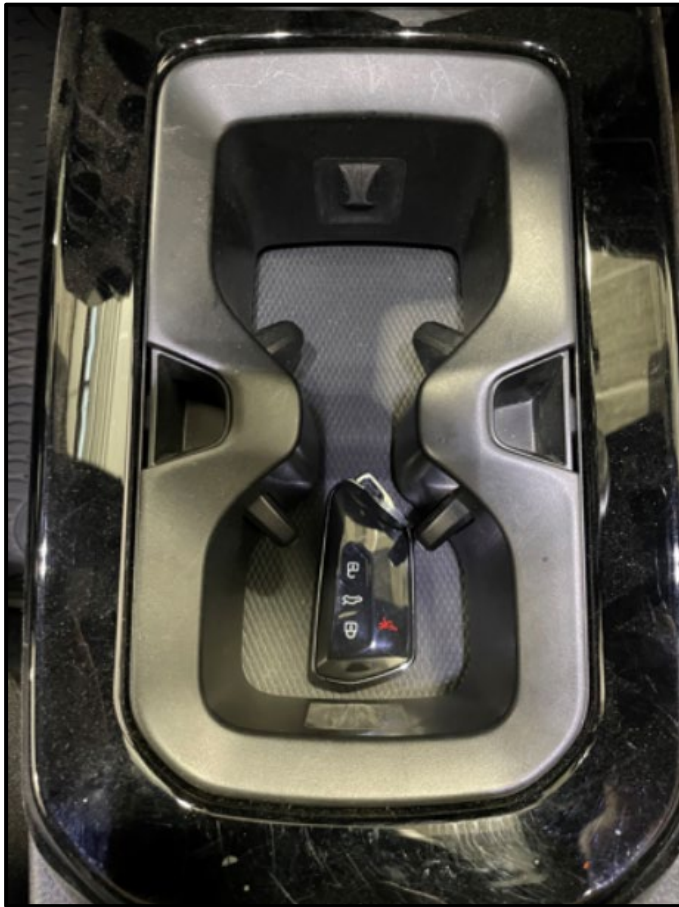
- Place the vehicle key over the reader coil in the center console cup holder.
- Any additional keys must be a minimum of 20 meters away from the vehicle.

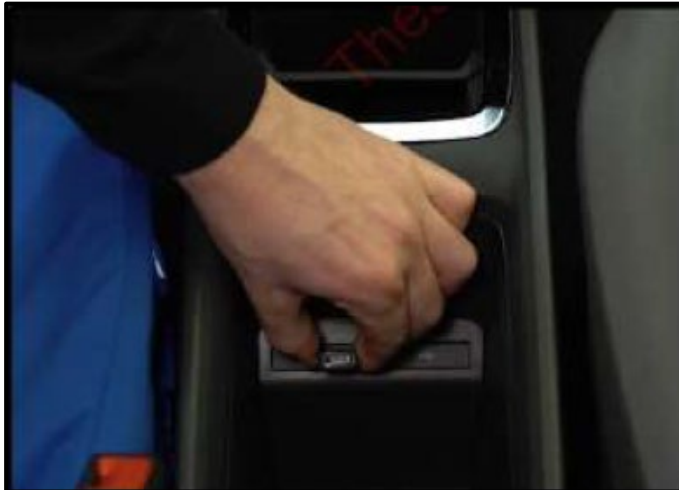
- Insert the USB drive into one of the USB ports.
- Turn the ignition ON.

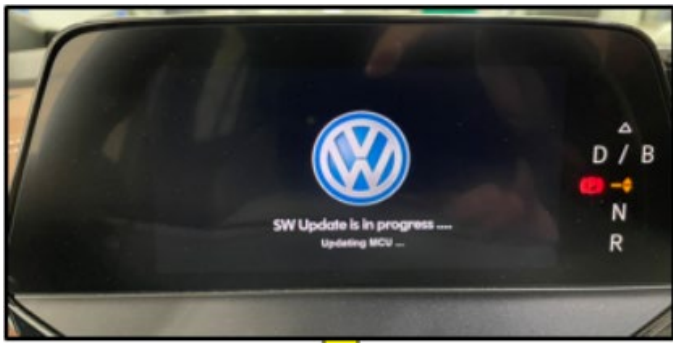
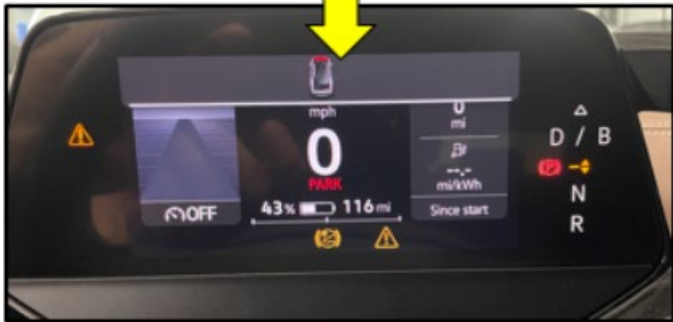
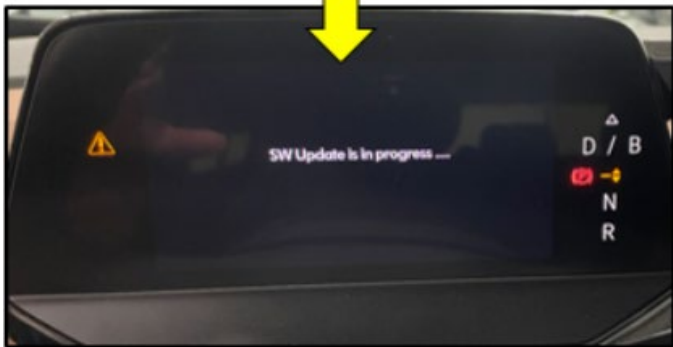
- The update will start on its own after about two minutes.
- During the update, the instrument cluster display will change multiple times.

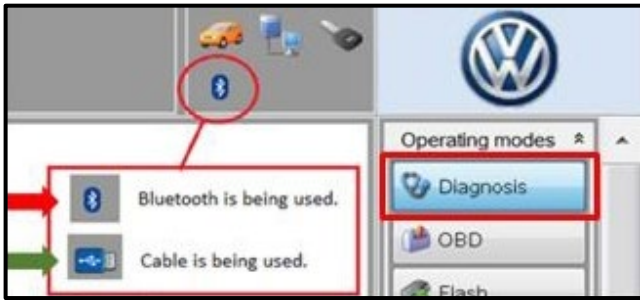
- Confirm that scan tool is communicating with the diagnostic head by USB <Green Arrow>.
 - If the Bluetooth symbol is shown <Red Arrow> then disconnect the diagnostic head from the vehicle and reconnect the USB cable to the diagnostic head and then reattach to the vehicle.
- Upon ODIS startup, verify the “Diagnosis” operating mode is selected <as shown>.
