GROUP	MODEL
Safety Recall Campaign	2017-2022MY Niro HEV (DE HEV) 2018 - 2022MY Niro PHEV (DE PHEV)
NUMBER	DATE
SC276 (Rev 1, 03/29/2024)	December 2023

ENGINE HCA INSPECTION AND FUUSE/HCA REPLACEMENT (SC276)

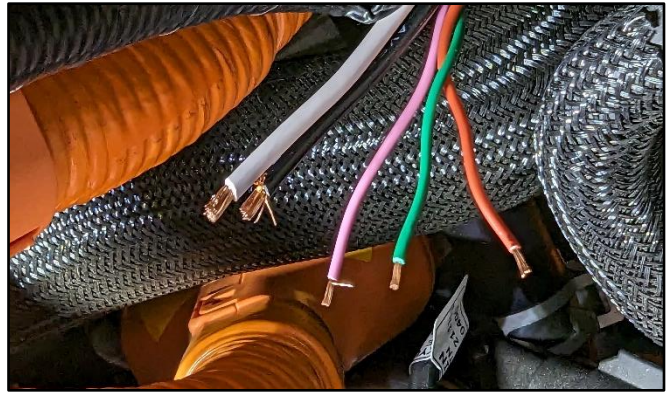
- Strip each of the engine HCA 5 wire ends on the vehicle wiring, as shown.
