Safety Recall – 2024 CX-90 Pedestrian Alert System Warning Sound Error

B. REPAIR PROCEDURE

This repair will reprogram or add and update the Approaching Vehicle Audible System Information Sound Box “AVAS ISB” amplifier software in the vehicle, by MDARS

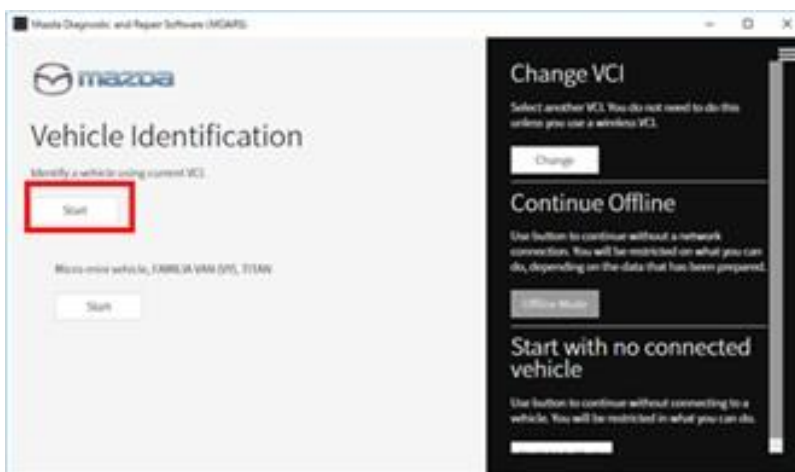
2. Click the "Start" button.

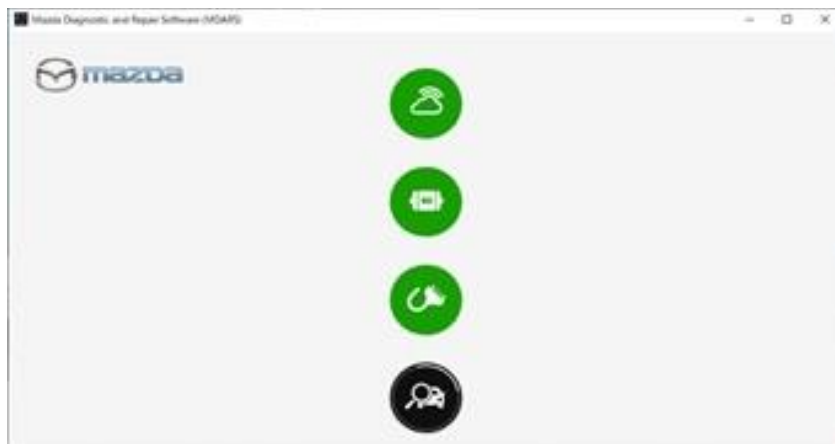
3. The Vehicle Identification process will start and automatically, checking for proper connections. If successful, then you can proceed to the next step.

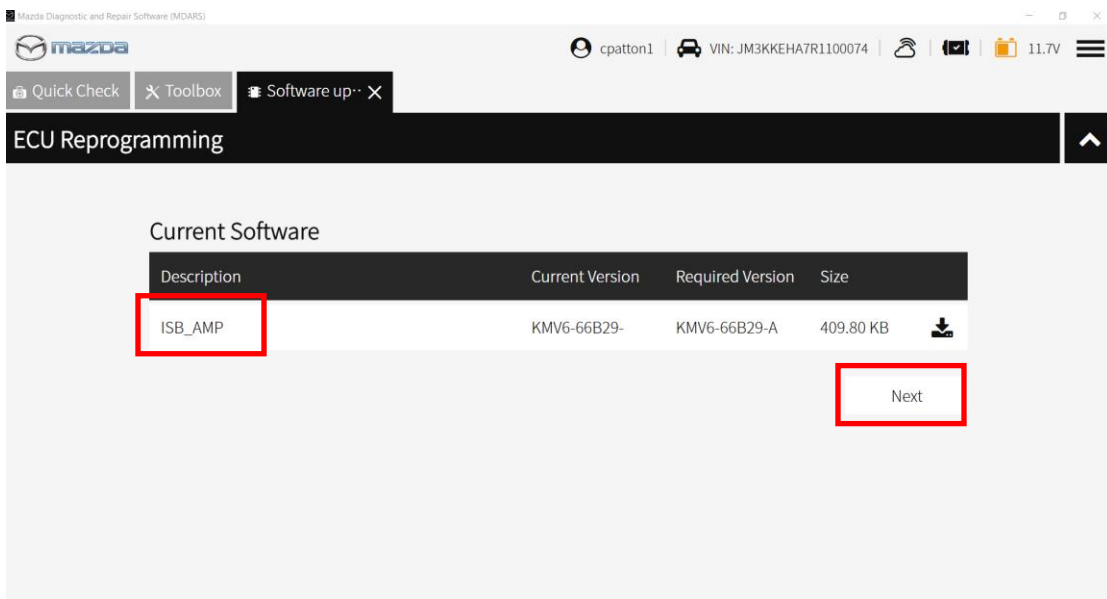
6. Select ISB_AMP on "ECU Reprogramming" screen. Start Reprogramming.

7. After completion of the software update, the previous and current software version are shown. Check **Current Version** at and **Required Version** below. Once you go through all steps, then click on "Finish" to exit the ECU reprogramming.
