**HYUNDAI**  
**Technical Service Bulletin**

GROUP <b>RECALL</b>	NUMBER <b>23-01-070H-1</b>
DATE <b>SEPTEMBER 2023</b>	MODEL(S) <b>ELANTRA HYBRID (CN7 HEV)</b>

**SUBJECT:** MOTOR CONTROL UNIT (MCU) SOFTWARE UPDATE (RECALL CAMPAIGN 248)

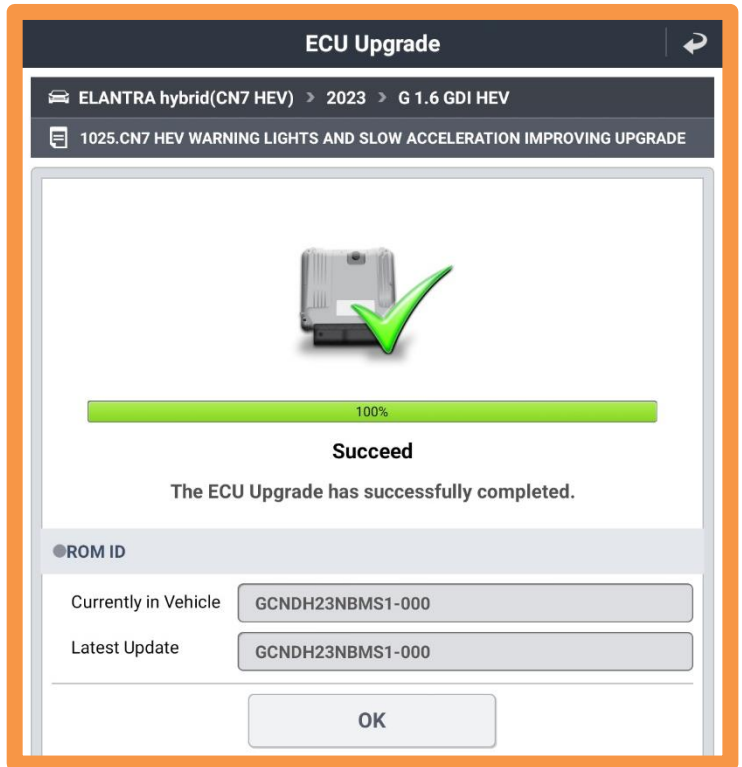
Take a screenshot of the MCU Update Complete screen using your particular tablet’s screenshot save method and upload to STUI.
