SIB 11 09 23

**RECALL 23V-707: REPLACE VANOS ADJUSTMENT UNIT SCREWS**This Service Information Bulletin (Revision 3) replaces SI B11 09 23 **dated February 2024**.

Vehicles equipped with the N51, N52K, N52T and N55 Engines.

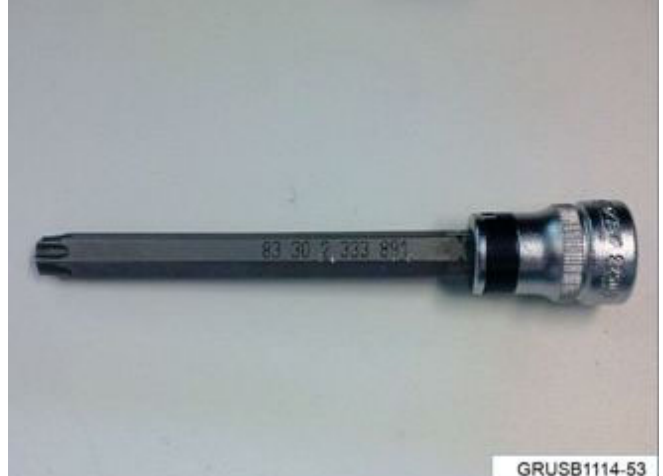
<p>Socket for Torque Wrench</p> <p>P/N 83 30 2 333 891</p> <p>Distributed via Automatic Tool Shipment. Refer to SI B04 08 14.</p>

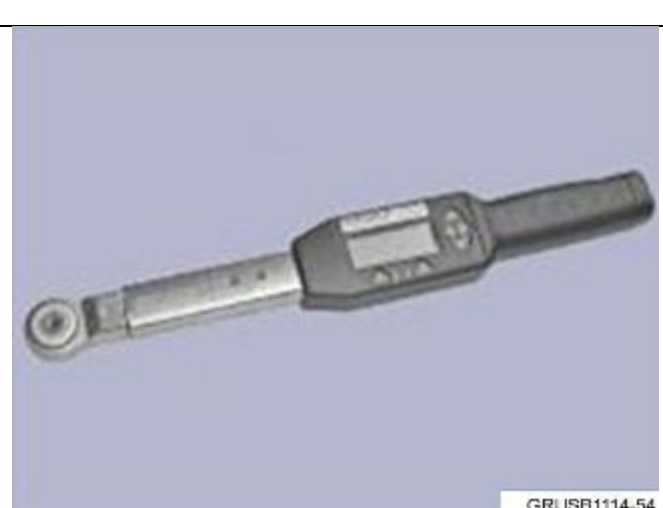
<p>Torque Wrench</p> <p>P/N 81 64 0 418 185</p> <p>Distributed via Automatic Tool Shipment. Refer to SI B04 08 14.</p>

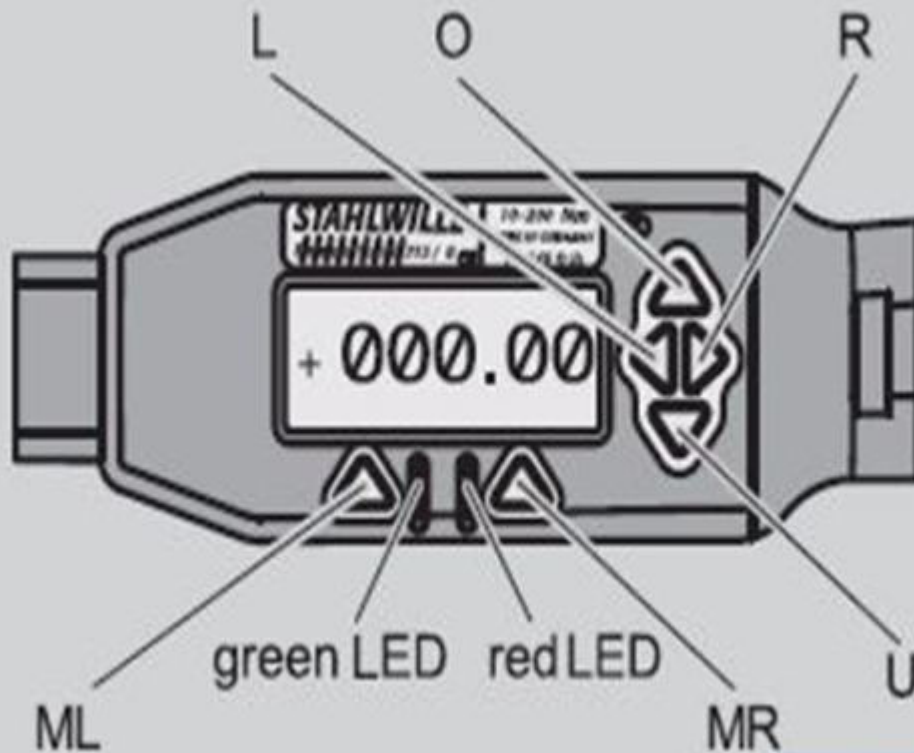
GRUSB114-55

<b>Torque Wrench Set Up:</b>	
------------------------------	--

**Initial set up of torque wrench must be completed when using the tool for the first time.**

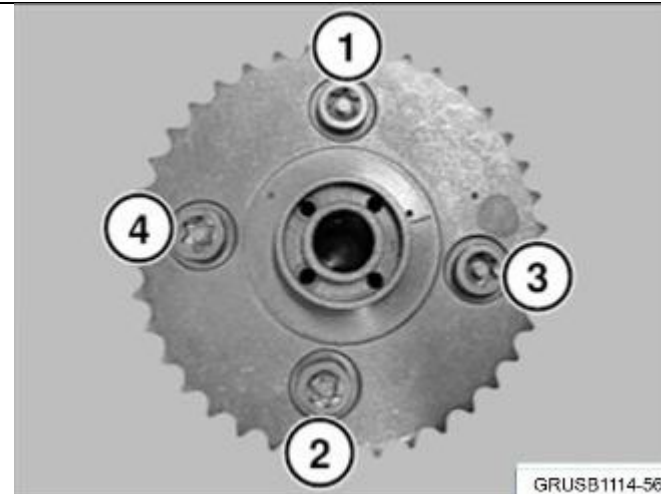
#### Exhaust VANOS Adjustment Unit:

9. Replace and torque aluminum bolts (1 - 4) one at a time.
