# MULTIPLE CAMPAIGNS REPAIR PROCEDURE AND MULTIPLE MODULE REPROGRAMMING

**\*\*\*UPDATED July 2, 2024 – Add Module recovery Mode to procedure\*\*\***

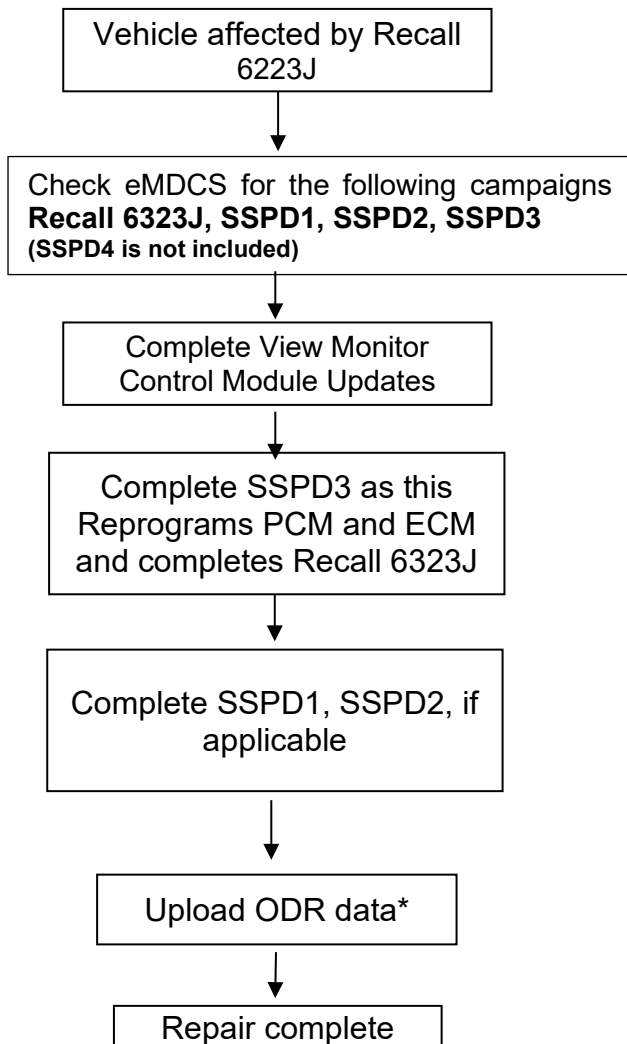
**CX-90 PHEV**

**Section A : Flow Chart – NOTE: You must clear any DTC's (diagnose and repair) before performing any of these campaigns. The recall or SSP repairs will NOT fix/clear a DTC issue. Once repaired, then start the repair process for campaigns.**

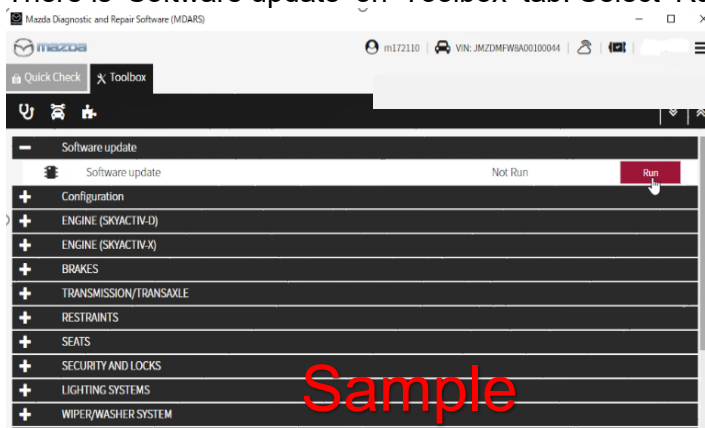
4. Reprogram VMC - View Monitor Control Module as below. There is 'Software update' on 'Toolbox' tab. Select 'Run'.

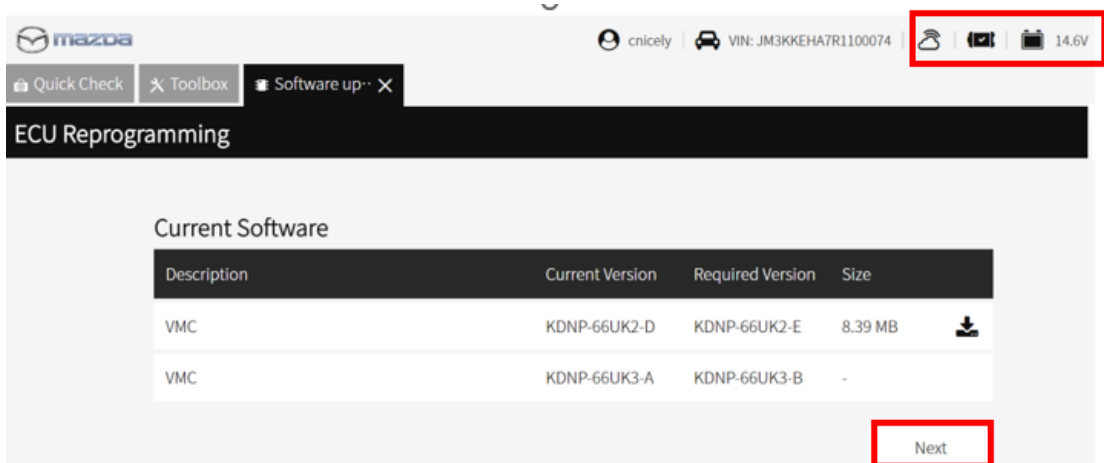
6. After completion of software update, the previous and current software version are shown. Check current version at “Calibration File information” below. **NOTE: The software may be updated, if it is the current version proceed to the next step, ODR data transmission.**
  - a. Then, click on “Finish” to exit the ECU reprogramming and disconnect the 12V battery charger.
  - b. Then, perform the ODR update procedure (Step 7).

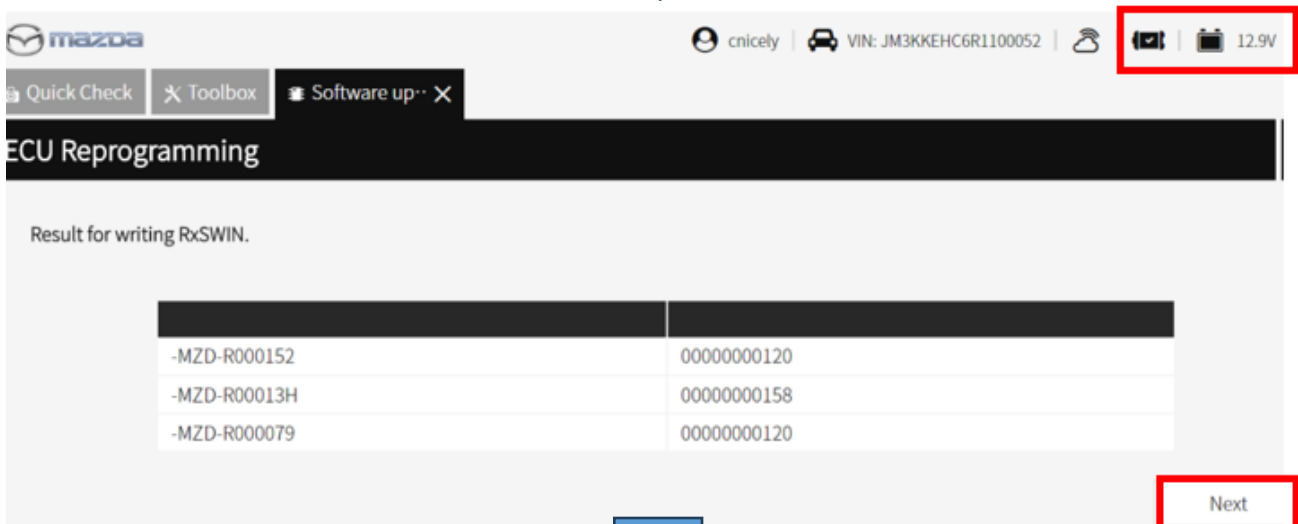
The screenshot shows the Mazda software update interface after the software update. The main heading is 'ECU Reprogramming'. Below this, a section titled 'Result for writing RxSWIN' contains a table with the following data:

-MZD-R000152	00000000120
-MZD-R00013H	00000000158
-MZD-R000079	00000000120

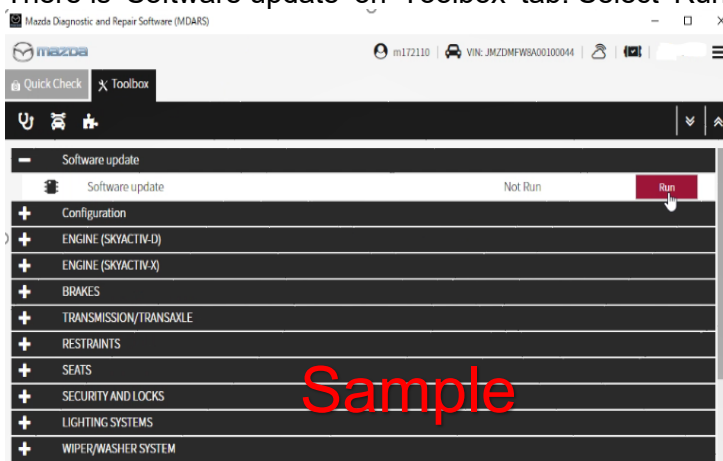
- Reprogram PCM and ECM as below  
There is 'Software update' on 'Toolbox' tab. Select 'Run'.

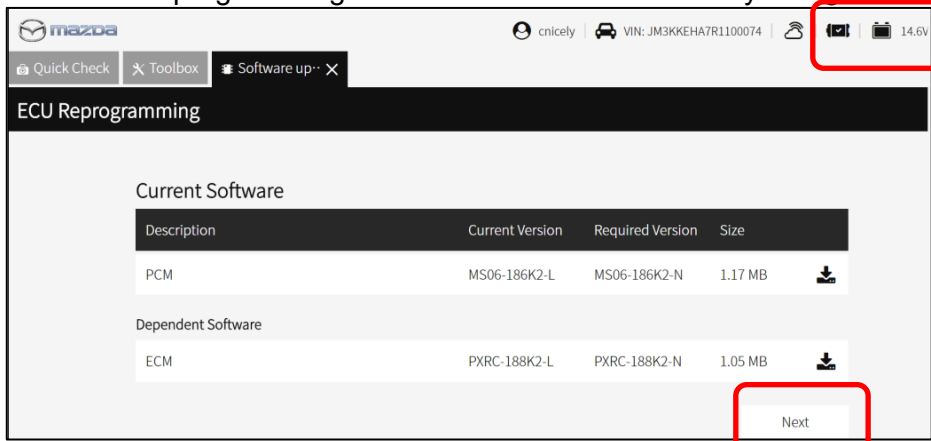
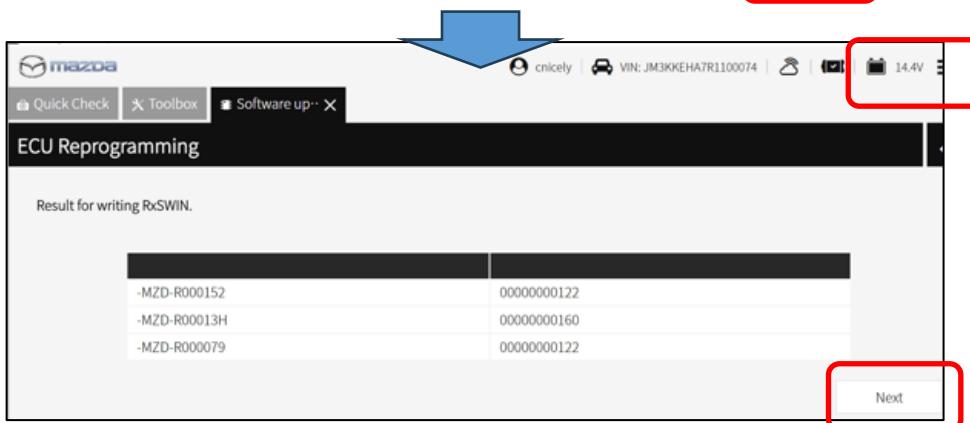
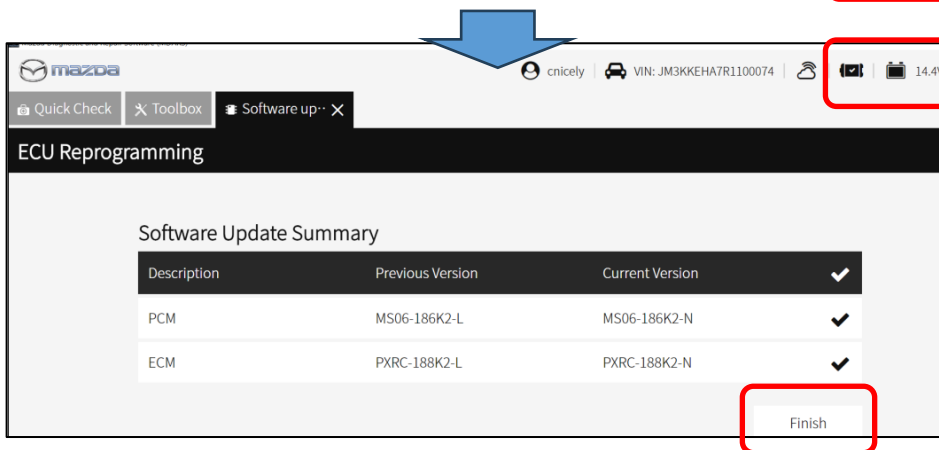
- After completion of software update, the previous and current software version are shown. Check current version at "Calibration File information" below. Then, click on "Finish" to exit the ECU reprogramming and disconnect the 12V battery charger.

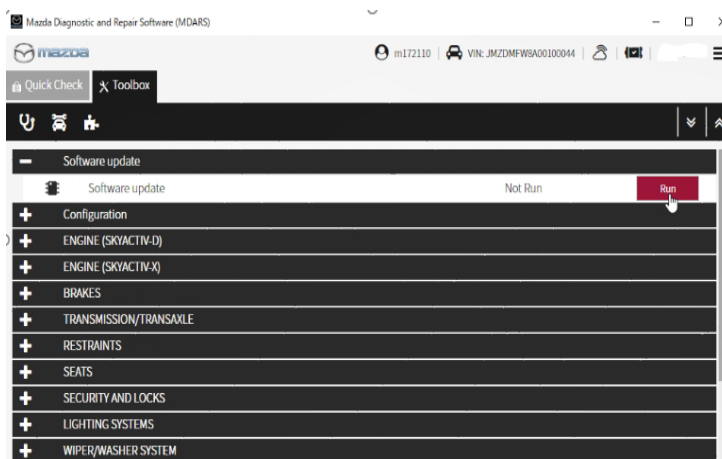
4. Reprogram PCM as below  
There is ‘Software update’ on ‘Toolbox’ tab. Select ‘Run’.

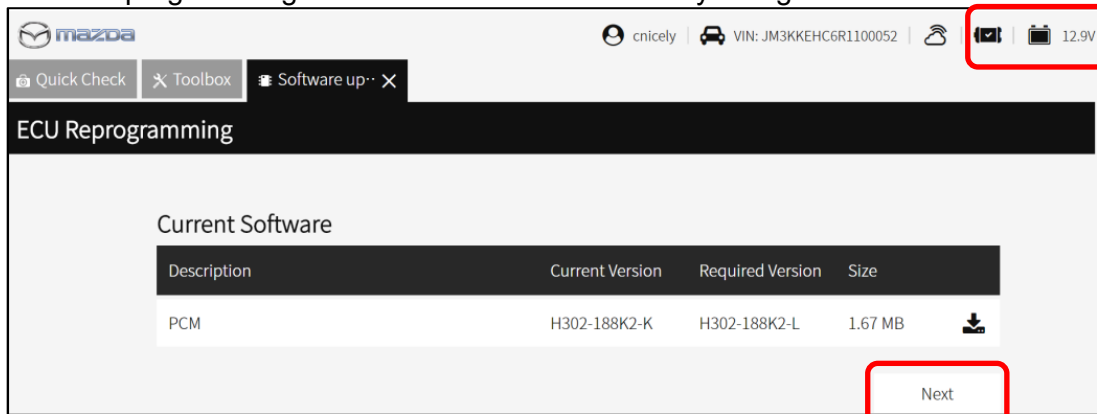
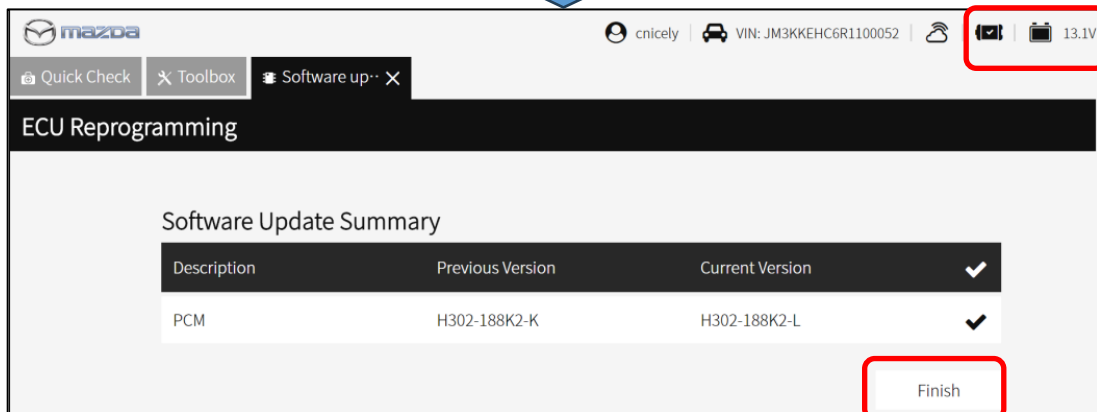
- After completion of software update, the previous and current software version are shown. Check current version at "Calibration File information" below. Then, click on "Finish" to exit the ECU reprogramming and disconnect the 12V battery charger.

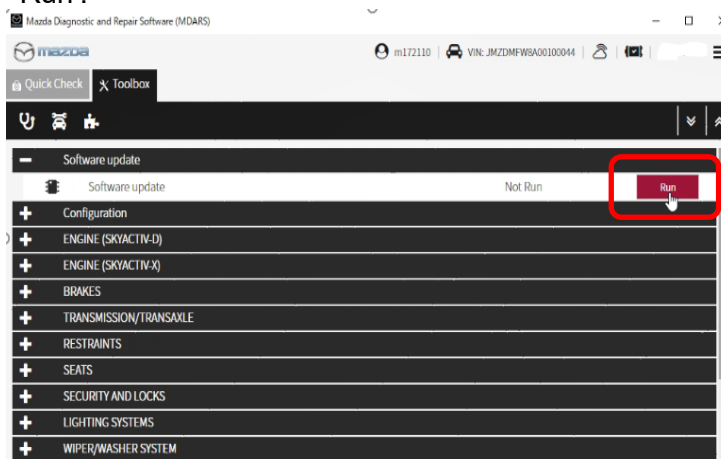
- Reprogram Side Radar as below. If there is 'Software update' on 'Toolbox' tab. Select 'Run'.

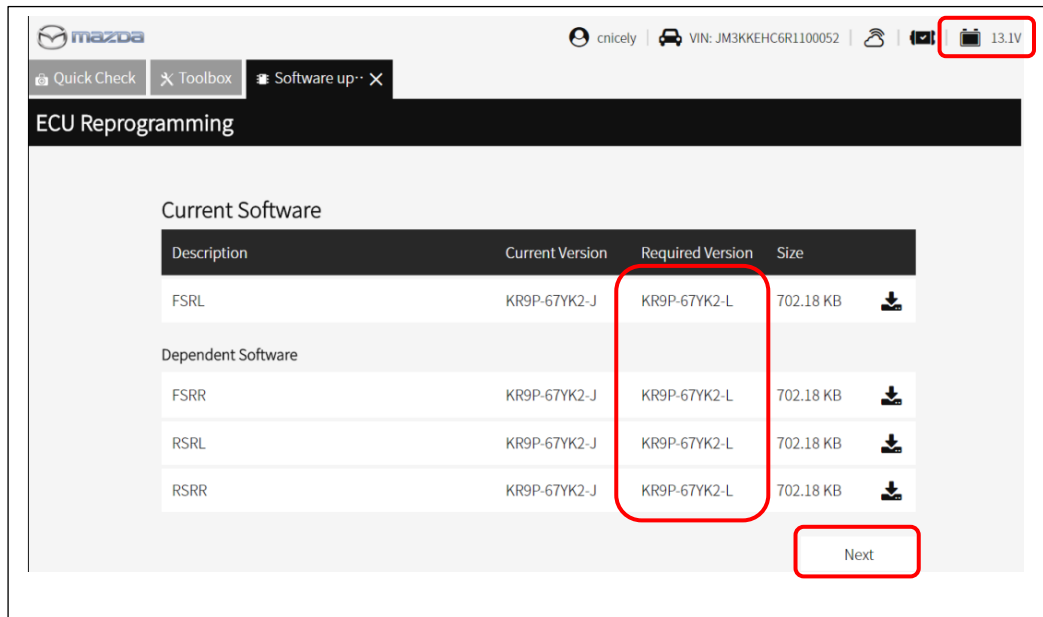
5. Select required module on 'ECU Reprogramming' screen.
6. Start Reprogramming.

Side Radar Sensor ECU Programming	Applicable Vehicle	Not Applicable
<p><b><u>NOTE: Not all trims have Front Side Radar</u></b></p> <ul style="list-style-type: none"> <li>• FSRR (Front Side Radar Right)</li> <li>• FSRL (Front Side Radar Left)</li> </ul>	<p>Standard PT</p> <ul style="list-style-type: none"> <li>• 3.3 Turbo Premium Plus</li> </ul> <p>High PT</p> <ul style="list-style-type: none"> <li>• 3.3 Turbo S Premium Plus</li> </ul> <p>PHEV</p> <ul style="list-style-type: none"> <li>• PHEV Premium Plus</li> </ul>	<p>Standard PT</p> <ul style="list-style-type: none"> <li>• 3.3 Turbo Select</li> <li>• 3.3 Turbo Preferred</li> <li>• 3.3 Turbo Preferred Plus</li> <li>• 3.3 Turbo Premium</li> </ul> <p>High PT</p> <ul style="list-style-type: none"> <li>• 3.3 Turbo S</li> </ul> <p>PHEV</p> <ul style="list-style-type: none"> <li>• PHEV Preferred</li> <li>• PHEV Premium</li> </ul>
<ul style="list-style-type: none"> <li>• RSRR (Rear Side Radar Right)</li> <li>• RSRL (Rear Side Radar Left)</li> </ul>	All	N/A – All vehicles have Rear Side Radar Sensors

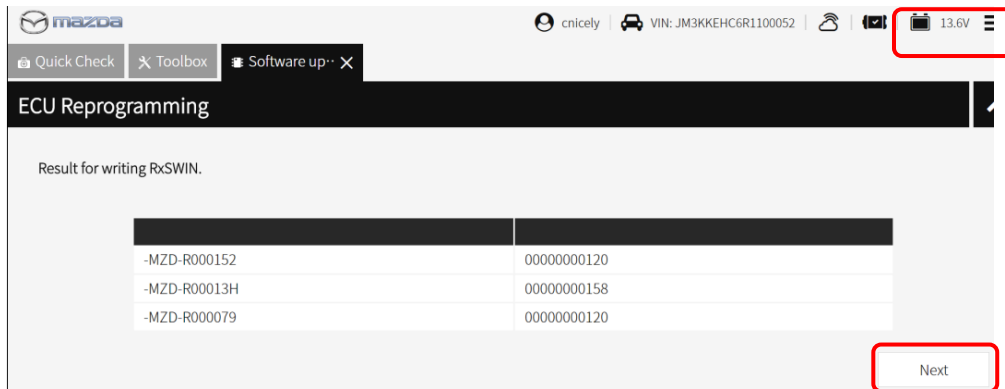
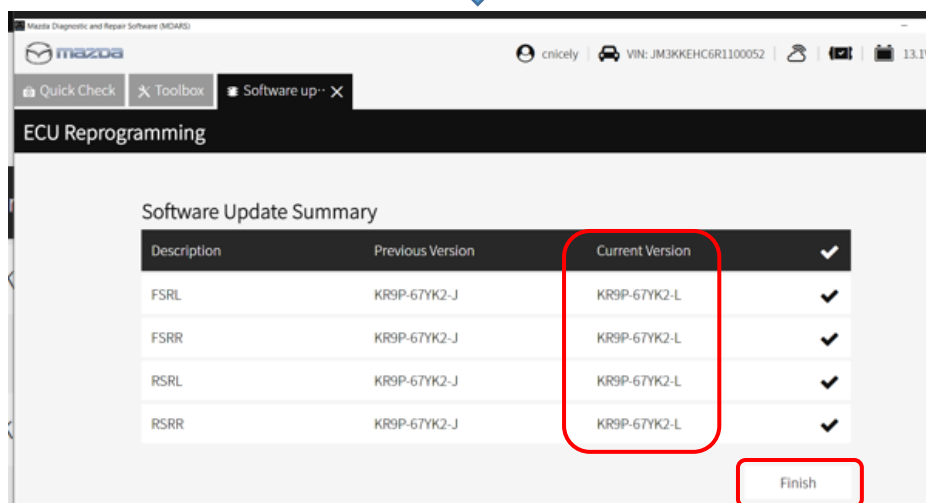
7. After completion of software update, the previous and current software version are shown. Check current version at "Calibration File information" below. Then, click on "Finish" to exit the ECU reprogramming and disconnect the 12V battery charger.

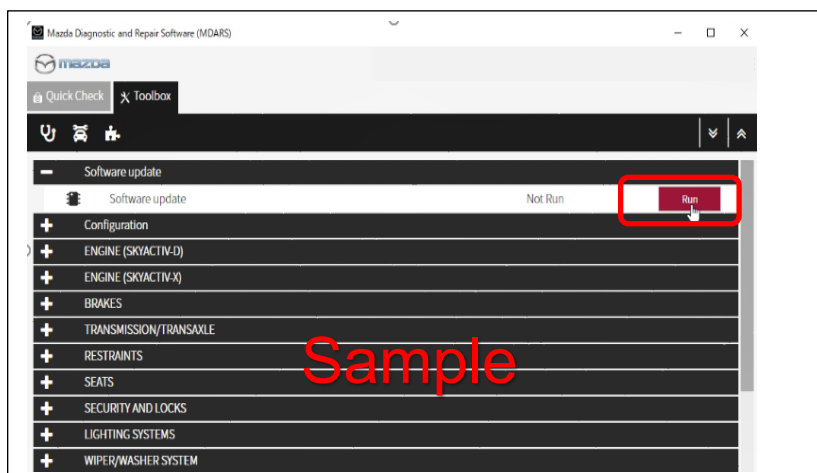
- Reprogram TCM as below  
There is 'Software update' on 'Toolbox' tab. Select 'Run'.

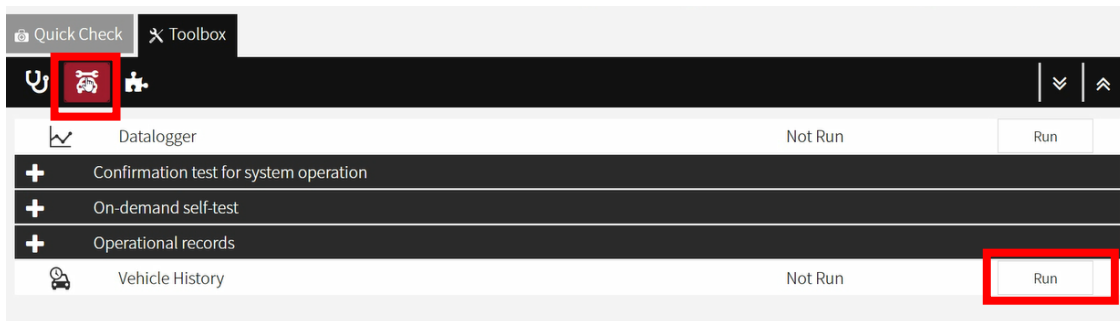
7. Open the vehicle history on toolbox tab.

(5) Go back to step 7 and 8 to confirm the Collect Diagnostic Information (Manual) status shows 'SUCCESS' on green.

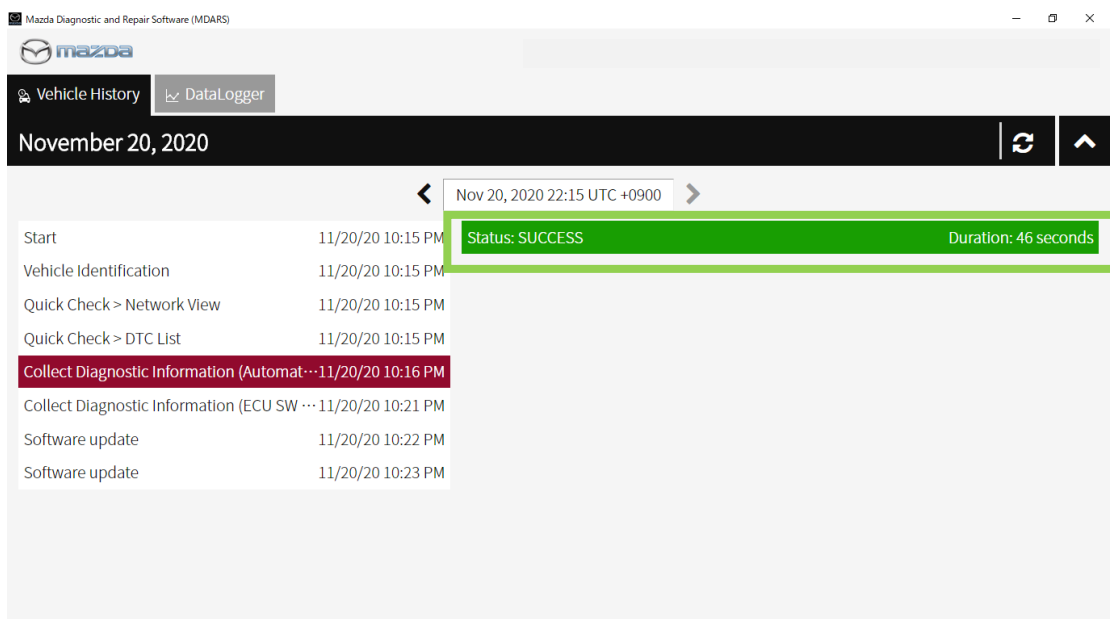
8. Click the 'Collect Diagnostic Information' and the status has 'SUCCESS' on green.

Verify the "Collect Diagnostic Information" after all required modules are updated. Not necessary to confirm the 'Collect Diagnostic Information' after required module reprogram every time.

Only the latest "Collect Diagnostic Information" is the valid one and that needs to show "SUCCESS"

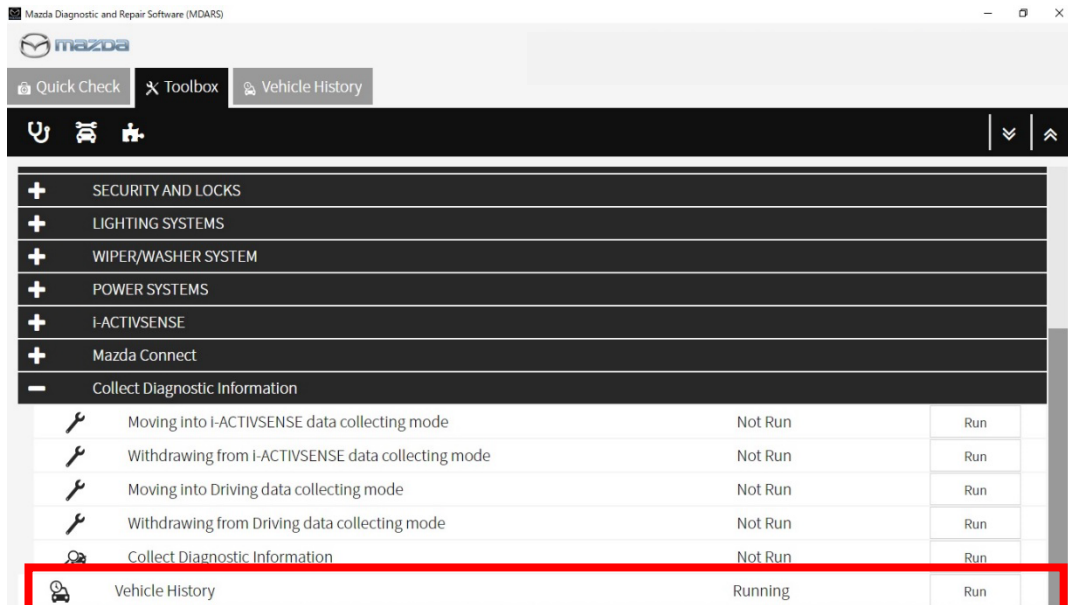
\*\*\*\*\*If the status is 'FAILURE', the ODR (latest vehicle information) has not been submitted to the server. Perform following process.

(1)'Collect Diagnostic information' then click 'Run' at the tool box tab.

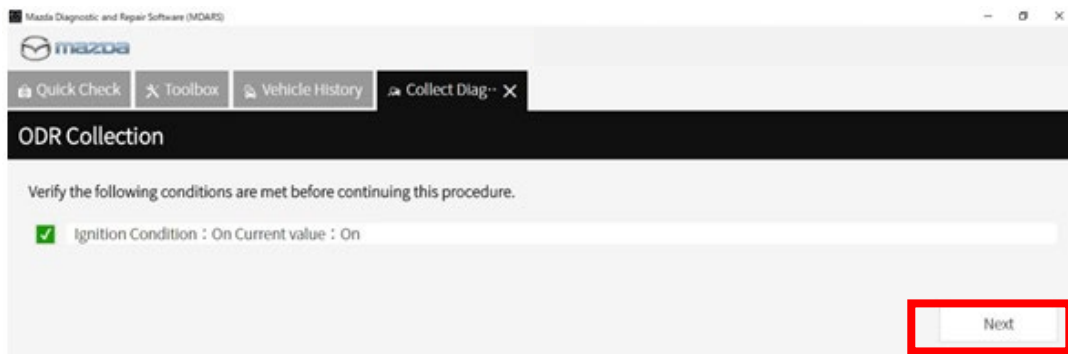
(2)Click 'Next'

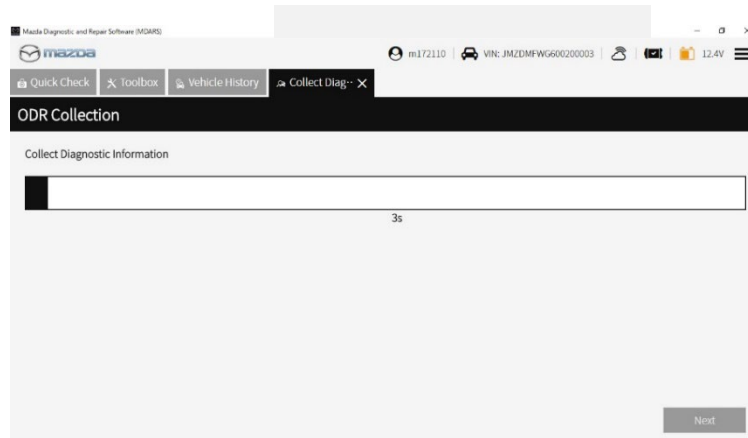
(3)It may take around 60 seconds.

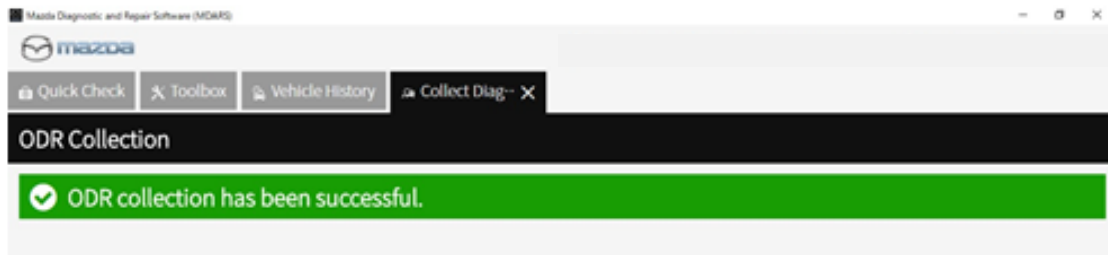
(4) MDARS has collected ODR and sent to the server.

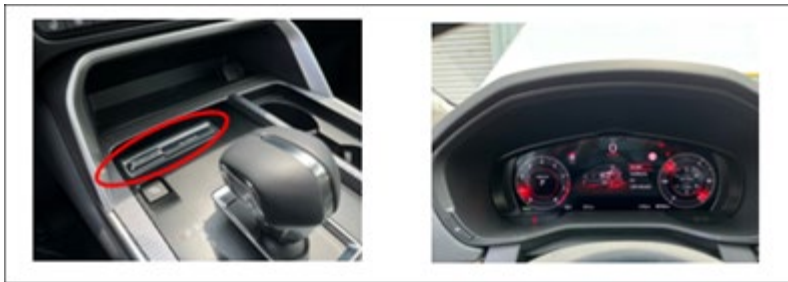
10. Verify the repair by starting the engine. If subject vehicle is PHEV, proceed with following steps. Make sure there is no MIL illumination or abnormal warning lights present.

<How to start the engine in PHEV>

- (10-1) Switch to 'Sport Mode' and shift to 'D' range
- (10-2) Confirm Engine RPM is shown correctly in IC.
- (10-3) Shift to 'P' range then stop the engine. Turn ignition off.
