# MULTIPLE CAMPAIGNS REPAIR PROCEDURE AND MULTIPLE MODULE REPROGRAMMING

## Section B : Repair Procedure Recall 6223J

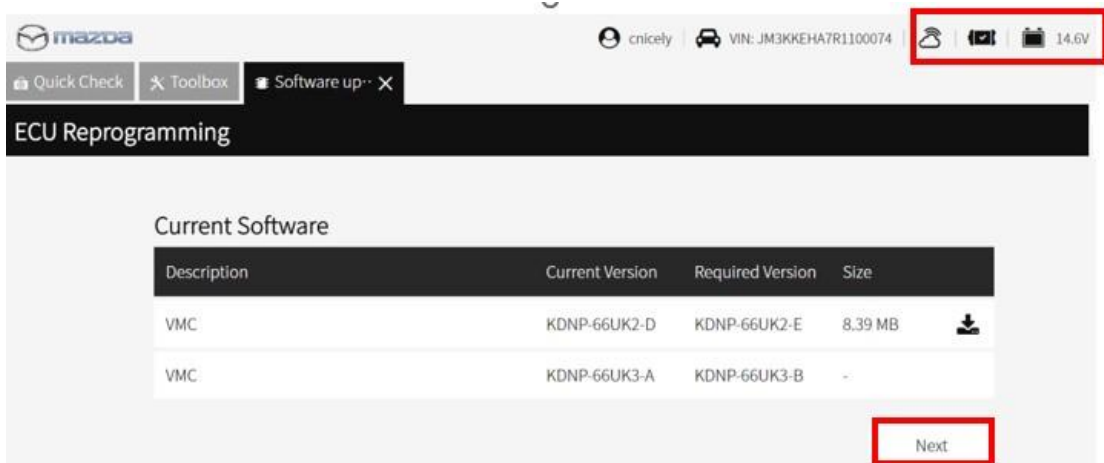
6. After completion of software update, the previous and current software version are shown. Check current version at "Calibration File information" below. **NOTE: The software may be updated, if it is the current version proceed to the next step, ODR data transmission.**
- Then, click on "Finish" to exit the ECU reprogramming and disconnect the 12V battery charger.
  - Then, perform the ODR update procedure (Step 7).

The screenshot shows the Mazda software update interface. At the top, there is a navigation bar with 'Quick Check', 'Toolbox', and 'Software up...' tabs. The main heading is 'ECU Reprogramming'. Below this, a section titled 'Current Software' contains a table with the following data:

Description	Current Version	Required Version	Size	
VMC	KDNP-66UK2-D	KDNP-66UK2-E	8.39 MB

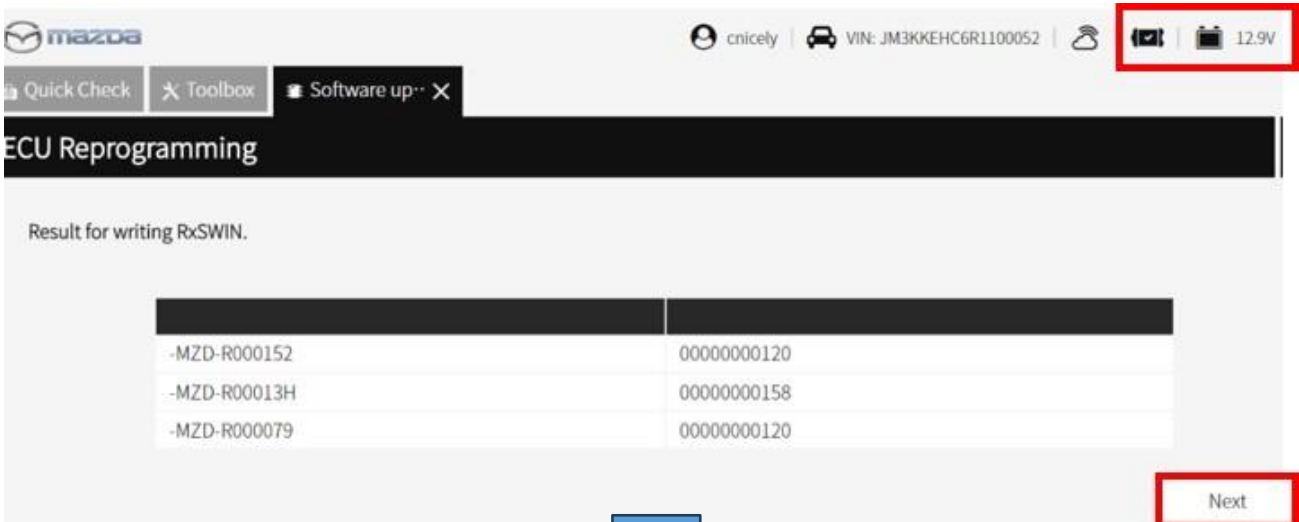
The screenshot shows the Mazda software update interface after the software update. The main heading is 'ECU Reprogramming'. Below this, a section titled 'Result for writing RxSWIN' contains a table with the following data:

-MZD-R000152	00000000120
-MZD-R00013H	00000000158
-MZD-R000079	00000000120

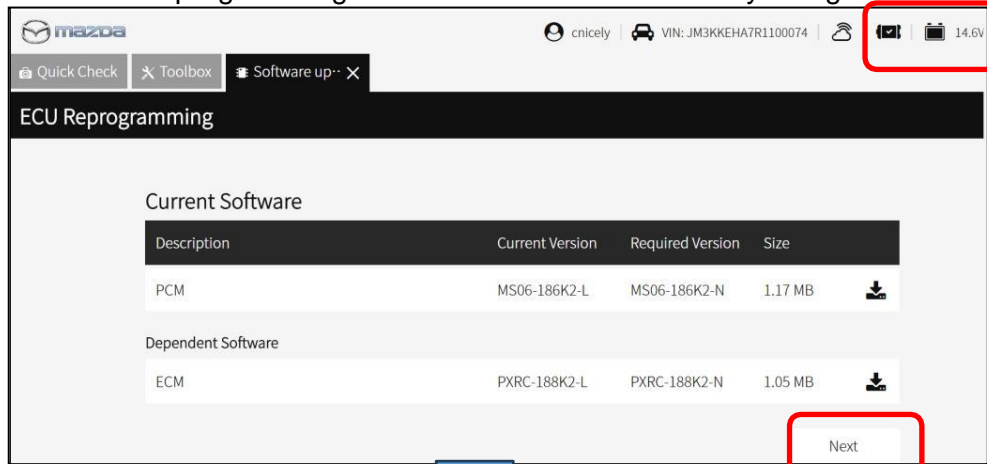
6. After completion of software update, the previous and current software version are shown. Check current version at "Calibration File information" below. Then, click on "Finish" to exit the ECU reprogramming and disconnect the 12V battery charger.

Current Software

Description	Current Version	Required Version	Size
PCM	MS06-186K2-L	MS06-186K2-N	1.17 MB

ECM	PXRC-188K2-L	PXRC-188K2-N	1.05 MB
-----	--------------	--------------	---------

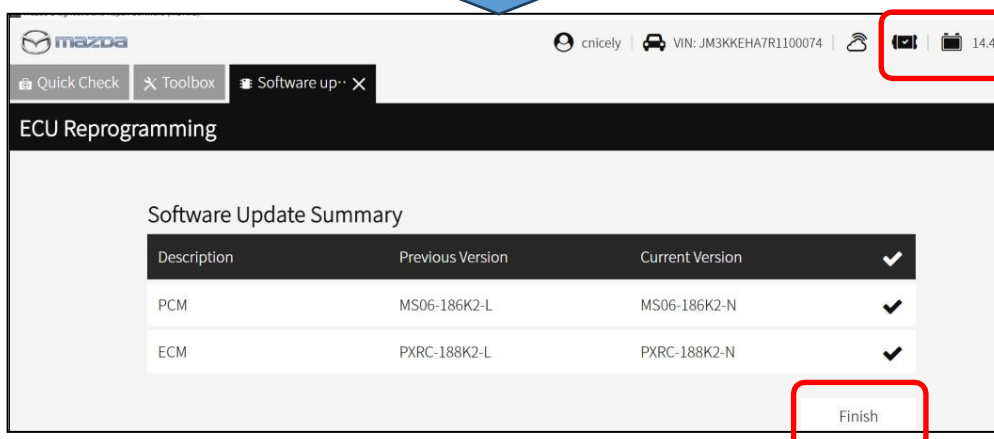
Software Update Summary

Description	Previous Version	Current Version
PCM	MS06-186K2-L	MS06-186K2-N
ECM	PXRC-188K2-L	PXRC-188K2-N

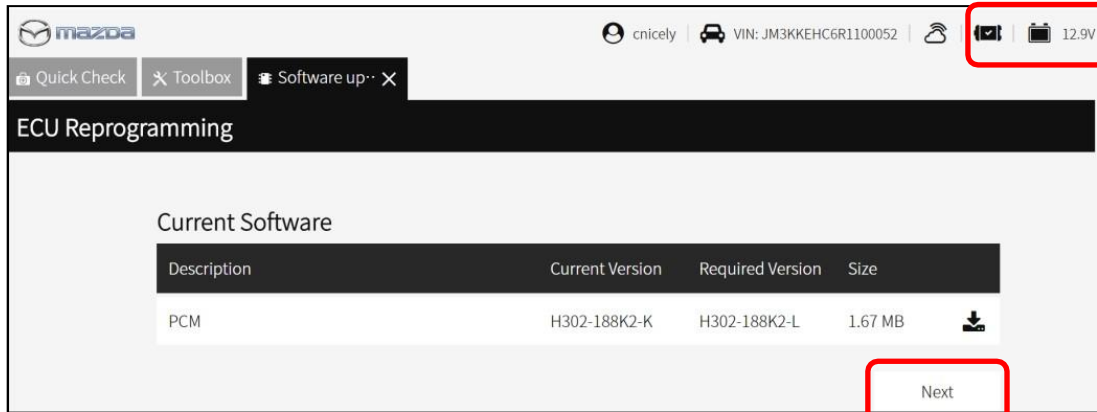
Current Software

Description	Current Version	Required Version	Size
PCM	H302-188K2-K	H302-188K2-L	1.67 MB

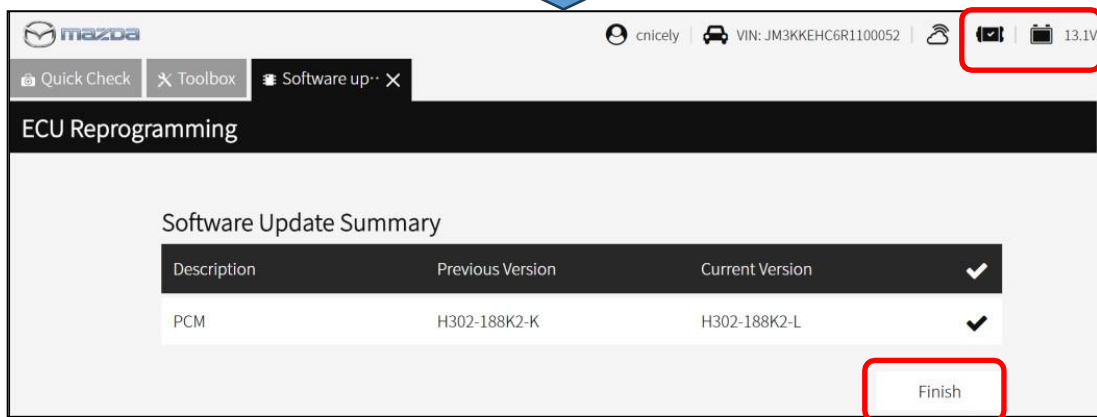
Software Update Summary

Description	Previous Version	Current Version
PCM	H302-188K2-K	H302-188K2-L

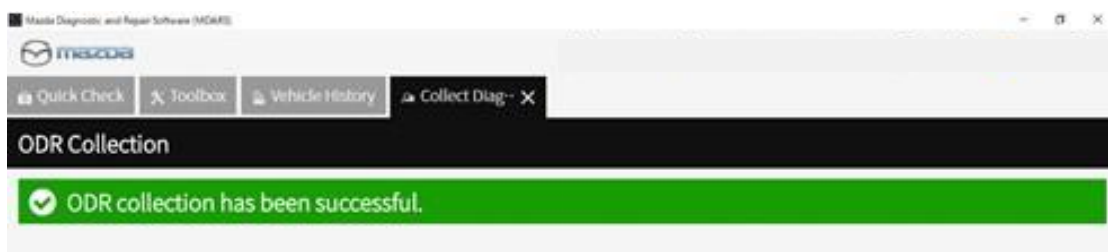
(4) MDARS has collected ODR and sent to the server.

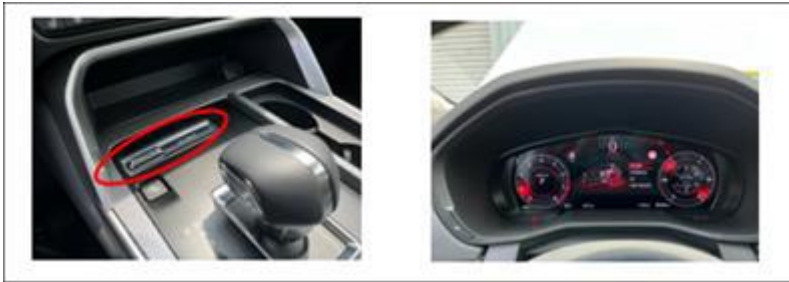
10. Verify the repair by starting the engine. If subject vehicle is PHEV, proceed with following steps. Make sure there is no MIL illumination or abnormal warning lights present.

<How to start the engine in PHEV>

- (10-1) Switch to 'Sport Mode' and shift to 'D' range
- (10-2) Confirm Engine RPM is shown correctly in IC.
- (10-3) Shift to 'P' range then stop the engine. Turn ignition off.
