MULTIPLE CAMPAIGNS REPAIR PROCEDURE AND MULTIPLE MODULE REPROGRAMMING

Section B : Repair Procedure Recall 6223J

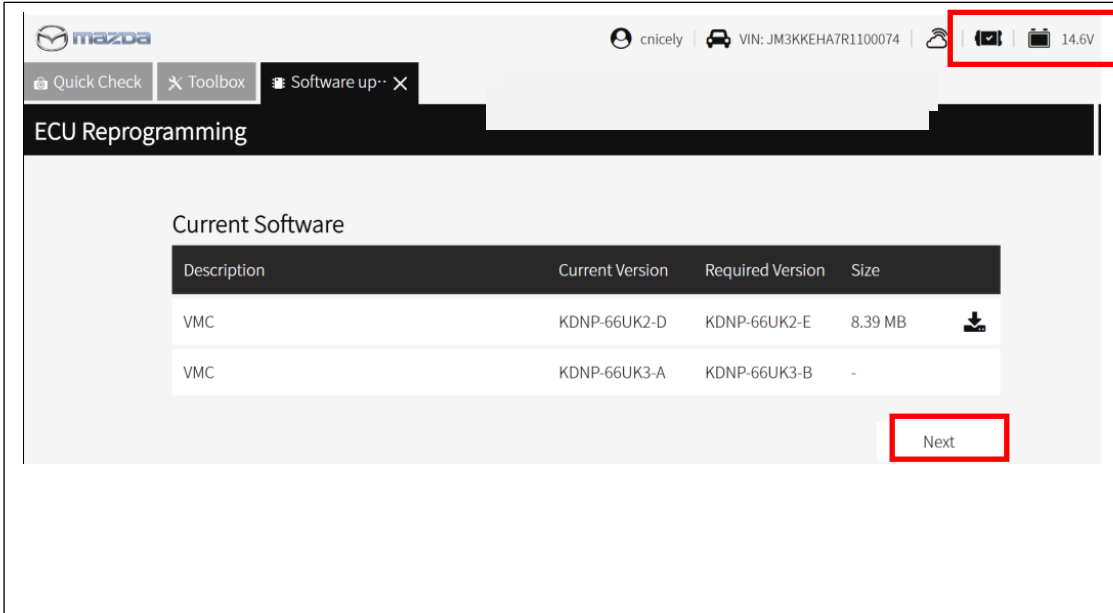
6. After completion of software update, the previous and current software version are shown. Check current version at “Calibration File information” below. Then, click on “Finish” to exit the ECU reprogramming and disconnect the 12V battery charger.

The screenshot shows the Mazda software update interface. At the top, there is a navigation bar with 'Quick Check', 'Toolbox', and 'Software up' tabs. The main heading is 'ECU Reprogramming'. Below this, a section titled 'Current Software' contains a table with the following data:

Description	Current Version	Required Version	Size
VMC	KDNP-66UK2-D	KDNP-66UK2-E	8.39 MB
VMC	KDNP-66UK3-A	KDNP-66UK3-B	-

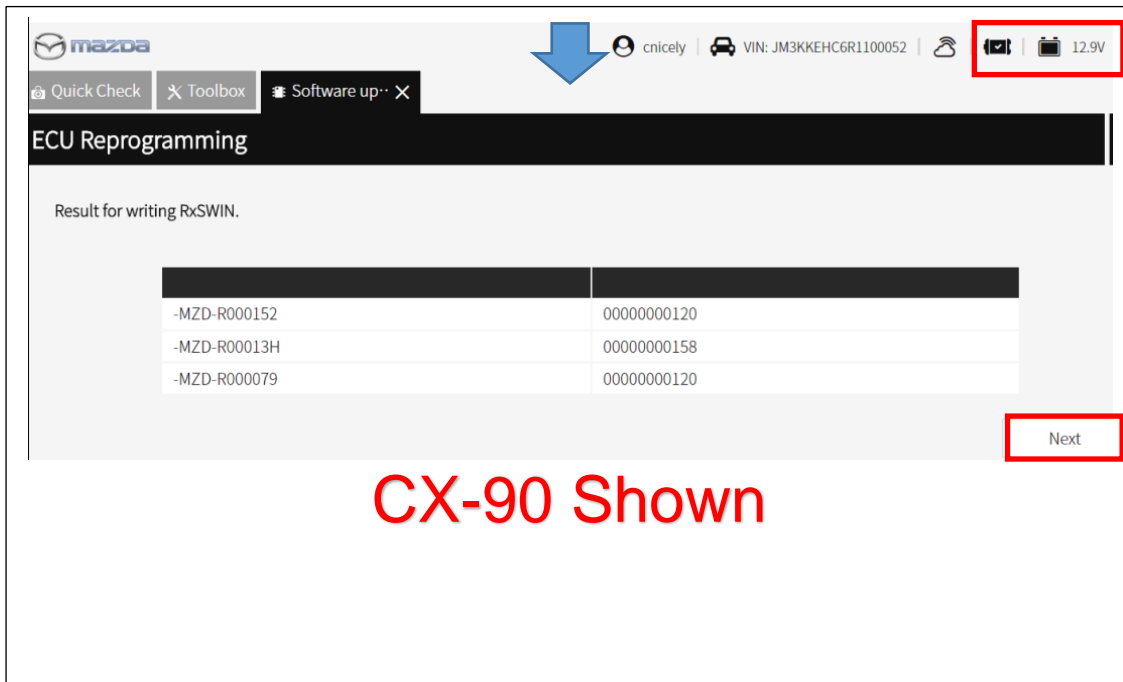
The screenshot shows the Mazda software update interface after the update. A blue arrow points to the top of the interface. The main heading is 'ECU Reprogramming'. Below this, a section titled 'Result for writing RxSWIN.' contains a table with the following data:

-MZD-R000152	00000000120
-MZD-R00013H	00000000158
-MZD-R000079	00000000120

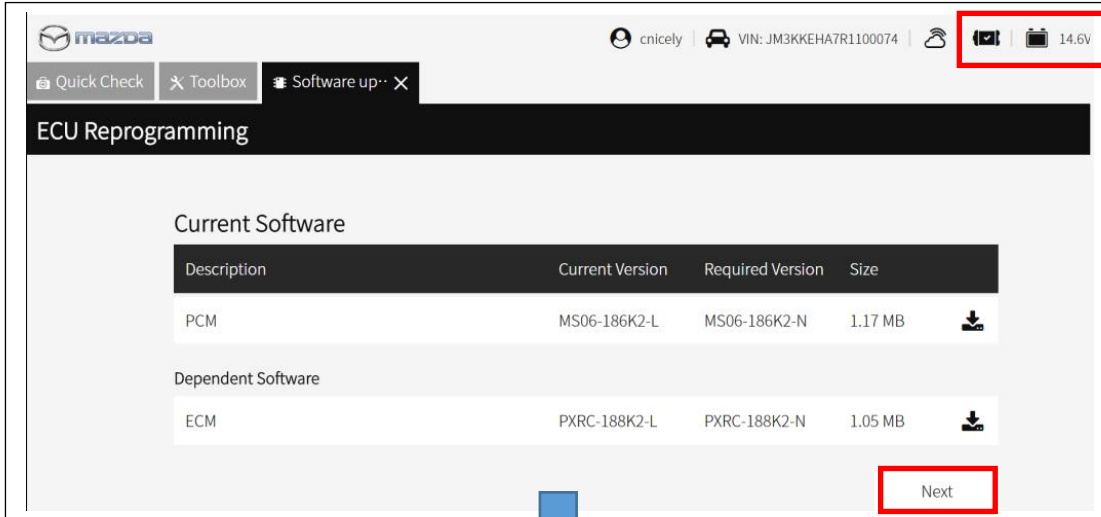
6. After completion of software update, the previous and current software version are shown. Check current version at "Calibration File information" below. Then, click on "Finish" to exit the ECU reprogramming and disconnect the 12V battery charger.

The screenshot shows the Mazda software update interface. At the top right, there are icons for video recording and a battery level indicator showing 14.6V. The main heading is "ECU Reprogramming". Below it, the "Current Software" section contains a table with the following data:

Description	Current Version	Required Version	Size	
PCM	MS06-186K2-L	MS06-186K2-N	1.17 MB

ECM	PXRC-188K2-L	PXRC-188K2-N	1.05 MB	
-----	--------------	--------------	---------	--

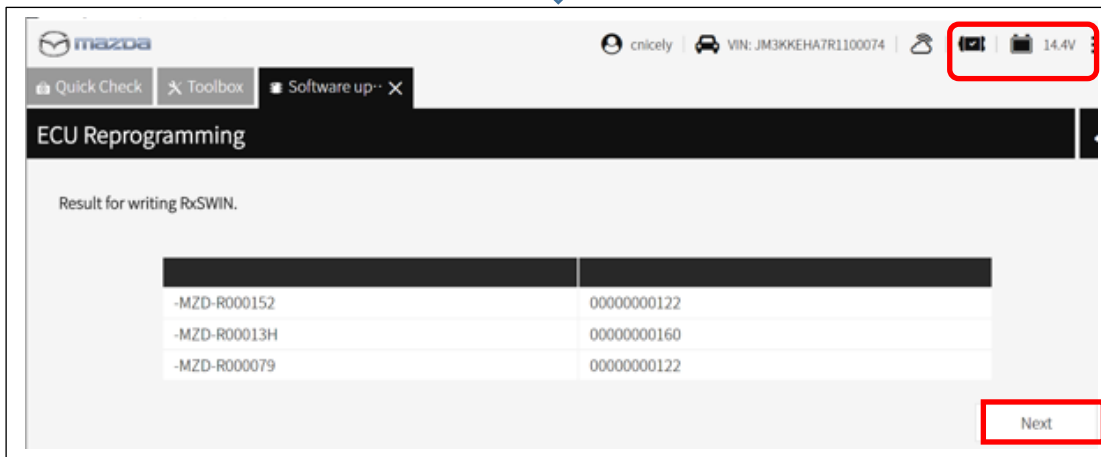
The screenshot shows the Mazda software update interface. At the top right, there are icons for video recording and a battery level indicator showing 14.4V. The main heading is "ECU Reprogramming". Below it, the "Result for writing RoSWIN" section contains a table with the following data:

-MZD-R000152	00000000122
-MZD-R00013H	00000000160
-MZD-R000079	00000000122

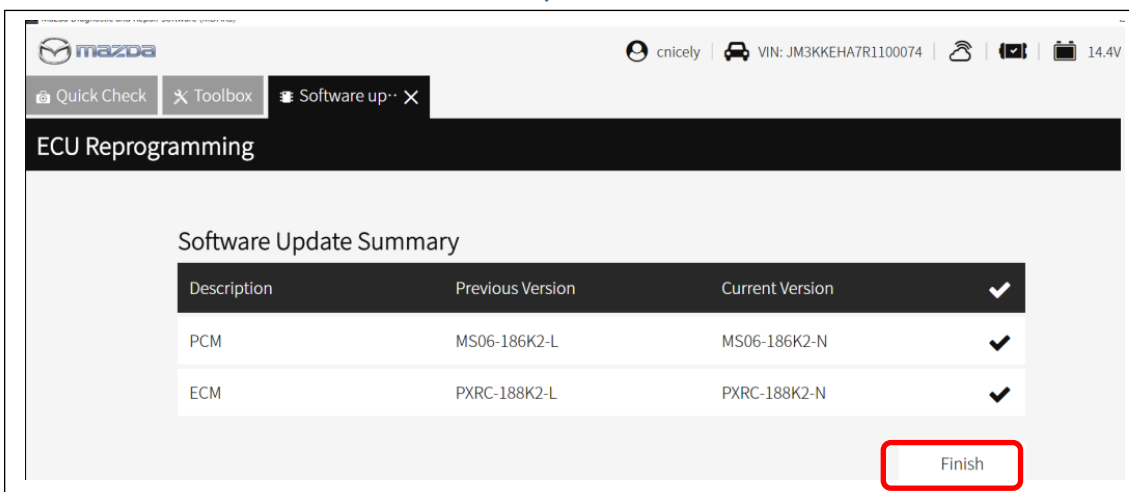
The screenshot shows the Mazda software update interface. At the top right, there are icons for video recording and a battery level indicator showing 14.4V. The main heading is "ECU Reprogramming". Below it, the "Software Update Summary" section contains a table with the following data:

Description	Previous Version	Current Version	
PCM	MS06-186K2-L	MS06-186K2-N	✓
ECM	PXRC-188K2-L	PXRC-188K2-N	✓

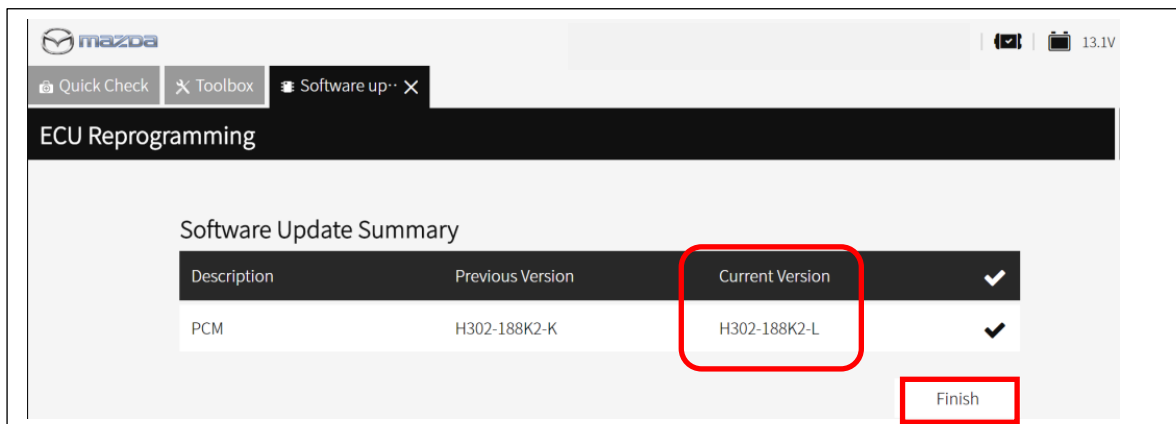
Software Update Summary

Description	Previous Version	Current Version	
PCM	H302-188K2-K	H302-188K2-L	✓

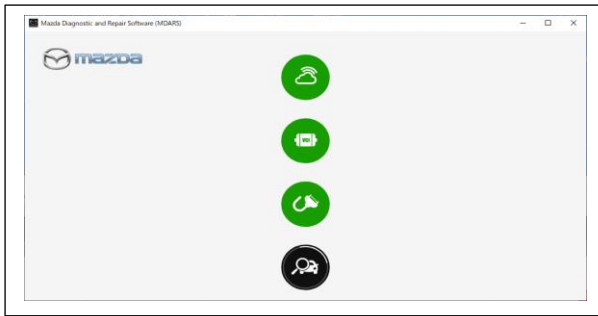
then collect the vehicle information.

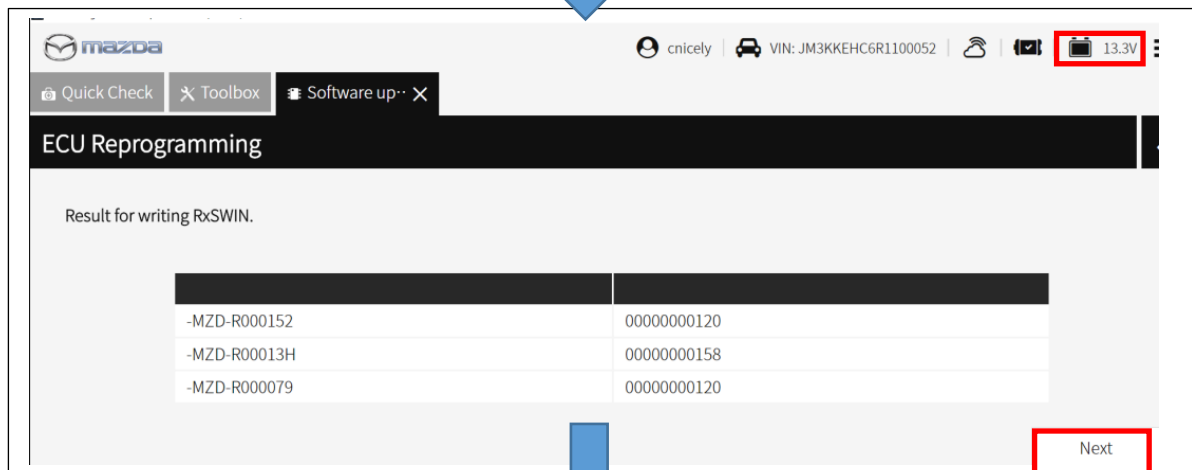
6. After completion of software update, the previous and current software version are shown. Check current version at "Calibration File information" below. Then, click on "Finish" to exit the ECU reprogramming and disconnect the 12V battery charger.

Calibration file information

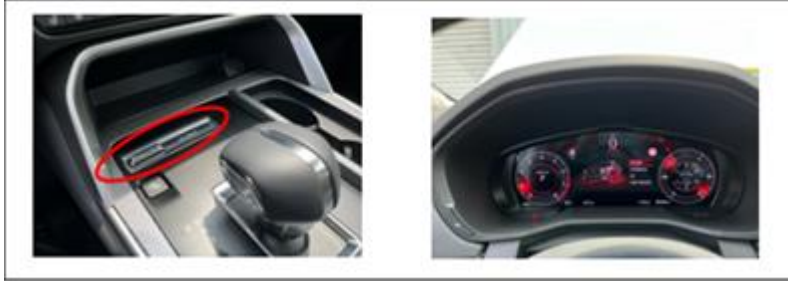
10. Verify the repair by starting the engine. If subject vehicle is PHEV, proceed with following steps. Make sure there is no MIL illumination or abnormal warning lights present.

<How to start the engine in PHEV>

- (10-1) Switch to 'Sport Mode' and shift to 'D' range
- (10-2) Confirm Engine RPM is shown correctly in IC.
- (10-3) Shift to 'P' range then stop the engine. Turn ignition off.
