MULTIPLE CAMPAIGNS REPAIR PROCEDURE AND MULTIPLE MODULE REPROGRAMMING

Section B : Repair Procedure Recall 6223J

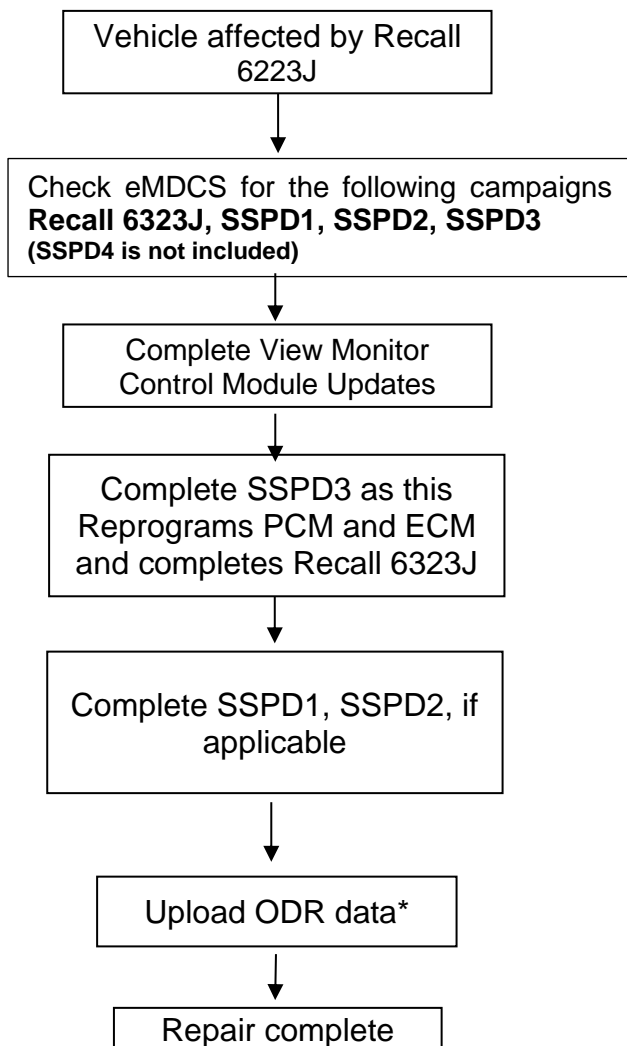
CX-90 PHEV

Section A : Flow Chart – NOTE: You must clear any DTC's (diagnose and repair) before performing any of these campaigns. The recall or SSP repairs will NOT fix/clear a DTC issue. Once repaired, then start the repair process for campaigns.

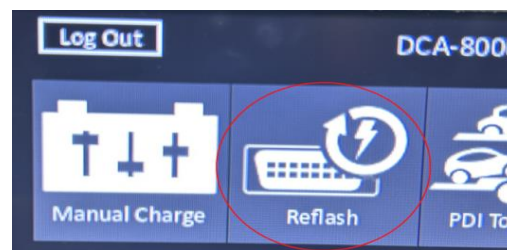
During reprogramming, connect battery charger to the vehicle to stabilize voltage fluctuation. If missing, it may cause damage to ECUs due to decreasing voltage.

7th generation vehicle will control to turn on headlight forcibly during reprogramming due to change CAN communication. Please use the “Reflash” setting in the charger, which will keep the voltage stable.

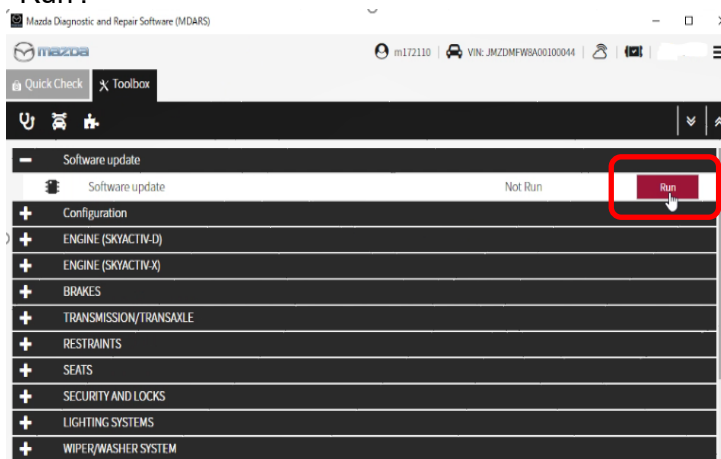
- Reprogram Side Radar as below. If there is 'Software update' on 'Toolbox' tab. Select 'Run'.

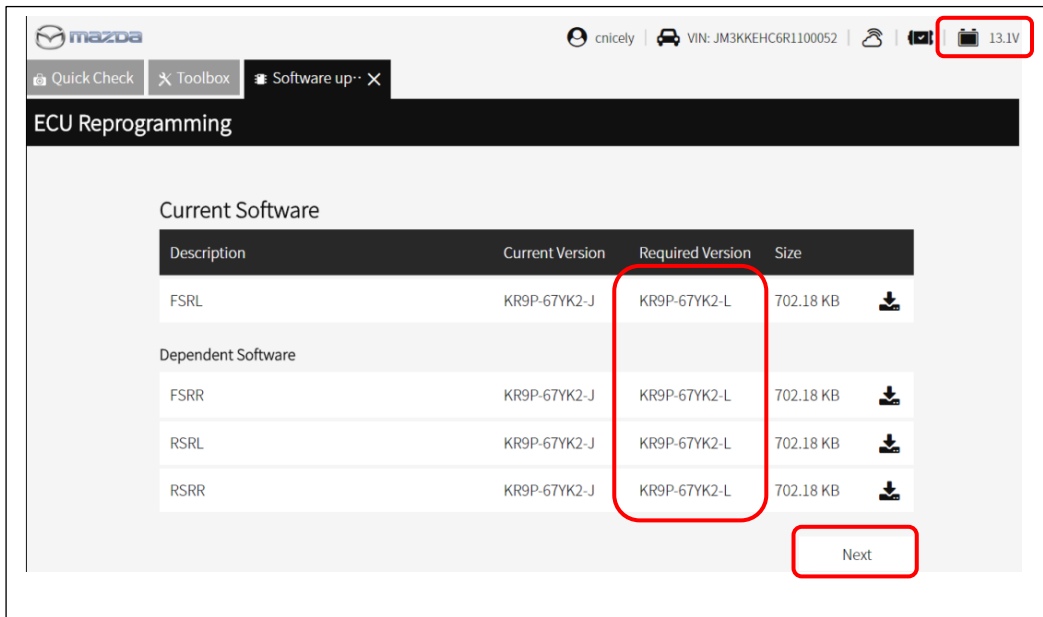
5. Select required module on 'ECU Reprogramming' screen.
6. Start Reprogramming.

Side Radar Sensor ECU Programming	Applicable Vehicle	Not Applicable
<p><u>NOTE: Not all trims have Front Side Radar</u></p> <ul style="list-style-type: none"> • FSRR (Front Side Radar Right) • FSRL (Front Side Radar Left) 	<p>Standard PT</p> <ul style="list-style-type: none"> • 3.3 Turbo Premium Plus <p>High PT</p> <ul style="list-style-type: none"> • 3.3 Turbo S Premium Plus <p>PHEV</p> <ul style="list-style-type: none"> • PHEV Premium Plus 	<p>Standard PT</p> <ul style="list-style-type: none"> • 3.3 Turbo Select • 3.3 Turbo Preferred • 3.3 Turbo Preferred Plus • 3.3 Turbo Premium <p>High PT</p> <ul style="list-style-type: none"> • 3.3 Turbo S <p>PHEV</p> <ul style="list-style-type: none"> • PHEV Preferred • PHEV Premium
<ul style="list-style-type: none"> • RSRR (Rear Side Radar Right) • RSRL (Rear Side Radar Left) 	<p>All</p>	<p>N/A – All vehicles have Rear Side Radar Sensors</p>

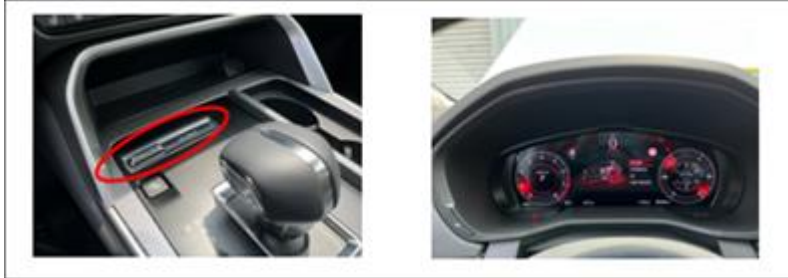
10. Verify the repair by starting the engine. If subject vehicle is PHEV, proceed with following steps. Make sure there is no MIL illumination or abnormal warning lights present.

- (10-1) Switch to 'Sport Mode' and shift to 'D' range
- (10-2) Confirm Engine RPM is shown correctly in IC.
- (10-3) Shift to 'P' range then stop the engine. Turn ignition off.
