GROUP	MODEL
Safety Recall Campaign	2015-2019MY
	Soul EV (PS EV)
NUMBER	DATE
SC287	December 2023

# SUBJECT: ECM EPB OPERATION LOGIC IMPROVEMENT (SC287)

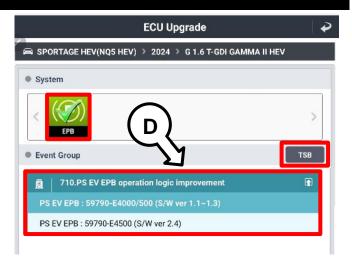
7. Select **'EPB'** system and applicable **'Event Group'** (D) for the vehicle:

**Event #710.PS EV EPB operation logic** improvement

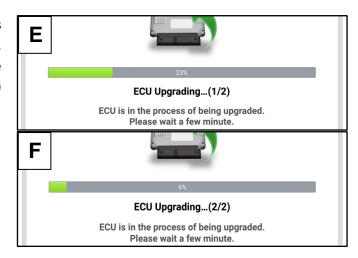
8. The ECU upgrade will begin, and the progress of the upgrade will appear on the bar graph. Upgrade part (1/2) (E) will download the upgrade event to the VCI-II. Upgrade part (2/2) (F) will upgrade the ECU.
