Safety Recall

A232424320 Intermittent Instrument Panel Blackout

Release Date: November 2023

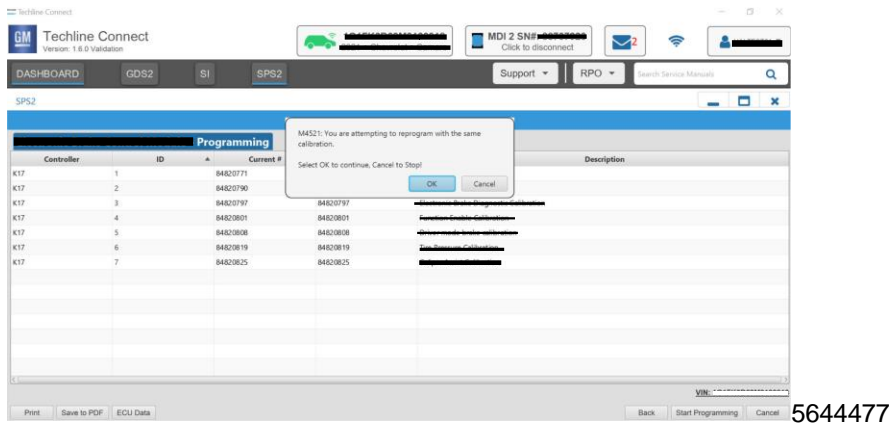
Important: Techline Connect screens shown above.

Important: If the same calibration/software warning is noted on the TLC Summary screen, select OK and follow screen instructions. After a successful programming event, the WCC is located in the Service Programming System dialogue box of the SPS Summary screen. No further action is required. Refer to the Warranty section of the bulletin.
