SAFETY RECALL
 NORTH AMERICA
Malfunctioning SCCM

Reference: B2A / NHTSA 23V-799

FCA US LLC

- Remedy available for
- 2023-2024 (D2) RAM 3500 Pickup
- 2023-2024 (DD) RAM 3500 Cab/Chassis
- 2023 (DF) RAM 3500 10K LB. Cab/Chassis
- 2023-2024 (DJ) RAM 2500 Pickup
- 2023-2024 (DP) RAM 4500/5500 Cab Chassis
- 2023 (DS) RAM 1500 Pickup

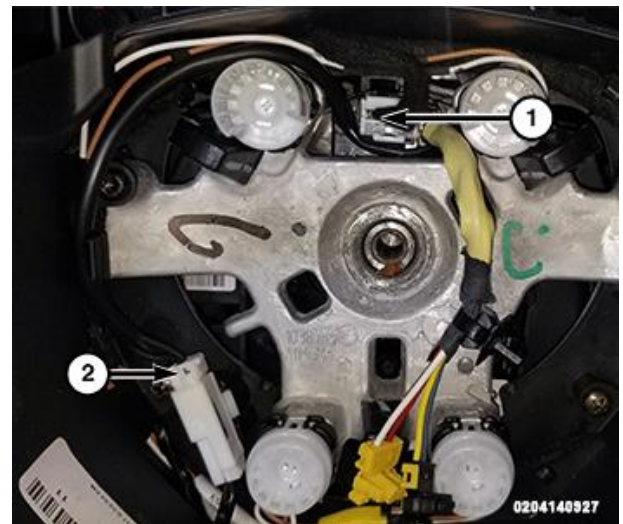
Figure 8 – Wire Harness Connectors

16. Disconnect the wire harness connectors (1) and (2) (Figure 8).
17. Remove the steering wheel.

13. Install the **NEW** steering wheel bolt. Tighten the bolt to 61 N·m (45 ft. lbs.).
14. Connect the wire harness connectors (1) and (2) (Figure 8).

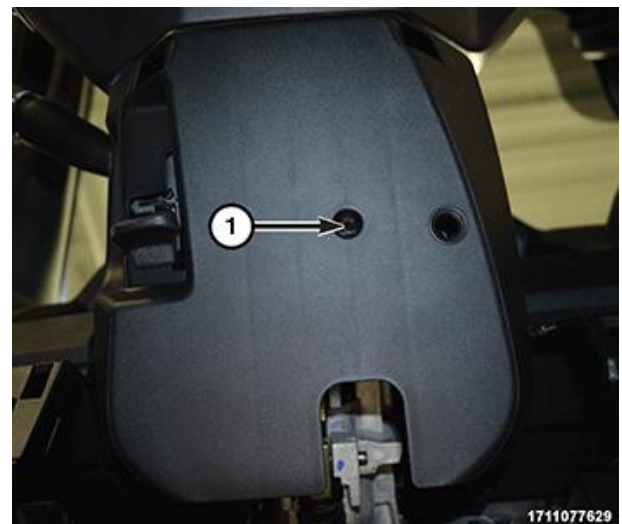
Figure 12 – Steering Column Lower Shroud

23. Remove the lower shroud to column retaining screw (1) and carefully move the lower shroud over the steering column tilt lever and off the steering column (Figure 12).

1. Connect the wire harness connectors (2&3) (Figure 15).
2. Secure the wire harness routing clip (1) (Figure 15).
3. While sliding the SCCM over the steering column connect the pedal adjustment wire harness connector, if equipped.
4. Install and securely tighten the screws (1) (Figures 13 & 14).
5. Remove the lock tab or any other device that is being used to secure the SCCM rotor to the SCCM case to maintain SCCM centering.
6. Install the lower shroud, shroud to column retaining screw (1) and tighten securely (Figure 12).

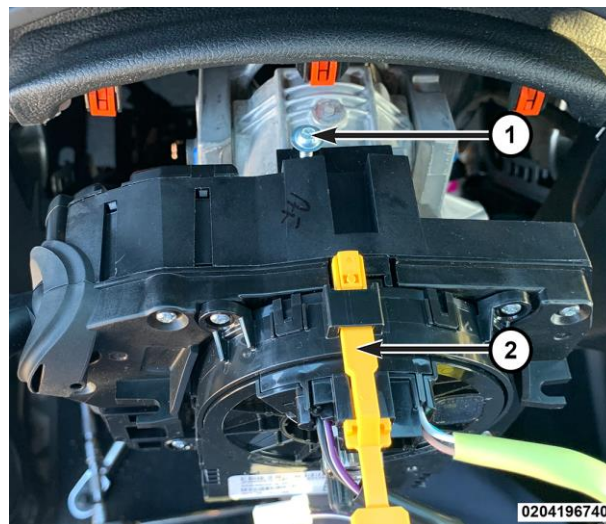
Figure 13 – SCCM Screw

24. Remove the screw (1) (Figure 13).

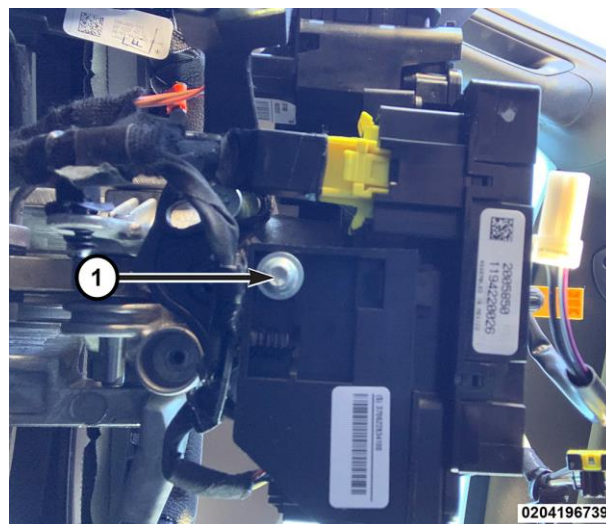
Figure 14 – SCCM Screw

25. Remove the screw (1) (Figure 14).

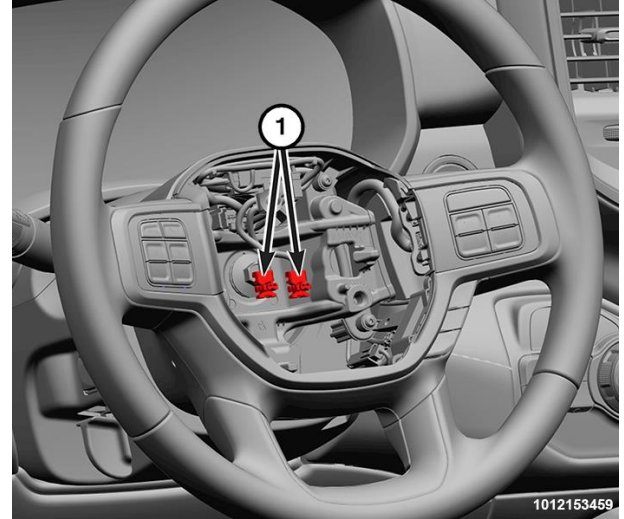
Figure 20 – Steering Wheel Wire Harness Connectors

11. Pull the DAB away from the steering wheel far enough to access the steering wheel wire harness connector to the DAB inflator initiators (1) (Figure 20).

13. Connect the two steering wheel wire harness connectors (Figure 20).
14. Position the DAB close enough to the steering wheel to connect the steering wheel wire harness connectors to the DAB inflator initiators (1) (Figures 20 and 21).

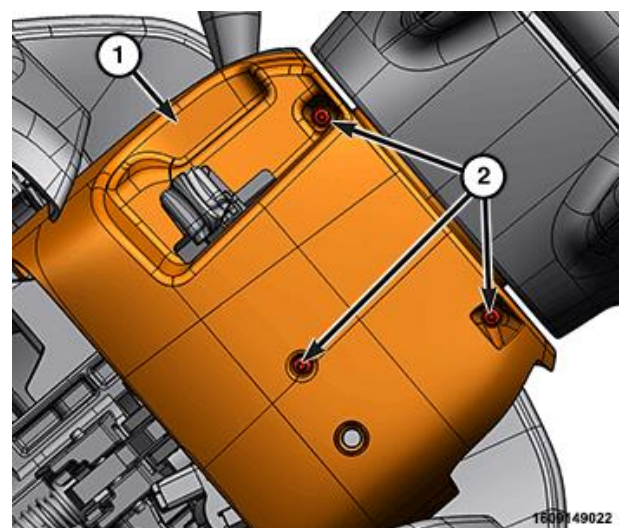
Figure 22 – Steering Column Shroud Screws

17. Remove the three steering column shroud screws (Figure 22).

9. Install and securely tighten the three steering column shroud screws (2) (Figure 22).
10. If equipped, connect the heated steering wheel wire harness connectors and secure the steering wheel wire harness.

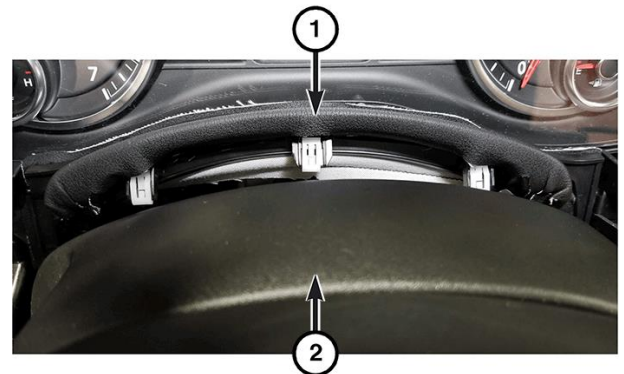
Figure 24 – Gap Hider

- 20. Disengage the gap hider (1) from the upper steering column shroud (2) and remove the upper steering column shroud (Figure 24).

6. Engage the upper steering column shroud (2) to the gap hider (1) (Figure 24). **Verify that the top shroud is properly secured to the gap hider. Move the tilt column up and down to ensure the gap hider stays connected to the upper shroud.**
