SAFETY RECALL
NORTH AMERICA
Malfunctioning SCCM

Reference: B2A / NHTSA 23V-799

FCA US LLC

2023-2024 (D2) RAM 3500 Pickup

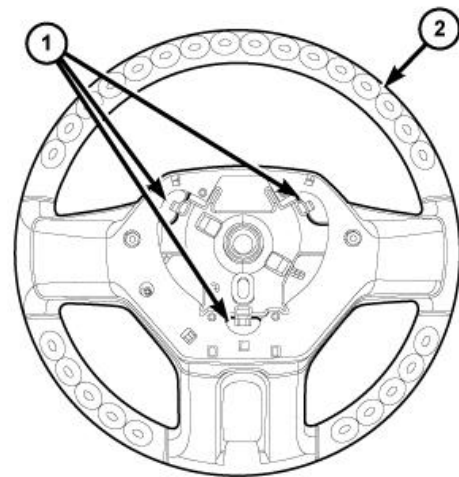
Figure 3 – Airbag Retainer Access Holes

7. There are three airbag retainer access holes (1) on the instrument panel side of the hub of the steering wheel (2), located at the two o'clock, six o'clock and ten o'clock positions. The steering wheel must be rotated to bring each of these access holes up to the twelve o'clock position of the steering column one at a time for removal access (Figure 3).

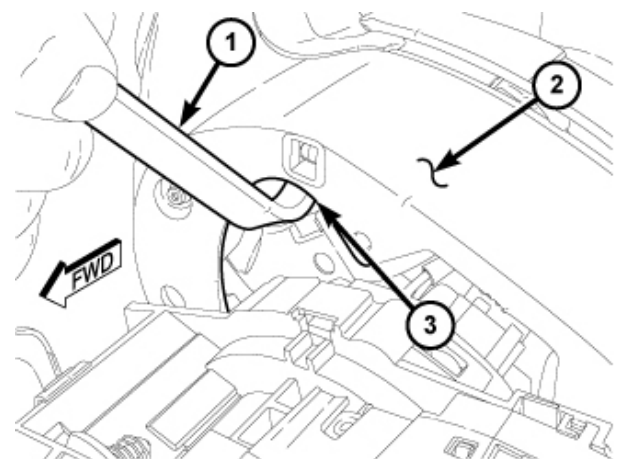
Figure 4 – DAB Removal Tool 10187

8. Insert the short blade (Tip A) of the DAB Removal Tool (Special Tool Number 10187) (1) or the blade of an equivalent prying tool into either of the upper (two o'clock or ten o'clock) access holes (3) of the steering wheel hub rear trim cover (2), being certain to place the blade of the tool on the inboard (steering wheel hub) side of the airbag snap retainer wire loop (Figure 4).

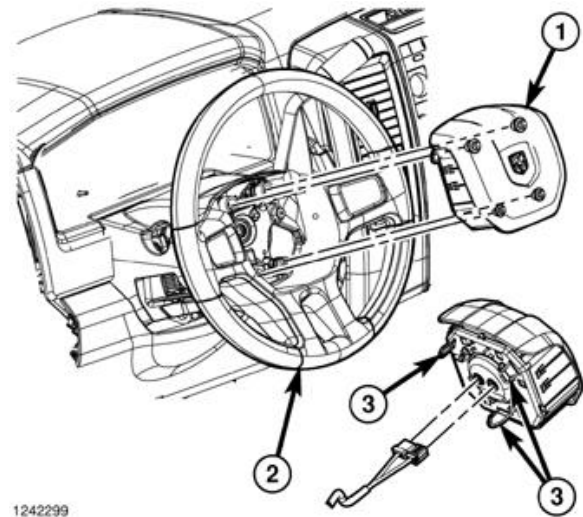
Figure 5 – Airbag Removal

9. Push the handle of the tool downward for the blade to pry the snap retainer wire loop (3) upward far enough to disengage the loop from the hook of the steering wheel armature. At the same time, gently pull the DAB (1) away from the steering wheel (2) to prevent the retainer from snapping back into place over the hook once it is disengaged (Figure 5).
10. Repeat Steps 7 and 8 at the other upper (two o'clock or ten o'clock) access hole to disengage the other upper snap retainer wire loop.
11. Repeat Steps 7 and 8 at the lower (six o'clock) access hole to disengage the lower snap retainer wire loop. The lower snap retainer wire loop has a distinctive V-shape and must always be installed onto the six o'clock hook of the steering wheel armature.

18. Carefully position the DAB (1) into the hub cavity of the steering wheel (2). Be certain that the clockspring pigtail wires and the steering wheel wire harness are not pinched between the DAB and the horn switch, the steering wheel armature or, on vehicles equipped with a diesel engine, the steering wheel damper weight (Figure 5).

19. Engage the lower airbag snap retainer wire loop (3) onto the lower hook of the steering wheel armature. The lower snap retainer wire loop has a distinctive V-shape and must always be installed onto the six o'clock hook of the steering wheel armature (Figure 5).

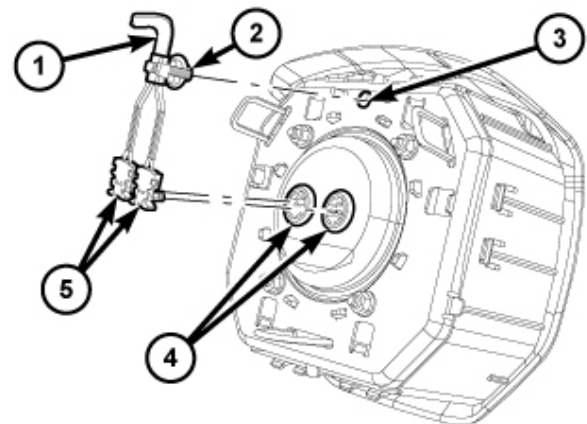
Figure 6 – Pigtail Wiring Harness Retainer

12. Pull the DAB away from the steering wheel far enough to access and disengage the plastic push-in retainer (2) of the clockspring pigtail wire harness (1) from the locator hole (3) at the 12 o'clock position on the back of the airbag housing (Figure 6).

15. Position the Driver AirBag (DAB) close enough to the steering wheel to reconnect the two clockspring DAB pigtail wire (1) electrical connections (5) to the inflator connector receptacles (4) on the back of the airbag housing (Figure 6).

17. Be certain to fully engage the plastic push-in retainer (2) of the clockspring pigtail wires into the locator hole (3) at the 12 o'clock position on the back of the airbag housing (Figure 6).

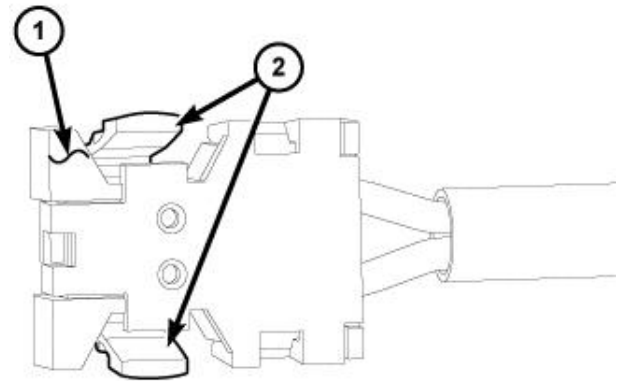
Figure 7 – Connector Insulator Latches

13. The clockspring DAB pigtail wire connector insulators (1) are secured by integral latches (2) to the airbag inflator connector receptacles, which are located on the back of the airbag housing. Pinch both latches firmly, then pull the insulators straight out from the airbag inflator to disconnect them from the connector receptacles (Figure 7).
14. Remove the DAB from the steering wheel
15. Remove the steering wheel bolt and **DISCARD**.

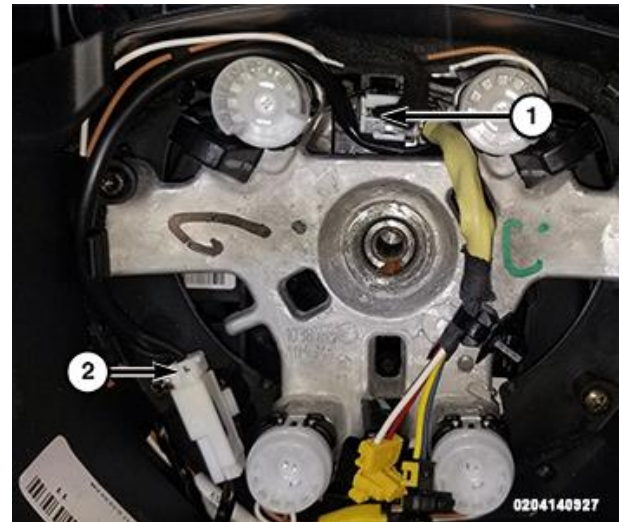
Figure 8 – Wire Harness Connectors

16. Disconnect the wire harness connectors (1) and (2) (Figure 8).
17. Remove the steering wheel.

13. Install the **NEW** steering wheel bolt. Tighten the bolt to 61 N·m (45 ft. lbs.).
14. Connect the wire harness connectors (1) and (2) (Figure 8).

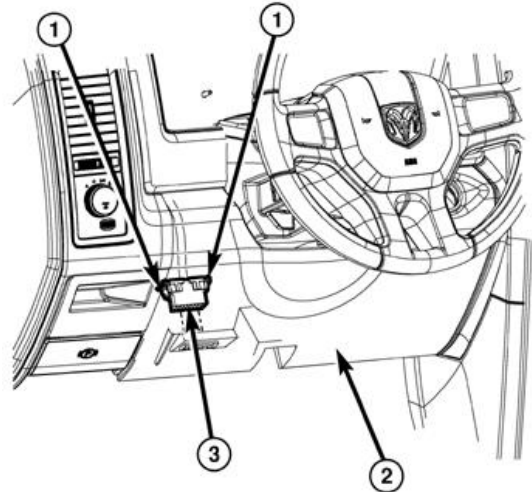
Figure 10 – Data Link Connector

20. Remove the Data Link Connector (3) from the steering column opening cover (2) by pressing in the tabs (1) and pushing the connector through the opening on the back side of the cover (Figure 10).

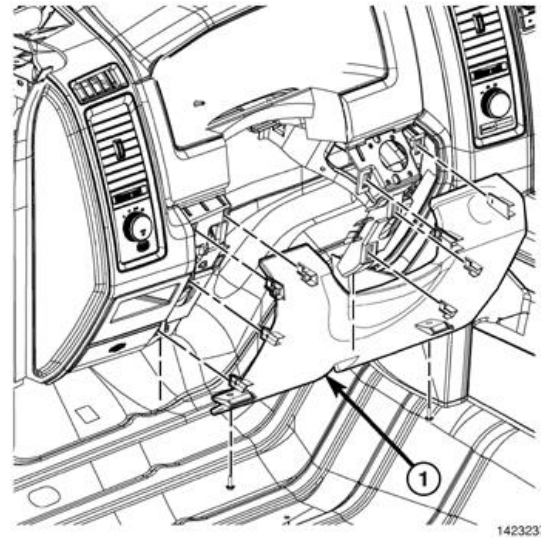
Figure 11 – Steering Column Opening Cover

21. Using a trim stick C-4755 or equivalent, release the retainer clips that secure the steering column opening cover (1) to the instrument panel and remove the cover (Figure 11).
22. Disconnect necessary wire harness connectors.

7. Lift the steering column opening cover into position. Connect necessary wire harness connectors.
8. Align the retainer clips that secure the steering column opening cover (1) to the instrument panel and install the cover (Figure 11).
9. Install the Data Link Connector (3) to the steering column opening cover (2) through the opening on the back side of the cover (Figure 10).
10. Install the two fasteners (2) that secure the bottom of the steering column opening cover (1) to the instrument panel and tighten securely (Figure 9).
11. Engage the retainer clip that secures the hood release to the steering column opening cover (Figure 9).

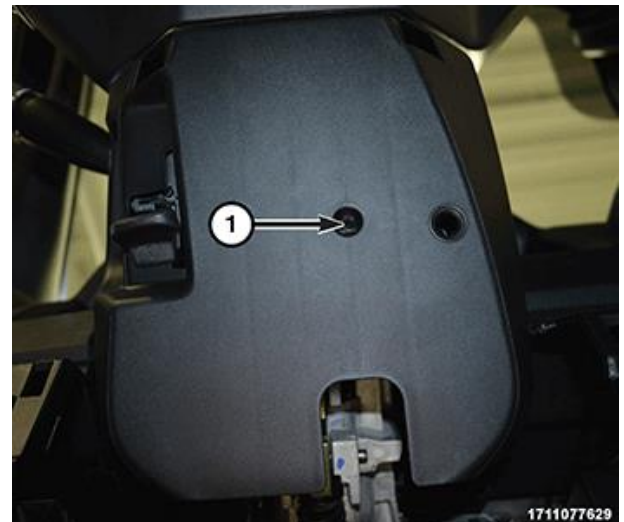
Figure 12 – Steering Column Lower Shroud

23. Remove the lower shroud to column retaining screw (1) and carefully move the lower shroud over the steering column tilt lever and off the steering column (Figure 12).

6. Install the lower shroud, shroud to column retaining screw (1) and tighten securely (Figure 12).

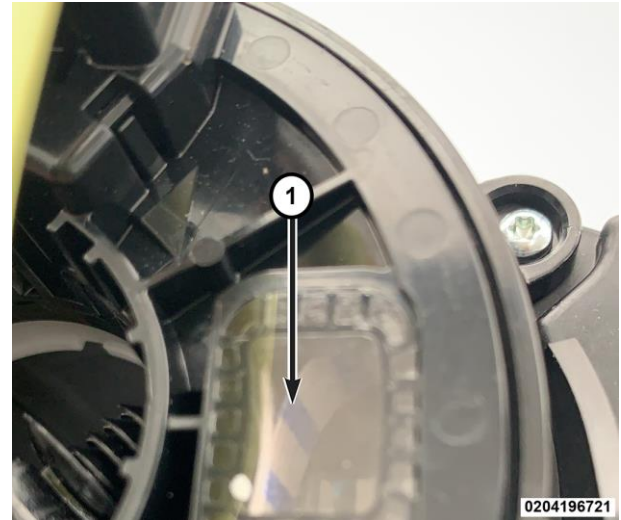
Figure 16 – Blue Stripe Ribbon

NOTE: The Steering Column Control Module (SCCM) centering can be verified by visually confirming the blue striped ribbon is present in the sight glass (Figure 16).

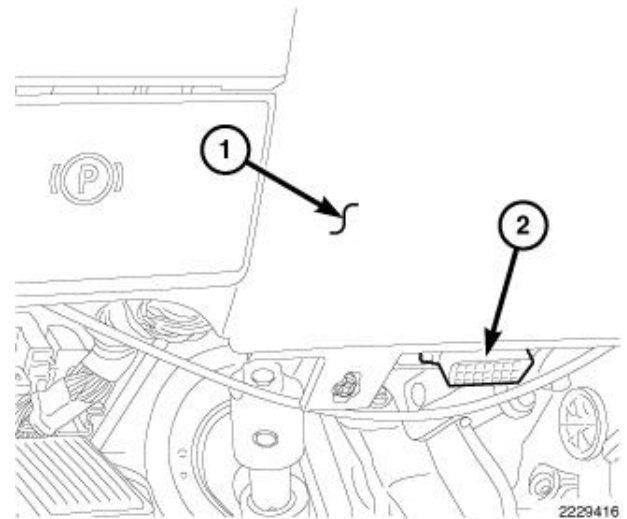
Figure 17 – DLC

25. Be certain that the diagnostic scan tool contains the latest version of the proper diagnostic software. Connect the scan tool to the 16-way Data Link Connector (DLC) (2). The DLC is located on the driver side lower edge of the instrument panel, near the steering column opening cover (1) and outboard of the steering column (Figure 17).

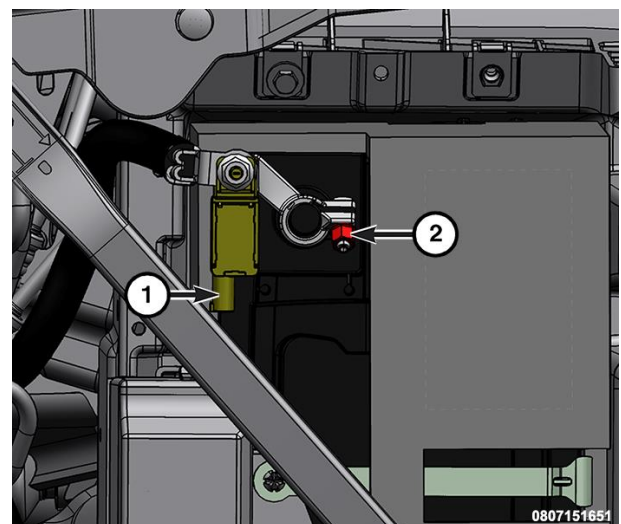
Figure 18 – IBS Connector

2. Disconnect the Intelligent Battery Sensor (IBS) wire harness connector (1) (Figure 18).

3. Loosen the ground terminal nut (2) and remove the negative battery cable with IBS from the battery and isolate it.

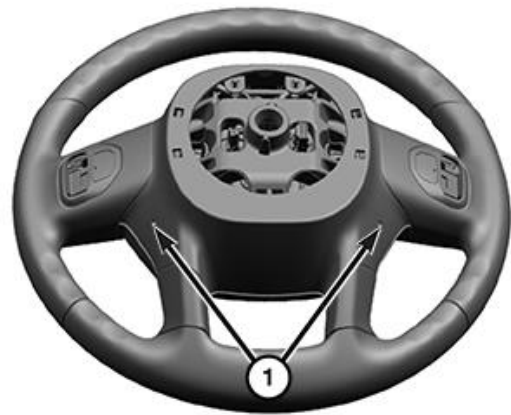
Figure 19 – DAB Removal

5. Wait 2 minutes for capacitor discharge.
6. Locate the access hole dimples (1) in the lower surface of the steering wheel hub rear trim cover near each of the two horizontal spokes.
7. Using the Remover, Driver Air Bag 2050200100, pierce the trim cover at the dimple and insert it through one of the steering wheel access holes. A guide and notch integral to each side of the steering wheel hub rear trim cover and the mounting/horn switch plate will assist in directing the tool to the ends of the retainer spring (Figure 19).

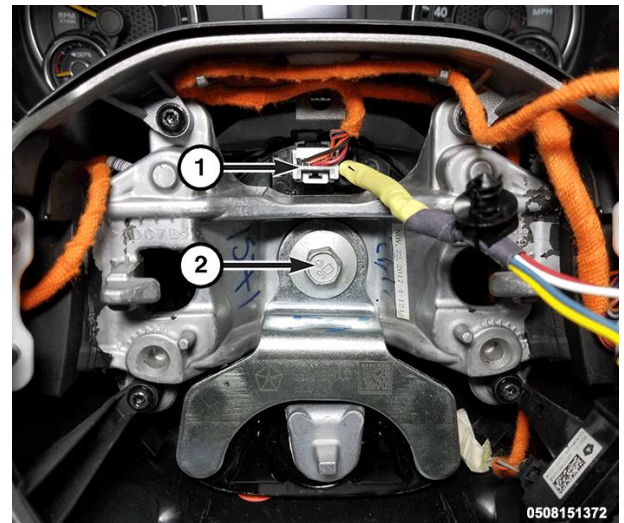
Figure 21 – Steering Wheel Wire Harness Connectors

12. The clockspring DAB pigtail wire connector insulators are secured by integral latches and a Connector Position Assurance (CPA) lock to the airbag tether cutter and inflator connector receptacles, which are located on the back of the floating horn switch plate and the DAB housing. Pull the lock straight away from the connector insulator, then pull the insulators straight away from the connector receptacles to disengage and disconnect them (Figure 20).
13. Remove the DAB and floating horn switch plate from the steering wheel as a unit.
14. Disconnect the steering wheel wire harness connectors (1) (Figure 21).
15. If equipped, disconnect the heated steering wheel wire harness connectors.
16. Remove and **DISCARD** the steering wheel bolt (2) and retain the damper if equipped (Figure 21).

11. Install the steering wheel to the steering column.
12. If equipped, position the damper to the steering wheel, then install a **NEW** steering wheel bolt and tighten the nut to 61 N·m (45 ft. lbs.) (Figure 21).

13. Connect the two steering wheel wire harness connectors (Figure 20).
14. Position the DAB close enough to the steering wheel to connect the steering wheel wire harness connectors to the DAB inflator initiators (1) (Figures 20 and 21).

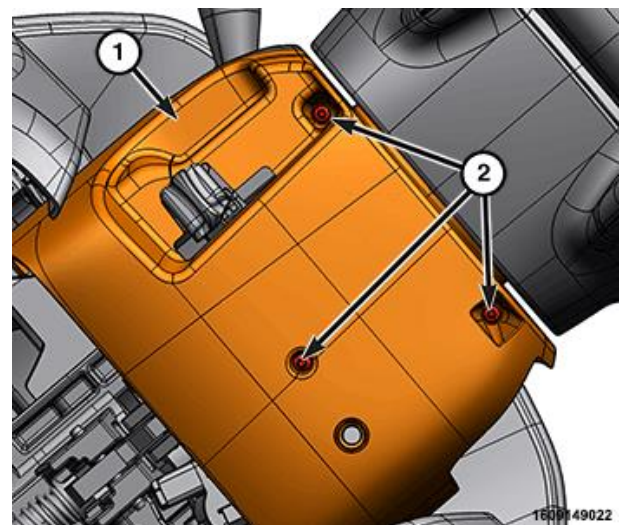
Figure 22 – Steering Column Shroud Screws

17. Remove the three steering column shroud screws (Figure 22).

9. Install and securely tighten the three steering column shroud screws (2) (Figure 22).
10. If equipped, connect the heated steering wheel wire harness connectors and secure the steering wheel wire harness.

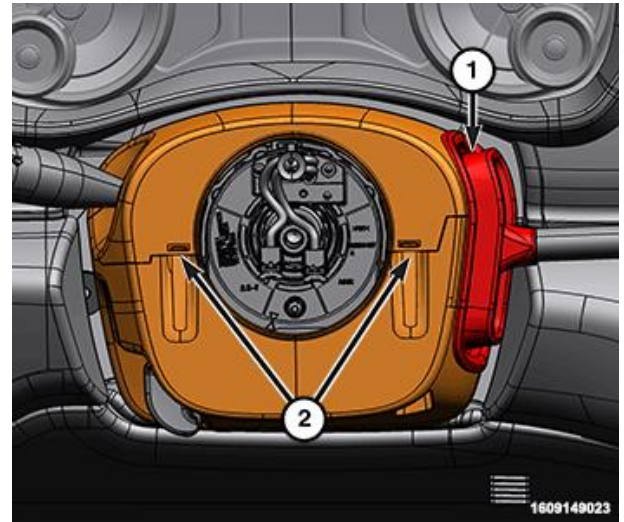
Figure 23 – Steering Column Shroud

- 18. If equipped, release the shifter boot (1) from the steering column shroud (Figure 23).
- 19. Disengage the upper steering column shroud tabs (2) from the lower steering column shroud (Figure 23).

7. Install the upper steering column shroud to the lower steering column shroud (Figure 23).
8. If equipped, install the shifter boot (1) to the steering column shroud (Figure 23).

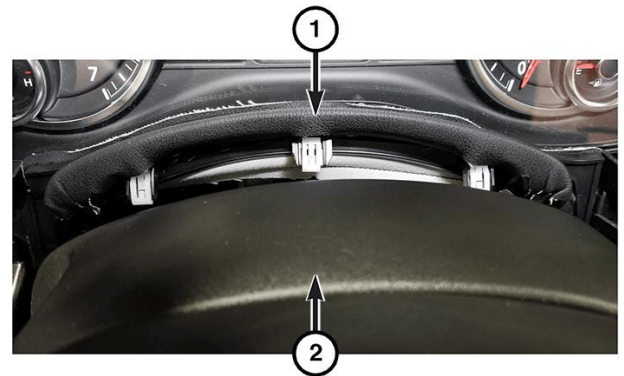
Figure 24 – Gap Hider

- 20. Disengage the gap hider (1) from the upper steering column shroud (2) and remove the upper steering column shroud (Figure 24).

6. Engage the upper steering column shroud (2) to the gap hider (1) (Figure 24). **Verify that the top shroud is properly secured to the gap hider. Move the tilt column up and down to ensure the gap hider stays connected to the upper shroud.**

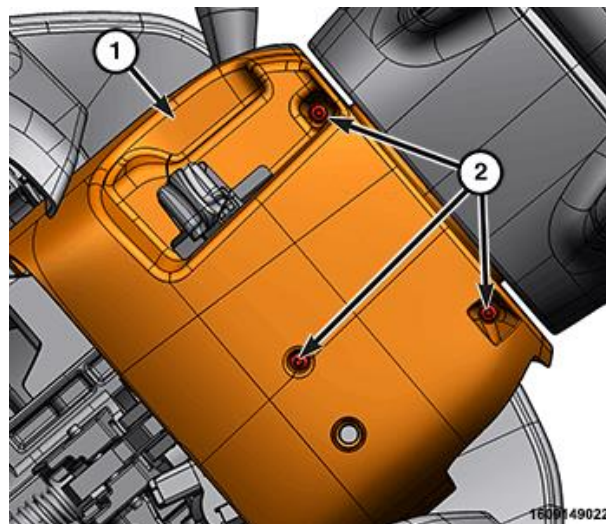
Figure 25 – Lower Steering Column Shroud

21. Remove the lower steering column shroud screws (2), then the shroud (1) (Figure 25).

4. Install and securely tighten the SCCM screws (1) (Figure 26 and 27).
5. Position the lower steering column (1) shroud to the steering column (Figure 25).

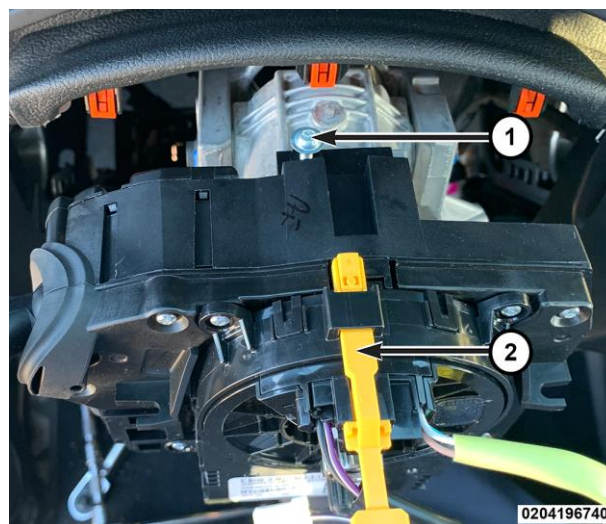
Figure 26 – SCCM

22. Secure the SCCM in the straight-ahead position.
23. Remove the screws (1) (Figure 26 and 27).
