# VOLUNTARY RECALL CAMPAIGN

Classification: EL23-022	Reference: ITB23-028	Date: December 18, 2023
-----------------------------	-------------------------	----------------------------

## VOLUNTARY SAFETY RECALL CAMPAIGN 2022-2024 QX60; ADAPTIVE FRONT LIGHT SYSTEM CONFIGURATION

**CAMPAIGN ID #:** PC994  
**APPLIED VEHICLES:** 2022-2024 QX60 (L51)

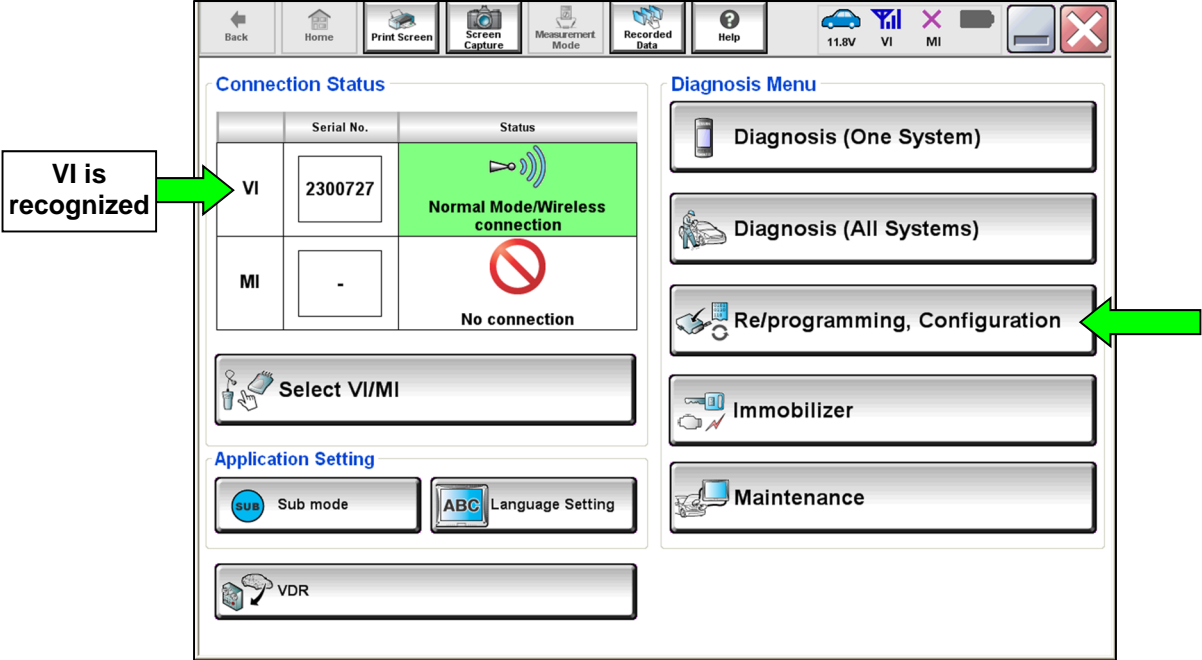
Figure 1

- 10. Wait for the VI to be recognized.
  - The serial number will be displayed when the VI is recognized.
- 11. Select **Re/programming, Configuration**.

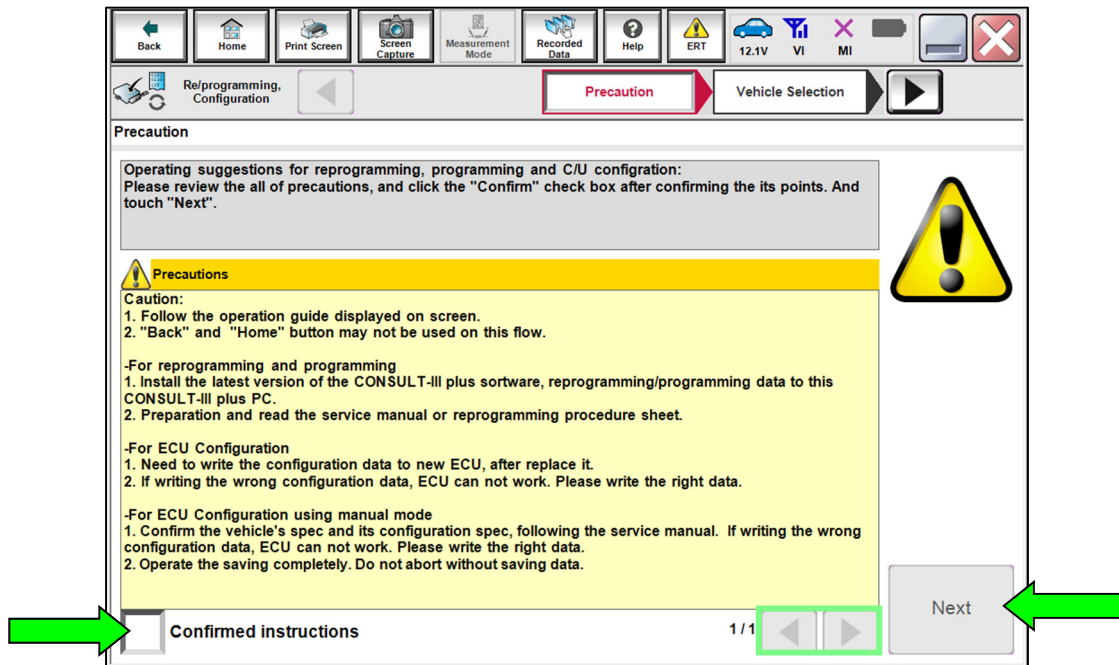
Figure 2

12. Use the arrows (if needed) to view and read all precautions.
13. Check the box confirming the precautions have been read.
14. Select **Next**.

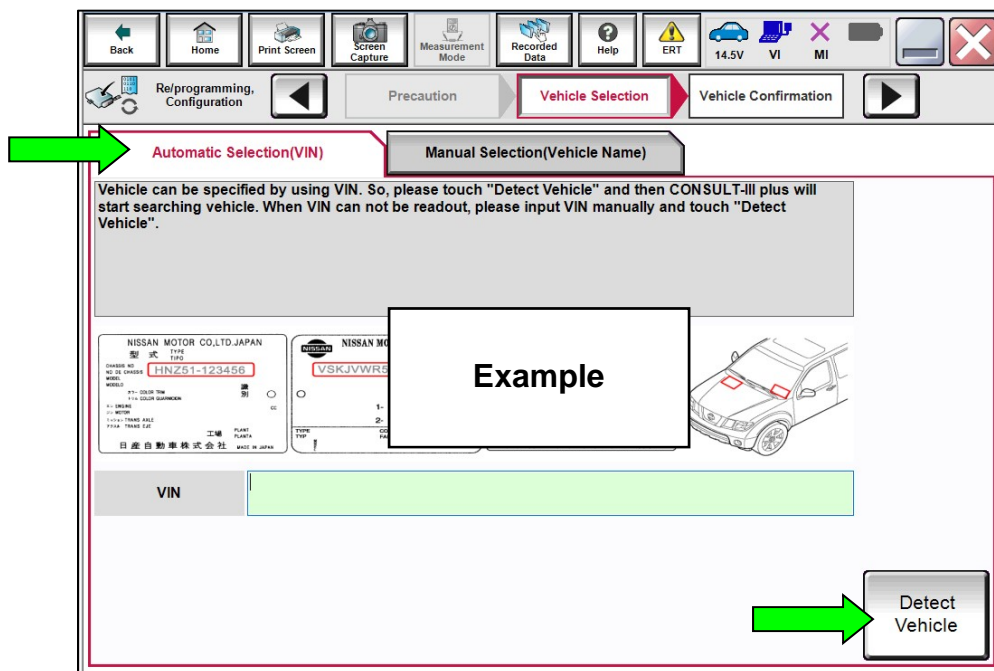
Figure 3

15. Select **Automatic Selection(VIN)**, and then select **Detect Vehicle**.

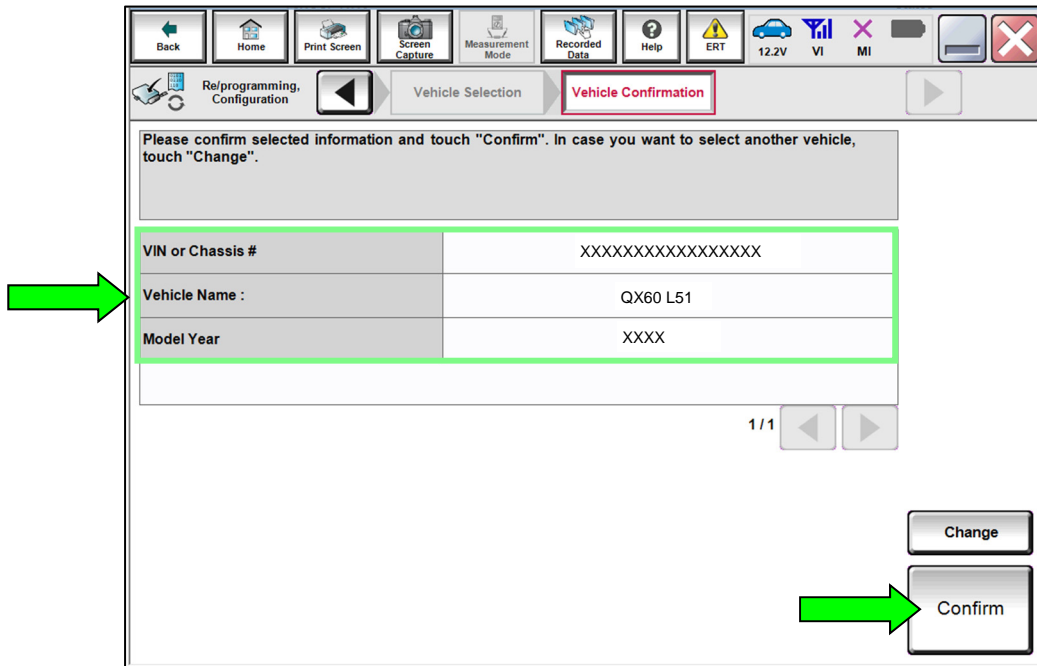
Figure 4

16. Make sure **VIN or Chassis #**, **Vehicle Name**, and **Model Year** are correct for the vehicle you are working on.
  - Select **Confirm**.

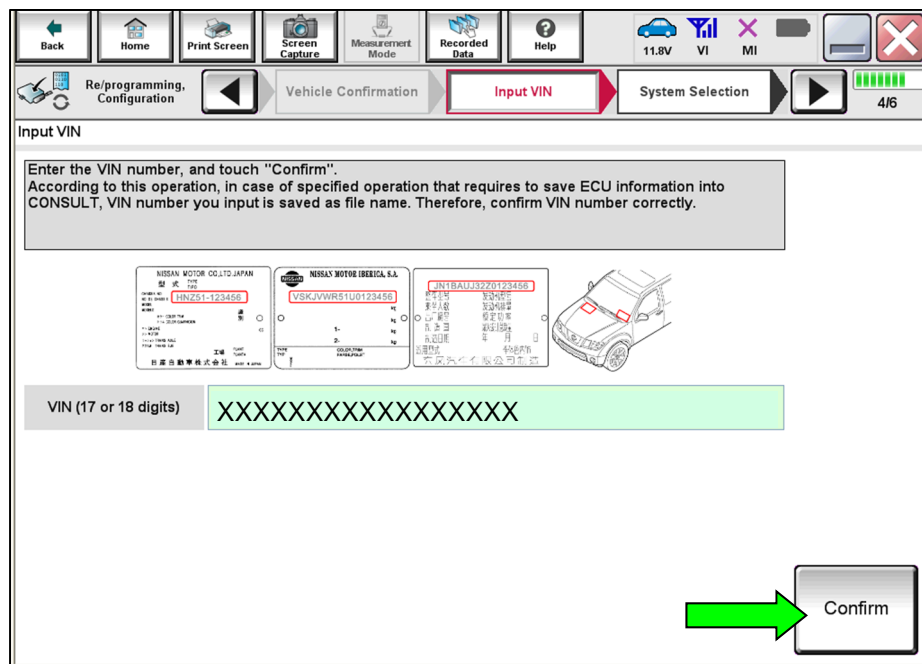
Figure 5

17. Verify the **VIN** is correct for the vehicle you are working on.
  - Select **Confirm**.

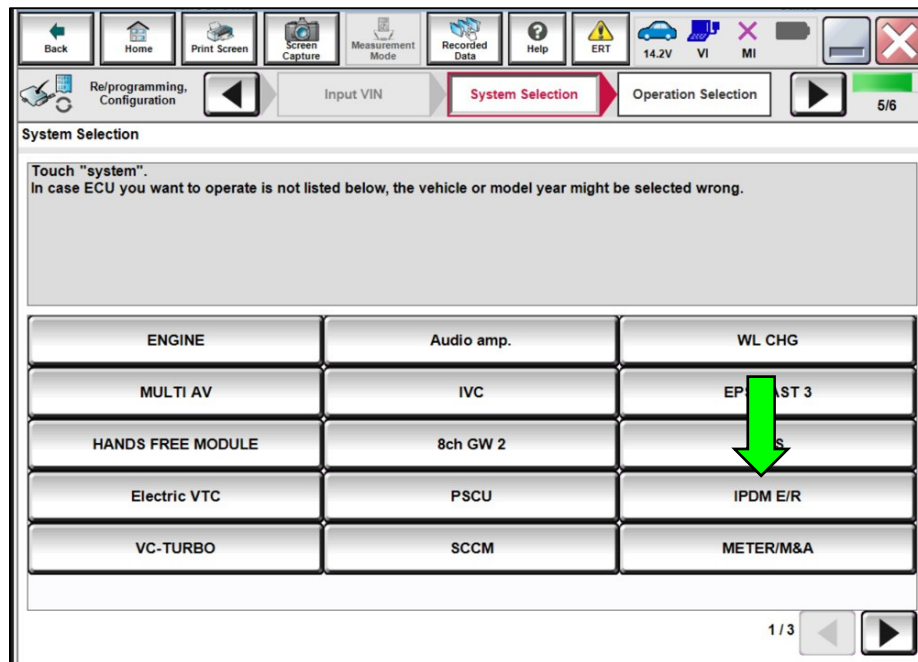
Figure 6

18. Select **IPDM E/R**.

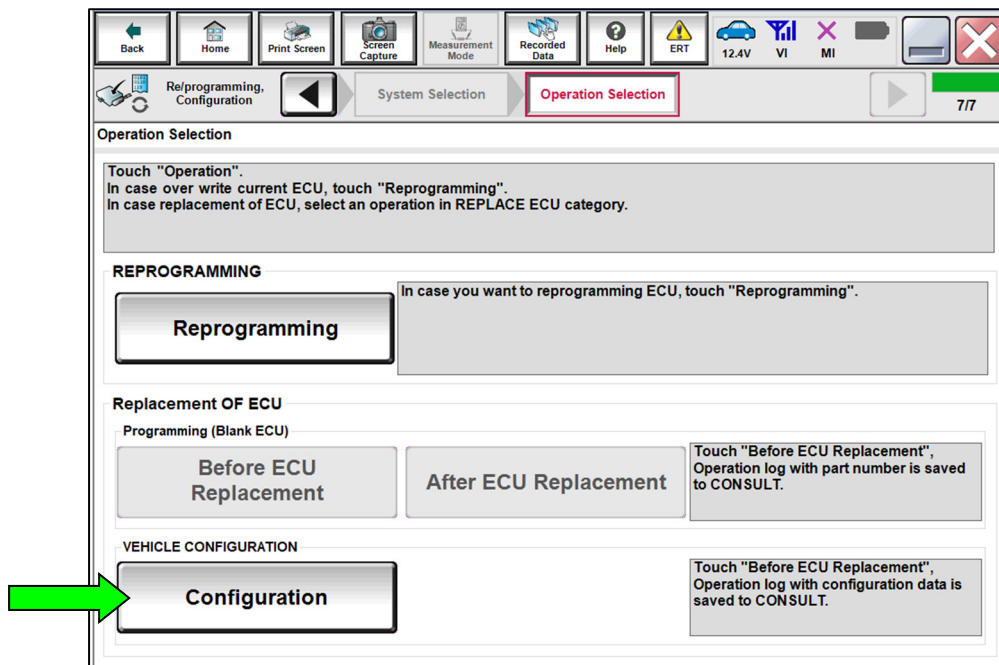
Figure 7

19. Select **Configuration**.

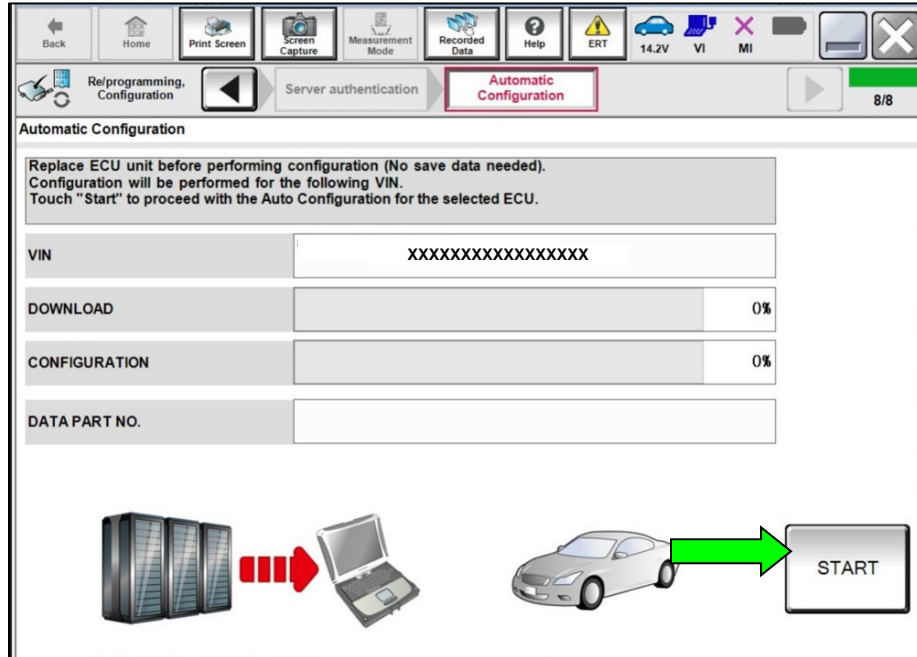
Figure 8

20. Select **START**.

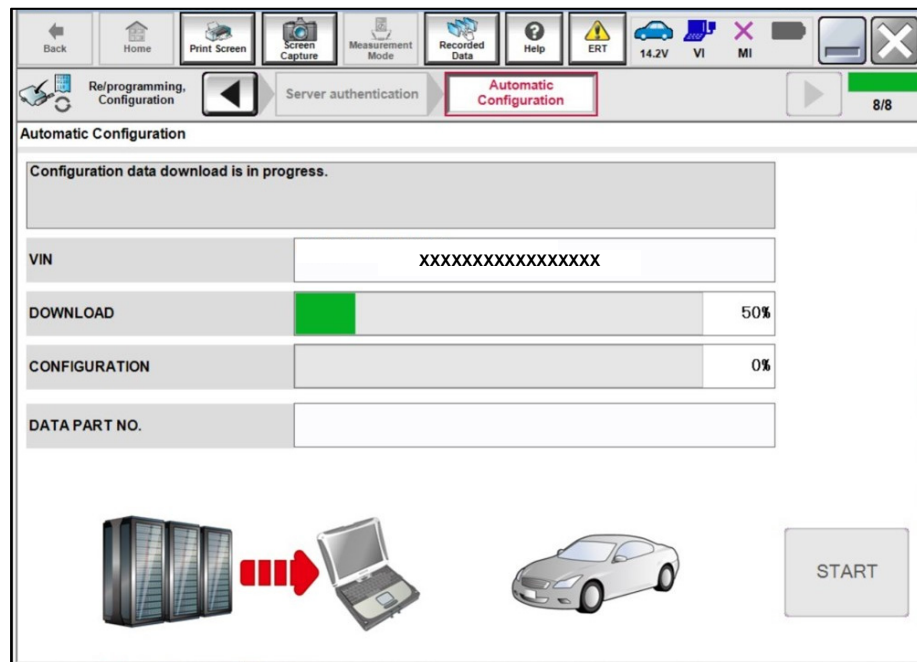
Figure 9

21. Allow the configuration to download to the IPDM.

- The configuration will take approximately 3 minutes to complete.

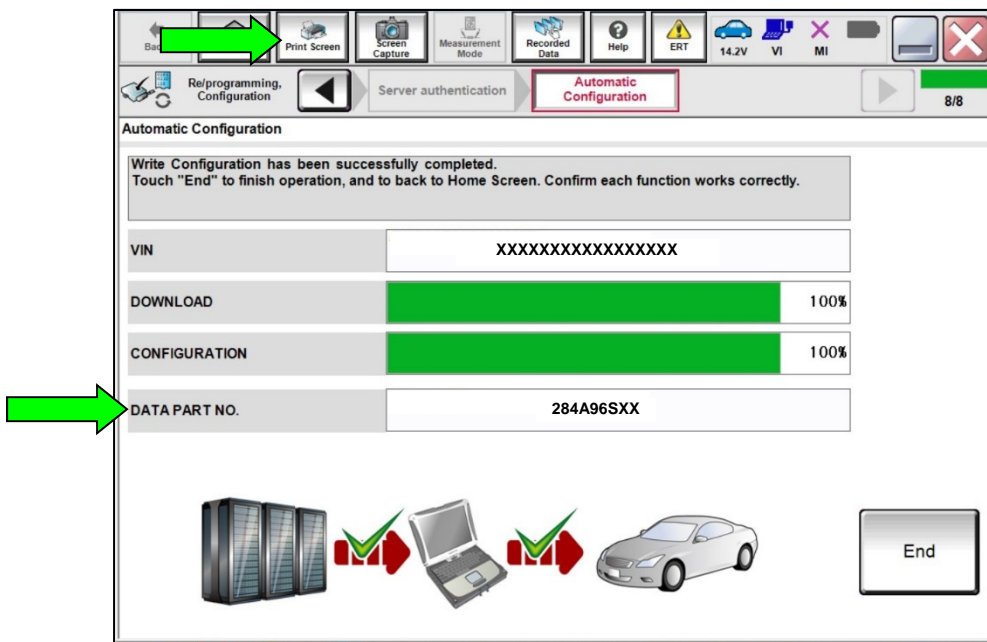
22. When the screen in Figure 10 displays, configuration is complete.

- After the configuration is complete, the configuration part number will display in the **DATA PART NO.** field.
- Select **Print Screen** at the top of the screen and attach the results to the repair order.
- If **DATA PART NO.** displays “0000000000” after configuration, make sure C-III plus has been updated to the latest level and reconfigure the IPDM/ER.

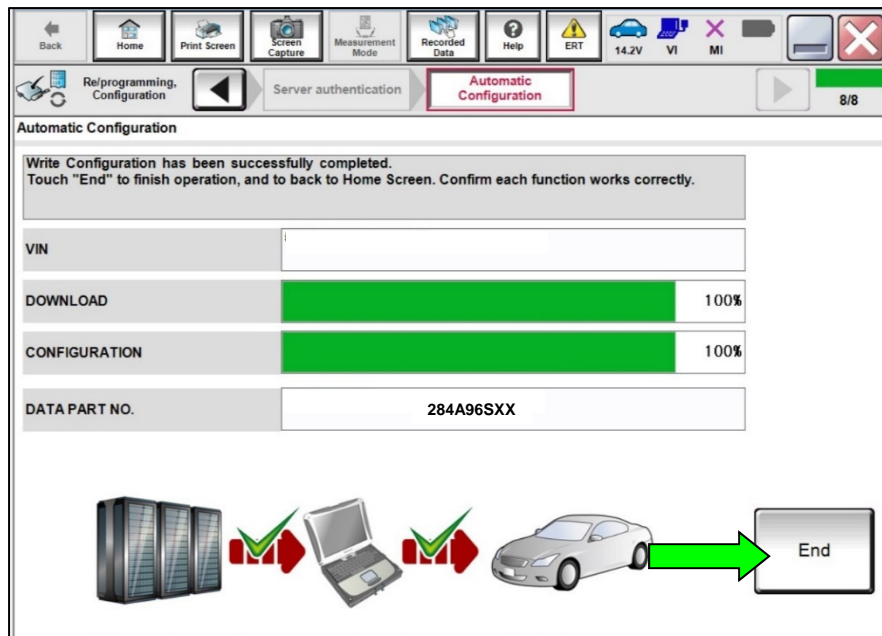
Figure 11

23. Select **End** to return to the home screen.
