Service Bulletin

24-043

Safety Recall: 2013 MDX Fuel Pump Module Set/Assembly Replacement

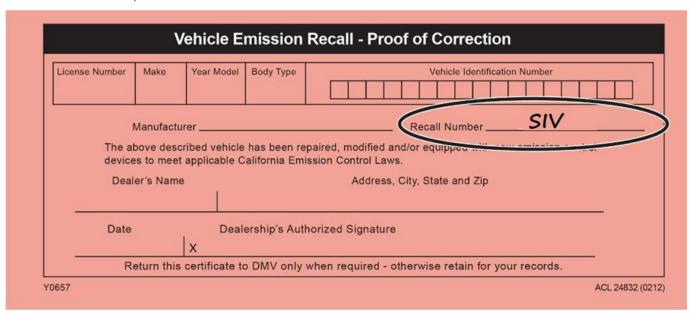
4. Remove the fuel unit and replace it with the new one.

- 5. Install all remaining parts in the reverse order of removal.
- 6. California residents only: Fill out a Vehicle Emissions Recall Proof of Correction certificate and use SIV as the recall number. Have the service advisor give the certificate to your client and advise him or her to keep it as proof that the recall was completed. Your client will need to submit this certificate to the DMV only if the DMV requests it. If you need more certificates, use reorder number **Y0657**.
