SAFETY RELATED RECALL

Global Recall Action
Number: N830

Subject: Tail Lamp Inoperative - Water Ingress	Publication No.: N830
	Model: Range Rover Sport (L1)
	Model Year: 2023
	Date of Issue: 22 March 2024

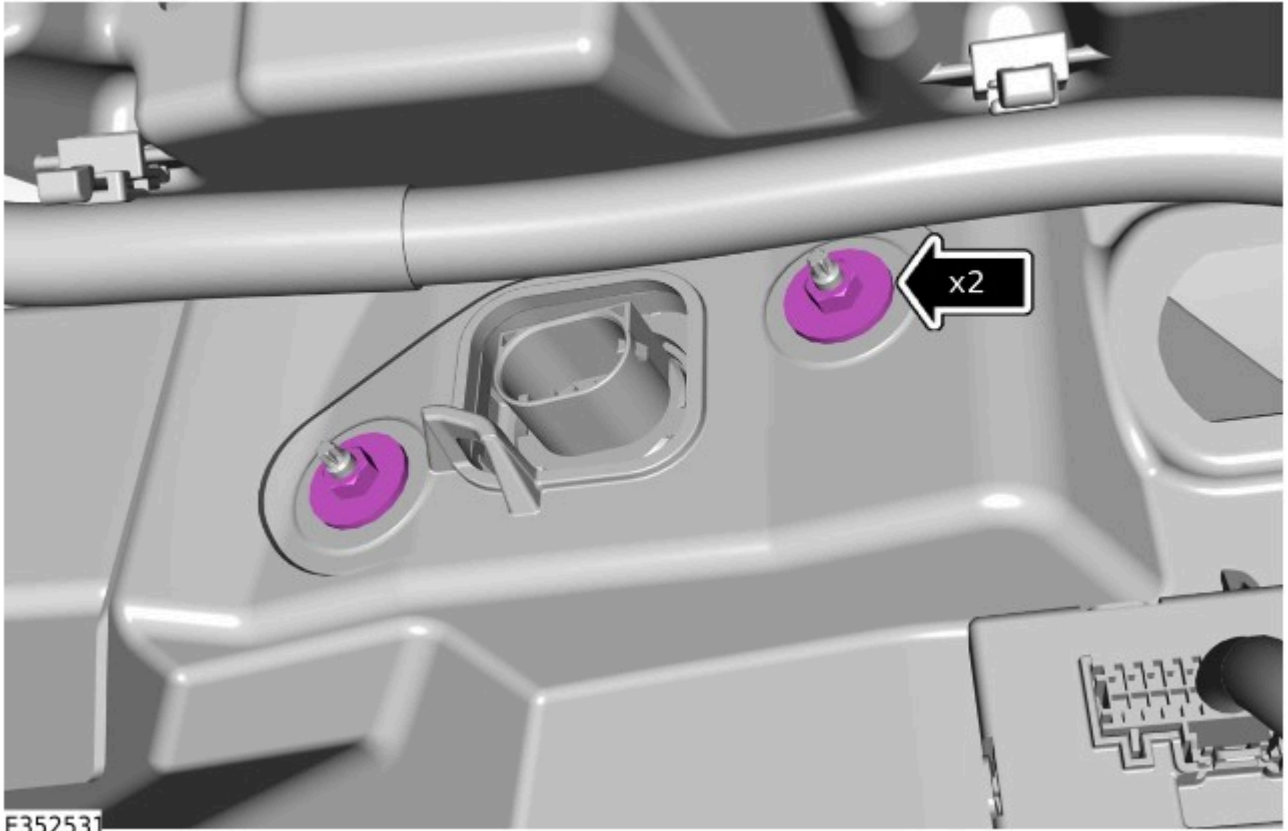
Install the 2 tailgate lamp assembly nuts.

- Torque: **3.5 Nm**

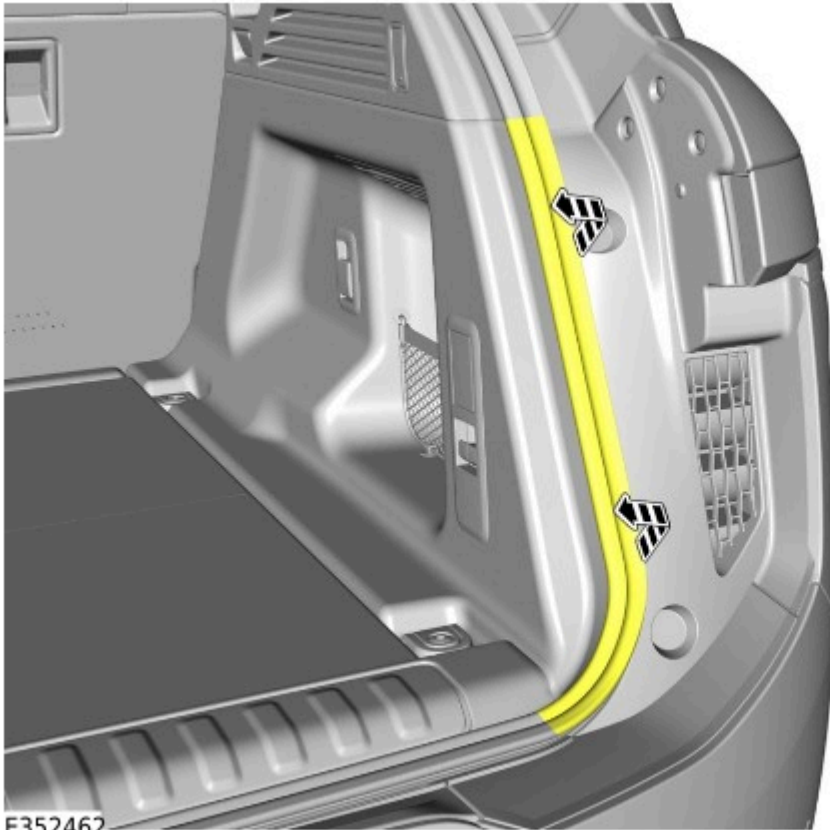
E352462

11. Release the tailgate aperture seal in the highlighted area, as shown in the illustration.

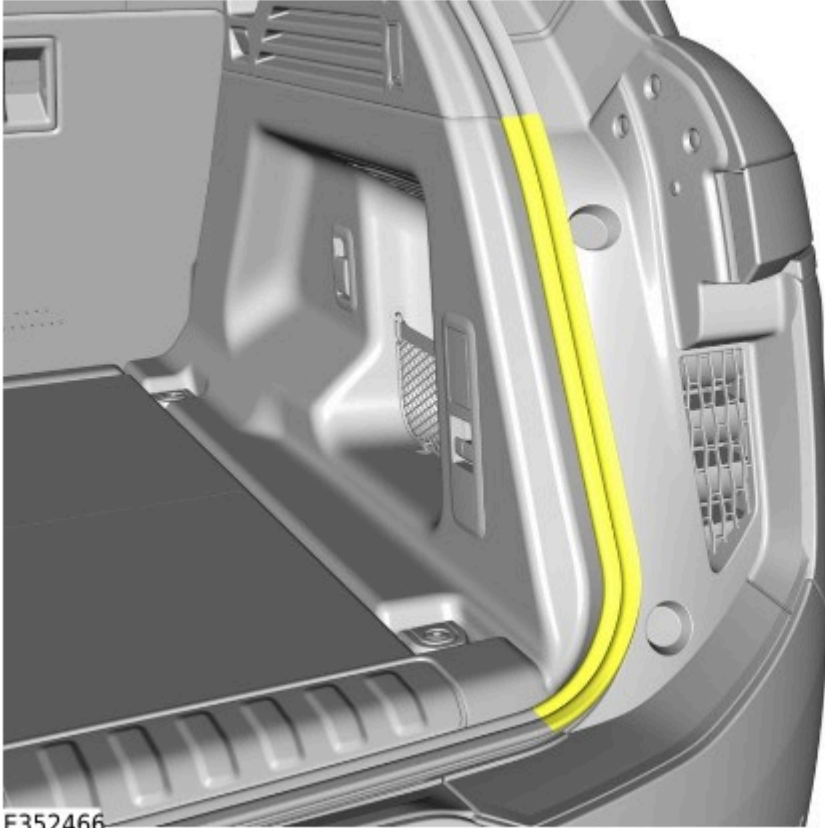
E352466

20. Install the tailgate aperture seal.
