GROUP	MODEL
Safety Recall Campaign	2011MY Sorento (XMA) w/Theta II 2.4L MPI
NUMBER	DATE
SC291	February 2024

ENGINE INSPECTION/REPLACEMENT AND KSDS S/W INSTALLATION (SC291)

This bulletin provides information to perform the Bearing Clearing Test (BCT) and, if necessary, replace the engine, and to update the Engine Control Unit (ECU) to install the Knock Sensor Detection System (KSDS) software on certain 2011MY Sorento (XMA) equipped with Theta II 2.4L MPI engine, produced from October 24, 2009 through June 24, 2011. Follow the flowchart on page 2 to perform the BCT and install the KSDS software. In some cases, engine long block replacement may be required if the BCT results in a "No Pass" or "Unable to Perform" (ex. seized engine).

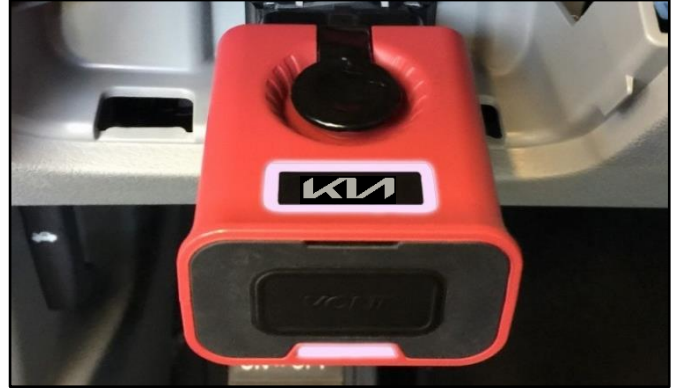
1. Connect the VCI-II to the OBD-II connector, located under the driver's side of the instrument panel.

The ECU upgrade function on KDS operates wirelessly. It is not necessary to perform the upgrade via USB cable.

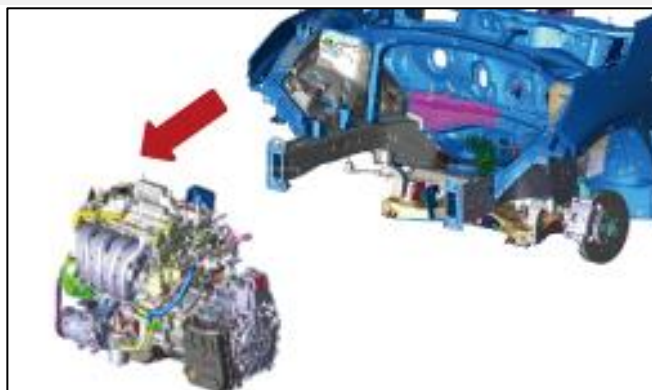
1. Replace the engine assembly by referring to the "Engine Mechanical System → Engine And Transaxle Assembly → Engine Assembly → Repair procedures" chapter in the applicable Shop Manual on KGIS.

Refer to [TSB ENG190](#) for information regarding engine replacement practices.

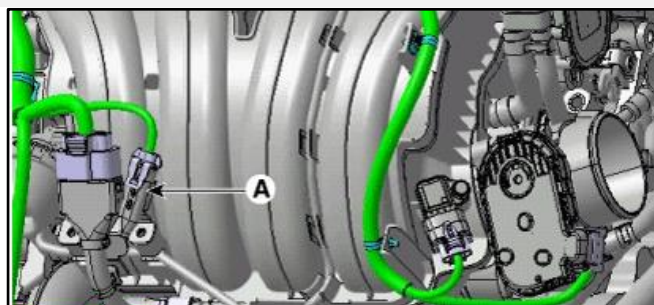
1. Replace the knock sensor (A) by referring to the "Engine Control / Fuel System → Engine Control System → Knock Sensor (KS) → Repair Procedures" chapter in the applicable Shop Manual on KGIS.

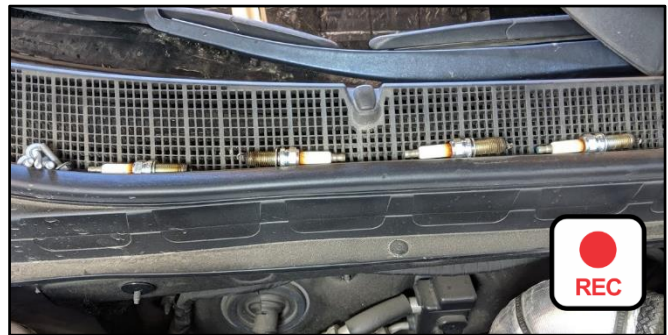
2. Show the removed spark plugs.

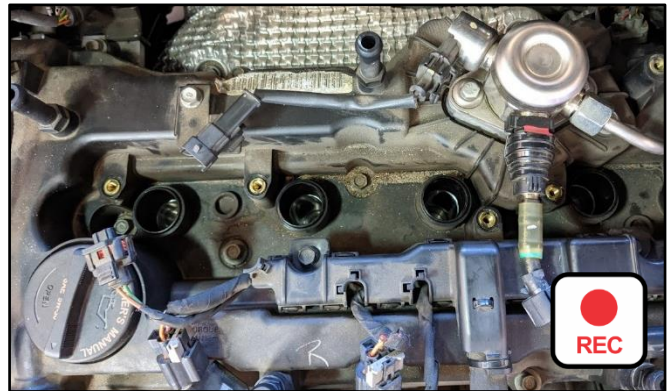
3. Show the empty spark plug holes from the engine.

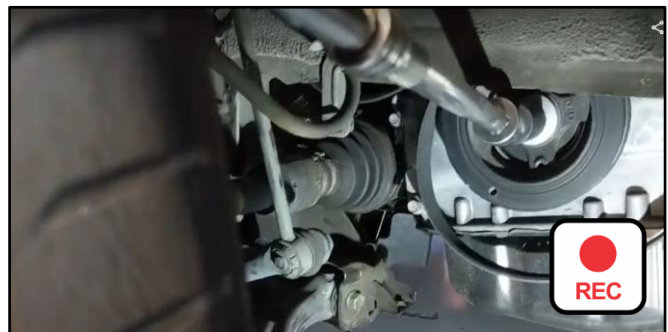
5. Show the removed drive belt and attached torque wrench to crank bolt.
