**Safety Recall – 2022-2023 CX-30 AND 2023 CX-50 Brake Pedal Travel May Increase**

CONDITION OF CONCERN: The Anti-lock Braking System Hydraulic Control Unit (“ABS HCU”) may be damaged which can increase brake pedal travel length and reduce braking ability, which can increase the risk of a crash.

OUTLINE OF REPAIR: For subject CX-30 vehicles, check the serial number of the ABS HCU with the repair calculator and if it has an affected serial number, the part must be replaced. For subject CX-50 vehicles, replace the ABS HCU with a new part as it has been already verified to be an affected unit.

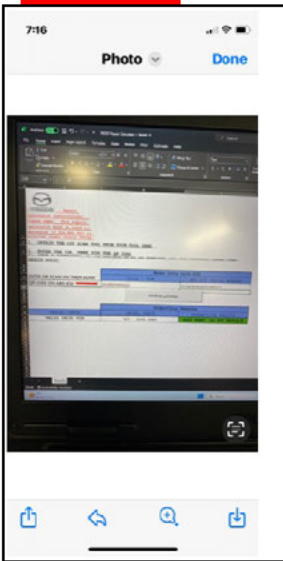
**NO GOOD:** Too Small

Required: Attachment ID: D40 must be readable. **DO NOT** take a photo of the computer screen, use the print screen function or a Photo Snipping Tool (Windows 10).

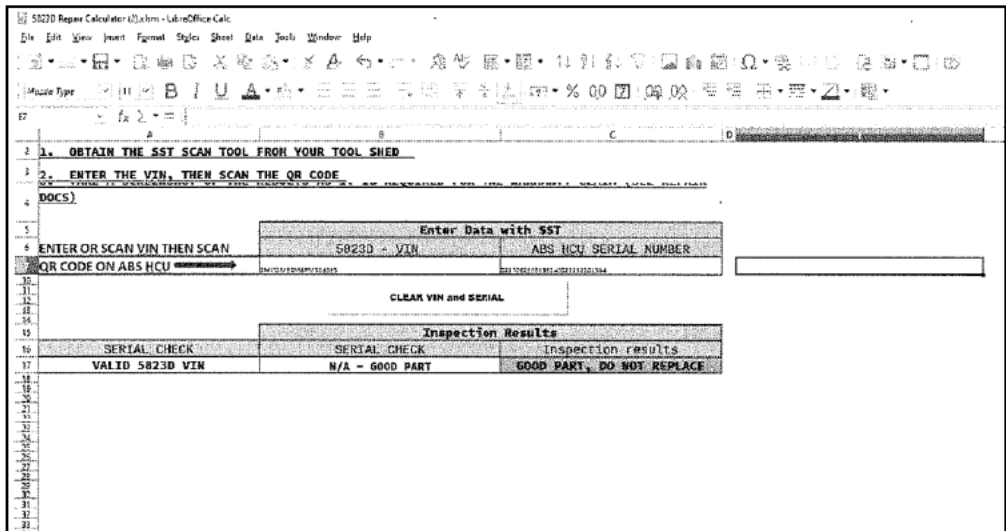
**NO GOOD:** Small, blurry, or black and white
