RECALL H441 – BATTERY ENERGY CONTROL MODULE (BECM) SOFTWARE UPDATE

SAFETY RECALL H441 – I-PACE BECM SOFTWARE UPDATE

BECM ENHANCED BATTERY DIAGNOSTICS 19-24 MY I-PACE

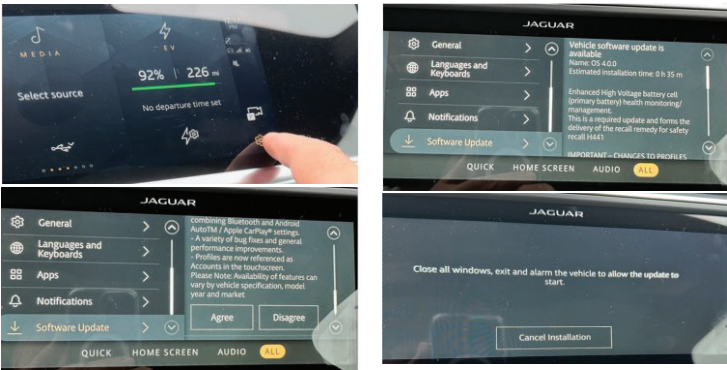
QUESTION	ANSWER
12	How do I install the H441 SOTA update on my I-PACE	<p>Refer the client to the following steps on the vehicle touch screen to check if OS 4.0.0 is available for installation, then follow the on-screen instructions.</p>

13	How do I know when the H441 Software-over-the-air update has been installed on my vehicle?	<p>Refer the client to the vehicle touch screen under 'Software Updates' The latest installed software is displayed</p>
