March 2024  
FL993 AB  
NHTSA #24V-058  
Transport Canada #2024-056

## Subject: Axle Spacing Parameters

**Models Affected: Specific model years 2024-2025 Freightliner Cascadia; and Western Star 49X vehicles manufactured December 1, 2023, through January 19, 2024.**

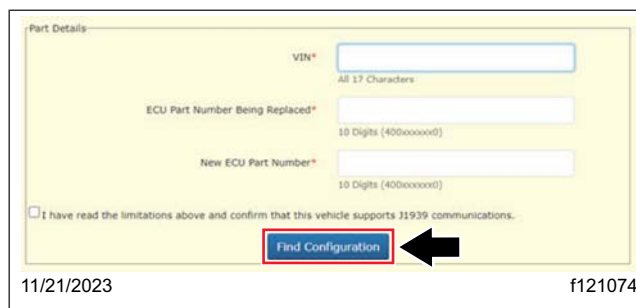
Fig. 4, Finding ABS ECU Configuration

IMPORTANT: The vehicle identification number (VIN) must include all 17 characters. The ABS ECU part number obtained earlier must be entered with no spaces in the 'ECU Part Number Being Replaced' and 'New ECU Part Number' fields.

5. Enter the VIN and the ABS ECU part number, then select 'Find Configuration.' See Fig. 4.

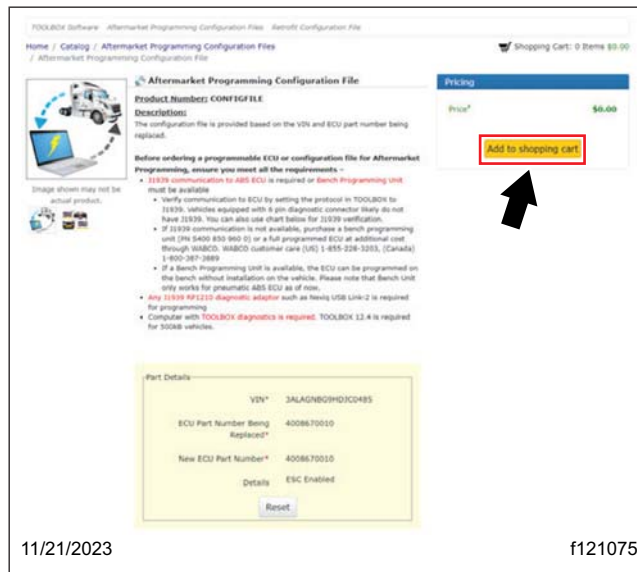
**Fig. 5, Adding Configuration Files to the Shopping Cart**

- The configuration file details for the VIN and ABS ECU part number combination are displayed. Verify the VIN and part number, then select 'Add to shopping cart.' See [Fig. 5](#).

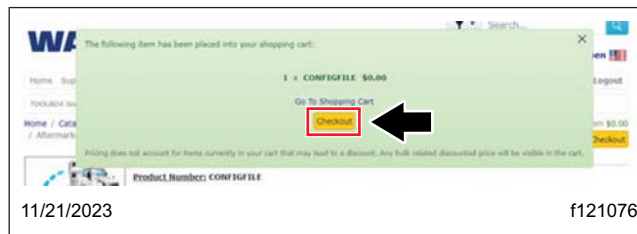
**Fig. 6, Selecting Checkout**

- Once the configuration file is added to the shopping cart, select 'Go To Shopping Cart' or 'Checkout' in the window that appears. See [Fig. 6](#).

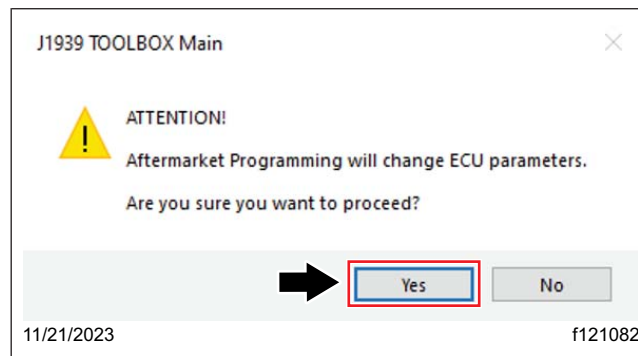
Fig. 12, Selecting Yes to Proceed with the ECU Programming

14. A message, indicating that the ECU parameters will change after programming, is displayed. To continue, select 'Yes.' See [Fig. 12](#).

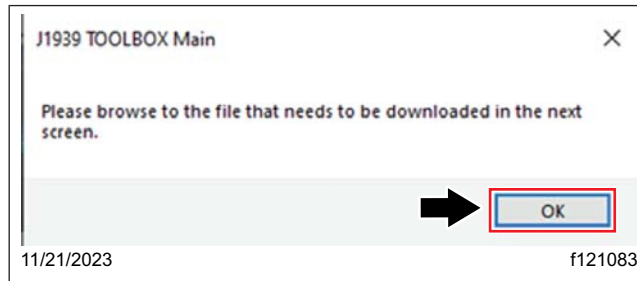
**Fig. 13, Selecting OK to Proceed to Browsing**

15. A window appears asking to select the configuration file. Select 'OK' to proceed. See [Fig. 13](#).

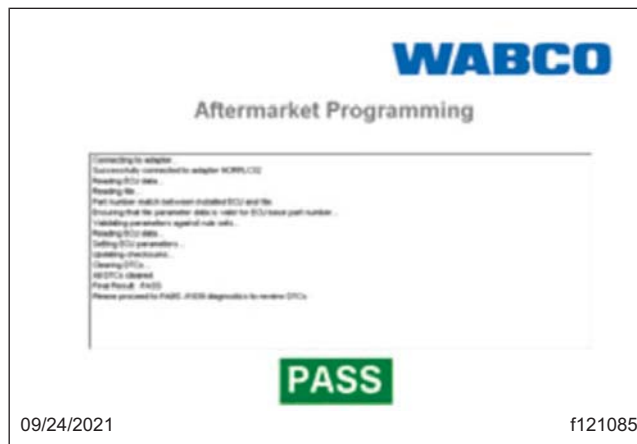
**Fig. 15, Green Pass Indicator**

17. Once the configuration file is selected, the 'Aftermarket Programming' window appears. The programming begins, and the process status is displayed in the status box. Upon successful programming, a green 'PASS' indicator appears at the bottom of the window. See [Fig. 15](#). If the programming process fails for any reason, a red 'FAIL' indicator appears at the bottom of the window. An error code is displayed with instructions. Record the error code, and contact the WABCO Customer Care Center 1-855-228-3203.

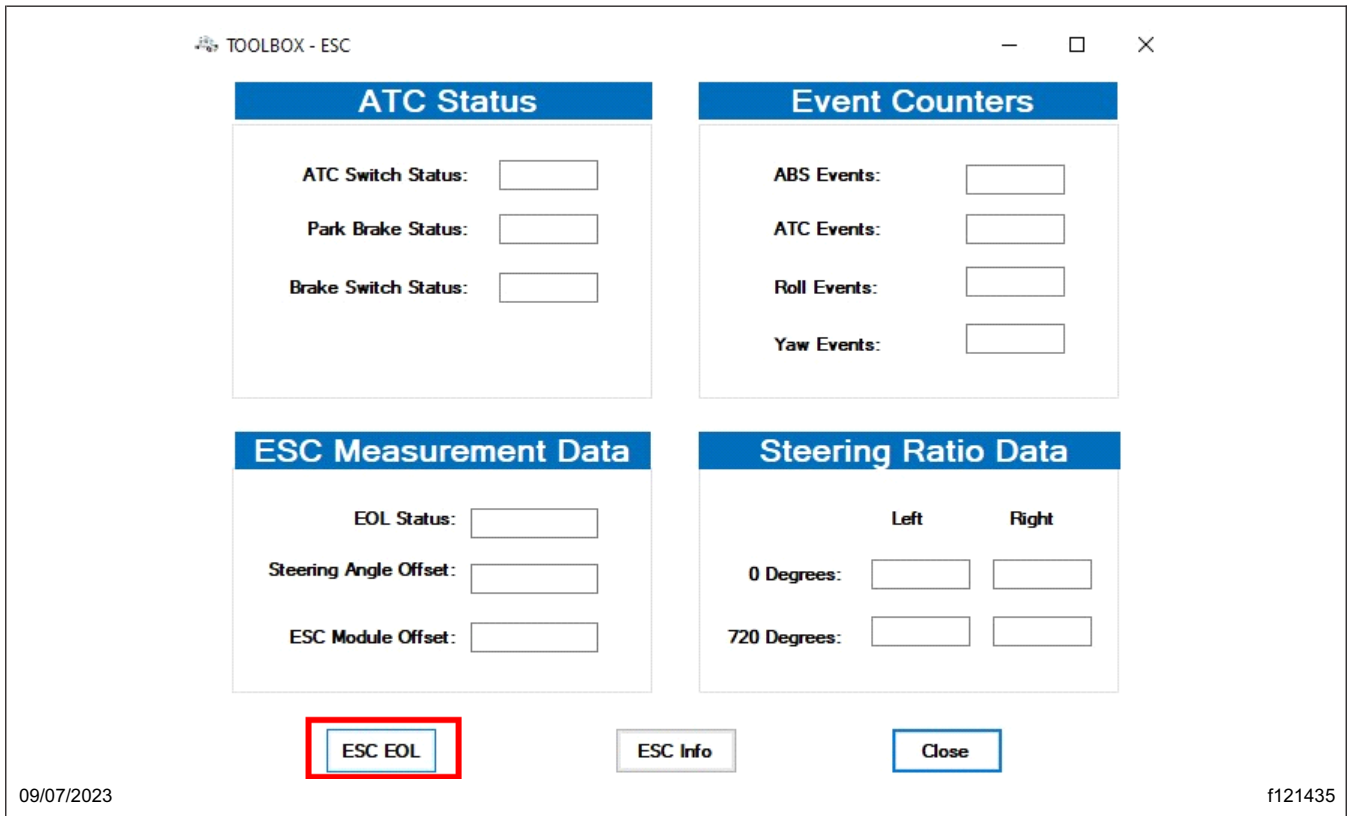
Fig. 18, Selecting the ESC EOL Procedure in Toolbox

21.3 Select the 'ESC EOL' button at the bottom-left. See [Fig. 18](#).

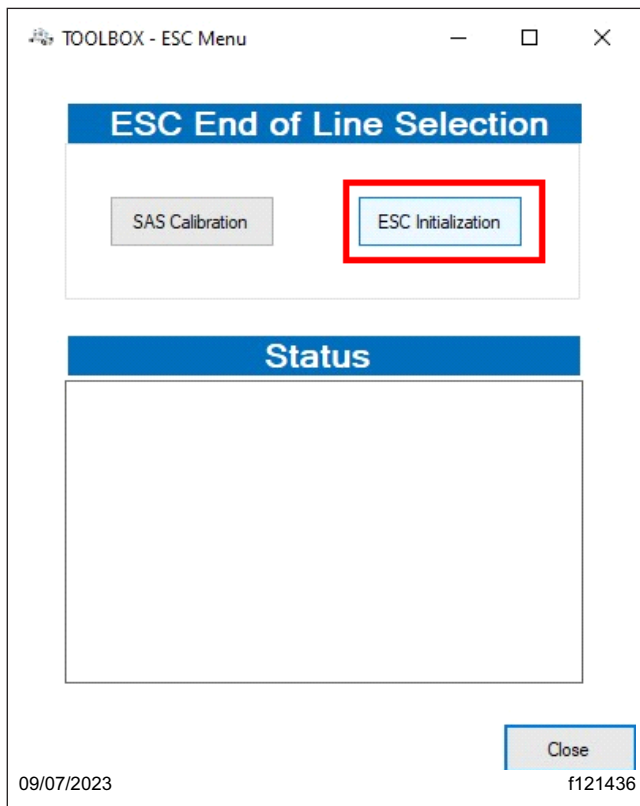
**Fig. 19, Selecting the ESC Initialization Procedure in Toolbox**

- 21.4 Select the 'ESC Initialization' button. See [Fig. 19](#).
- 21.5 ESC initialization instructions appear in the 'Status' panel. See [Fig. 20](#).
- 21.6 Follow the instructions in the 'Status' panel until the ESC initialization is complete.

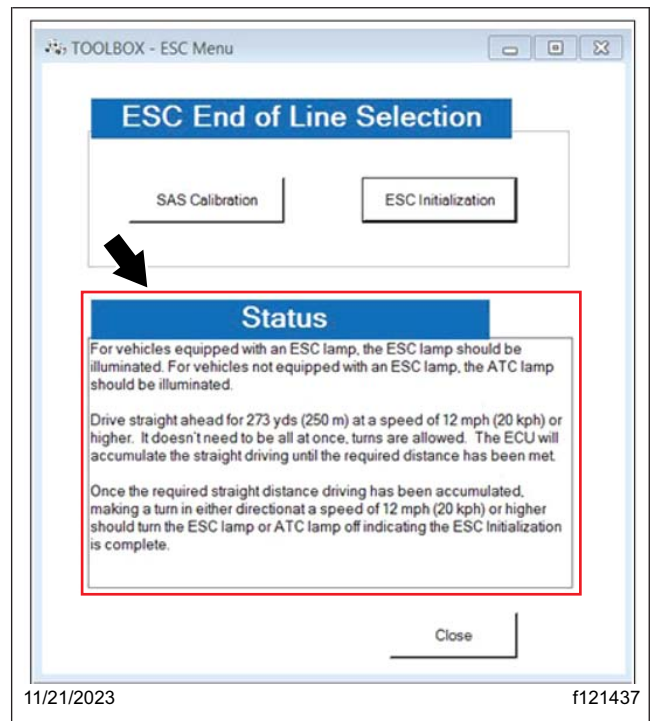
**Fig. 20, ESC Initialization Status**

NOTE: Carefully follow the instructions that appear in the message box. Once the ESC initialization is started, the messages will automatically change as the requirements are met. **Do not** click the 'continue' button again as this may cause the process to fail. The ESC initialization procedure requires the vehicle to be driven.
