April 2024
FL995 AB
NHTSA #24V-093

Subject: Steering Gear

Models Affected: Specific model year 2024 Freightliner Cascadia; and Freightliner Custom Chassis MT45, and MT45G vehicles, manufactured April 25, 2023, through December 20, 2023, equipped with an RH Sheppard steering gear.

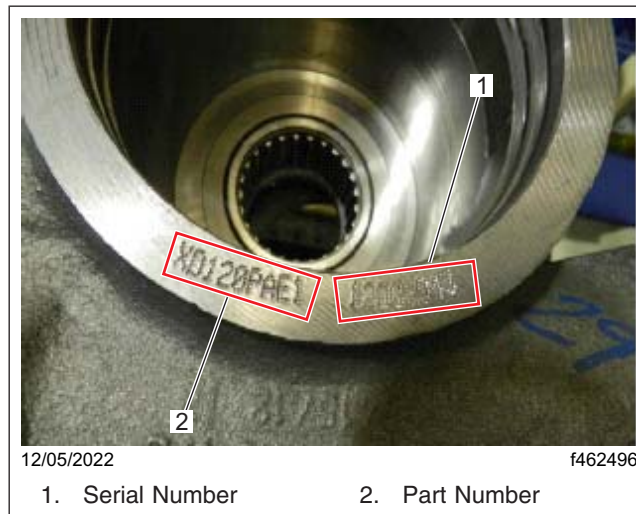
Fig. 1, Steering Gear Identification

1. Check the base label (Form WAR259) for a recall completion sticker for FL995 (Form WAR260) indicating this work has been done. The base label is usually located on the passenger-side door about 12 inches (30 cm) below the door latch. If a sticker is present, no work is needed. If there is no sticker, proceed with the next step.
2. Park the vehicle on a level surface, shut down the engine, and set the parking brake. Chock the tires.
3. Locate the steering gear on the front-left frame rail of the vehicle.
4. Locate the serial number on the steering gear. See **Fig. 1**.

6. Select the 'Select Vehicle Make' option. From the drop-down menu, select 'FREIGHTLINER, DAIMLER TRUCK.' See [Fig. 2](#).
7. Enter the steering gear serial number, noted in **step 4**, in the designated field. Select 'Search.' See [Fig. 2](#).

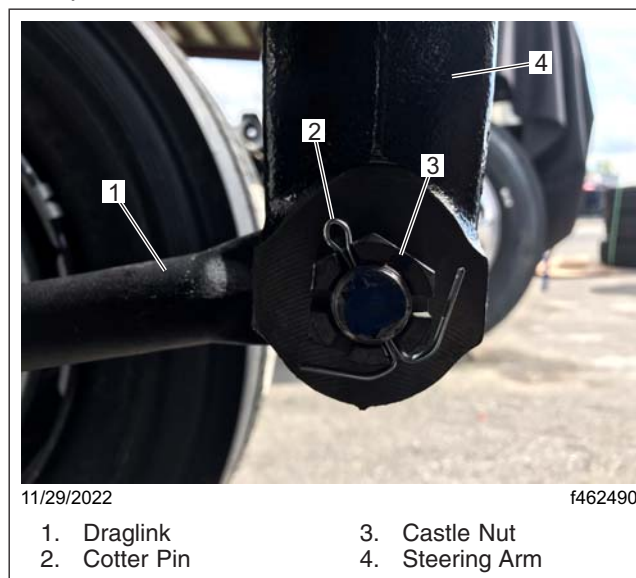
Fig. 5, Cotter Pin Removal

2. Remove the cotter pin from the castle nut at the steering arm-to-draglink connection. See **Fig. 5**.

3. Use a 1-1/8 inch socket to remove the castle nut. Retain the castle nut for installation in the later step. Remove the draglink from the pitman arm.

29. If the cotter pin hole is not accessible, advance the castle nut to the nearest slot, and install the cotter pin. Bend the split side of cotter pin around the nut as shown in [Fig. 5](#).

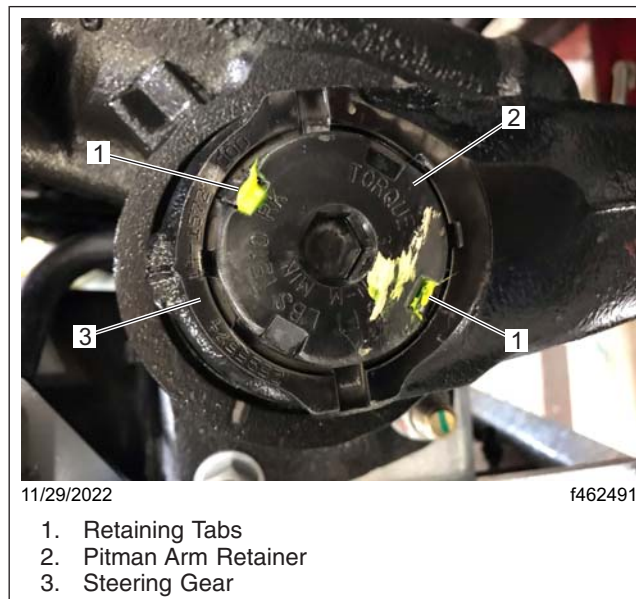
Fig. 6, Bending the Pitman Arm Retaining Tabs

4. At the pitman arm-to-steering gear connection, use a punch to bend the retaining tabs out of the pitman arm retainer. See **Fig. 6**.

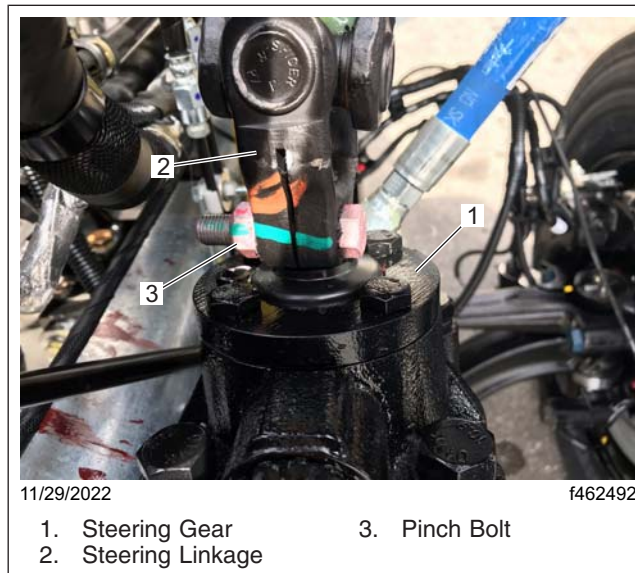
Fig. 7, Pinch Bolt Removal

5. Lubricate the face of the retainer with a clean chassis lube.
6. Disconnect the pitman arm from the steering gear.
 - 6.1 Slide the pitman arm puller over the pitman arm. Align the hole in the puller with the Allen socket in the retainer.
 - 6.2 Insert the Allen drive socket through the puller and into the retainer socket. Use an impact wrench to back off the retainer. The retainer will act as a jackscrew to disconnect the pitman arm from the steering gear.
7. Use a 5/8-inch wrench and a 11/16-inch socket to remove the pinch bolt that attach the steering linkage to the top of the steering gear. Discard the fasteners. See **Fig. 7**.

8. Remove the steering linkage from the gear by sliding the shaft upwards, away from the steering gear.

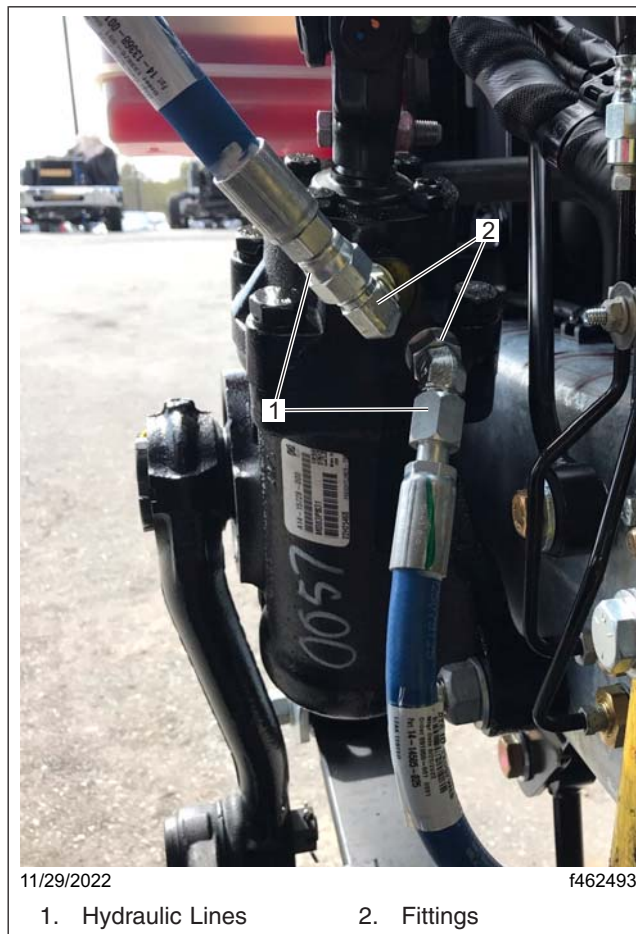
Fig. 8, Hydraulic Lines Removal

9. Use a 7/8-inch wrench to loosen and remove the hydraulic lines from the fittings on the rearward-facing side of the steering gear. See **Fig. 8**.

10. Use a 7/8-inch wrench to remove the fittings from the steering gear. Retain the fittings for installing on the replacement gear.

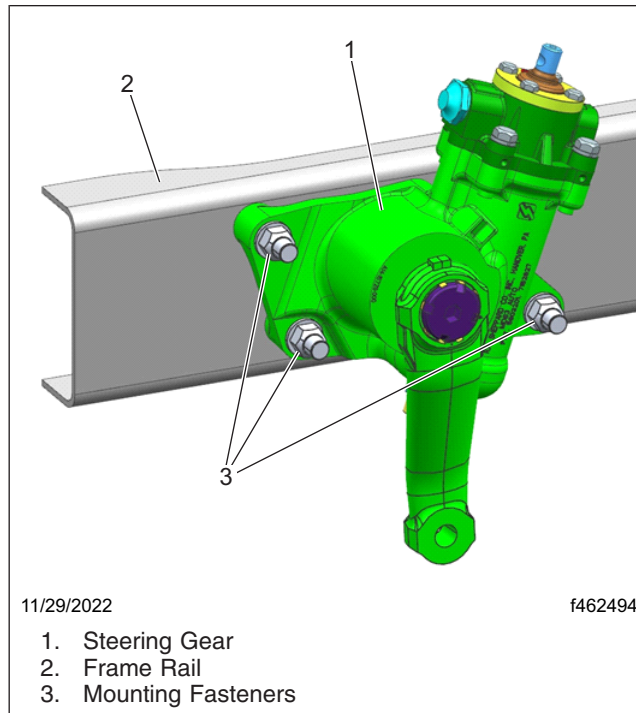
Fig. 9, Steering Gear Removal

11. Use a 1-1/8 inch socket and wrench to remove the three bolts and washers that attach the steering gear to the rail. Discard the fasteners. See [Fig. 9](#).
12. Remove the steering gear.

13. Install the washer (23-09114-004) on the new bolts (23-11757-350), then install the bolts into the three holes in the rail.
14. Install the new steering gear (RHS MD83PB3Y) on the bolts in the rail. Install the washer (23-09114-004) first, and then install the nut (23-13833-112). Hand tighten the fasteners.
15. Use a 1-1/8 inch socket and wrench to tighten the fasteners that attach the steering gear to the rail. Tighten the fasteners 221 lbf-ft (300 N·m).
16. Install the hydraulic hose fittings in the gear, oriented as shown in [Fig. 8](#). Tighten the hose fittings 45 lbf-ft (61 N·m).
17. Install the hose on the fittings, and hand tighten them.
18. While holding the small part of the fittings using a 3/4-inch wrench, use a 7/8-inch wrench to tighten the hose fittings. Tighten the hose fittings 45 lbf-ft (61 N·m).

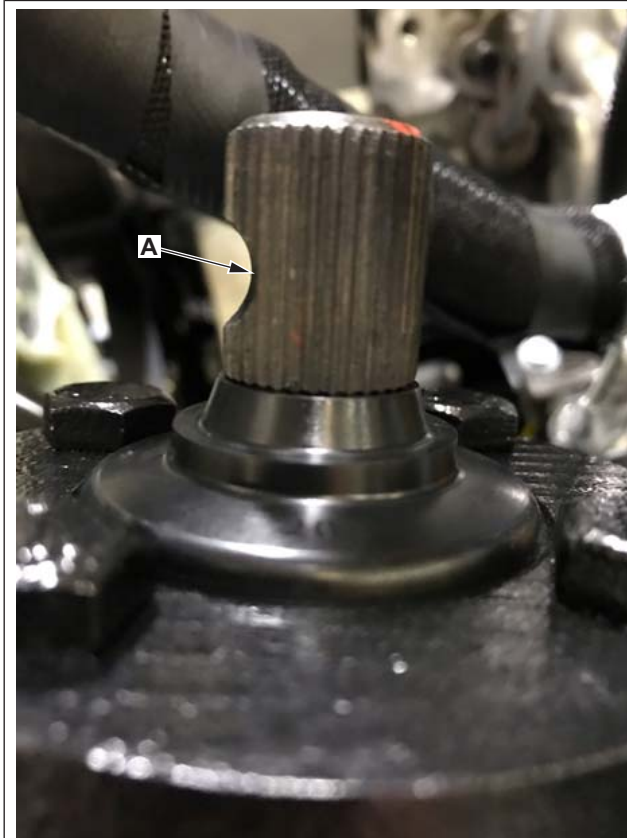
Fig. 10, Steering Linkage Installation

19. Make sure the bolt hole in the steering linkage, and the groove on the steering gear input shaft align properly. Install the steering linkage on top of the gear. See [Fig. 10](#).

20. Install the new bolt (14-18773-001) and the nut (14-18774-000) on the steering shaft. Tighten the nut 43 lbf·ft (58 N·m).
21. Align the timing marks on the pitman arm with the timing marks on the sector shaft, then install the pitman arm on the sector shaft. The timing marks will appear as shown in [Fig. 11](#) and [Fig. 12](#).
