Safety Recall Campaign 020G: Transmission Control Harness Connector/E-Module Connector Pin Rework & Replacement – Retailer Best Practice

October 08, 2024

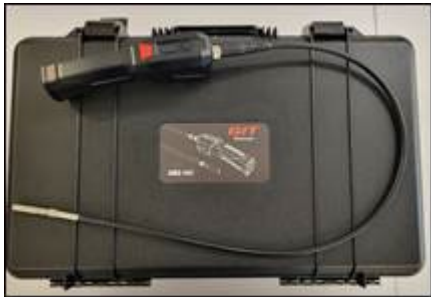
Tool Name	Part Number	Figure	Remarks
GIT Borescope	GODKDNN039

<p>This suggested tool, in conjunction with the STUI application, will be utilized to inspect and capture an image of the male E-Module connector as it is in an out-of-view location.</p> <p>This tool is available for purchase through GIT America at (833) 681-3926.</p> <p>If a borescope is not used for this case, a mirror and camera can be used as an alternative.</p>
Long Clip	N/A

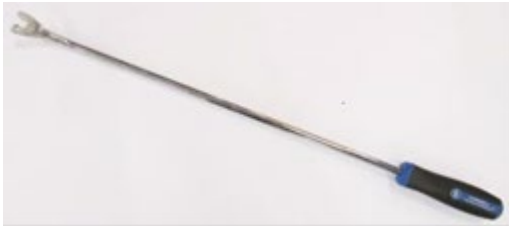
<p>This suggested and locally sourced tool will be utilized to detach/secure a hard-to-reach harness clip on top of the transmission housing.</p>
