TO: Mercedes-Benz Dealer Principals, General Managers, Sales Managers, Service Managers, Parts Managers	FROM: Gregory Gunther, Senior Manager, Vehicle Compliance and Analysis, Engineering Services
RE: <b>Recall Campaign Launch Notification</b> <b>Update Engine Control Unit Software</b> <b>MY21-23 S-Class (223 platform)</b>	DATE: February 8, 2025

Recall Campaign Launch Notification				February 8, 2025
Campaign No. :	NHTSA ID	CA DMV	Campaign Desc. :	Update Engine Control Unit Software
2024100007	24V704	241007	24P5496234	
<p>This is to notify you of the <b>Recall Campaign Launch</b> to update the Engine Control Unit Software on <b>10,872</b> Model Year (“MY”) 2021-2023 S-Class (223 platform) vehicles. The recall campaign will be visible on the www.NHTSA.gov website and may generate questions from customers. Affected VINs will be flagged in VMI as <b>"OPEN"</b> on <b>February 8, 2025</b></p>				
<b>Background</b>				
<b>Issue</b>		Mercedes-Benz AG, the manufacturer of Mercedes-Benz vehicles, has determined that on certain S-Class (223 platform) vehicles with an M176 8-cylinder gasoline engine with the cylinder deactivation feature, the lambda control in the Engine Control Unit softwar

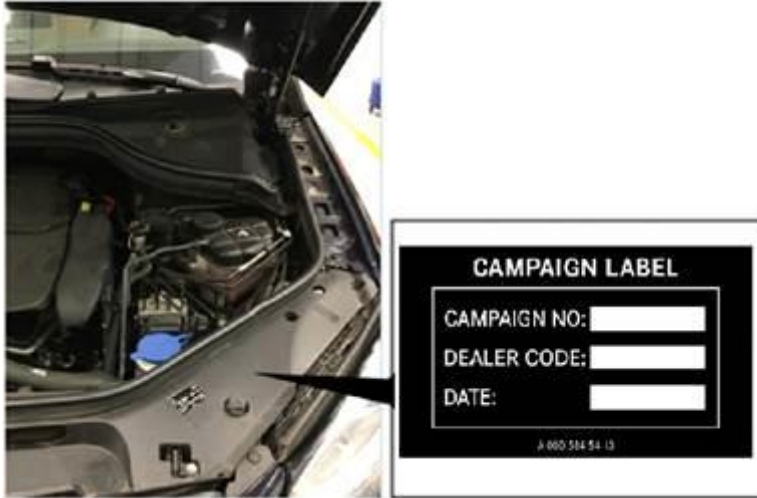
**Figure 1**

Apply Proof of Correction Label (A 000 584 54 13) to area identified in **Figure 1**. Fill in the blank areas of the label. The “**Campaign No.**” for the California Proof of Correction is unique and must be entered as such (24V704), your “**Dealer Code**”, and the “**Date**” of the repair, using a black permanent marker.
