Service Engineering Operations
Customer Service Division

SUBJECT: **VEHICLE DEMONSTRATION / DELIVERY HOLD**
Safety Recall 24S66 – Supplement #1
 Certain 2023-2024 Model Year Super Duty Vehicles
 Tailgate Top View Camera Replacement and Image Processing Module
 Reprogramming

CERTAIN 2023-2024 MODEL YEAR SUPER DUTY VEHICLES — TAILGATE TOP VIEW CAMERA REPLACEMENT AND IMAGE PROCESSING MODULE REPROGRAMMING

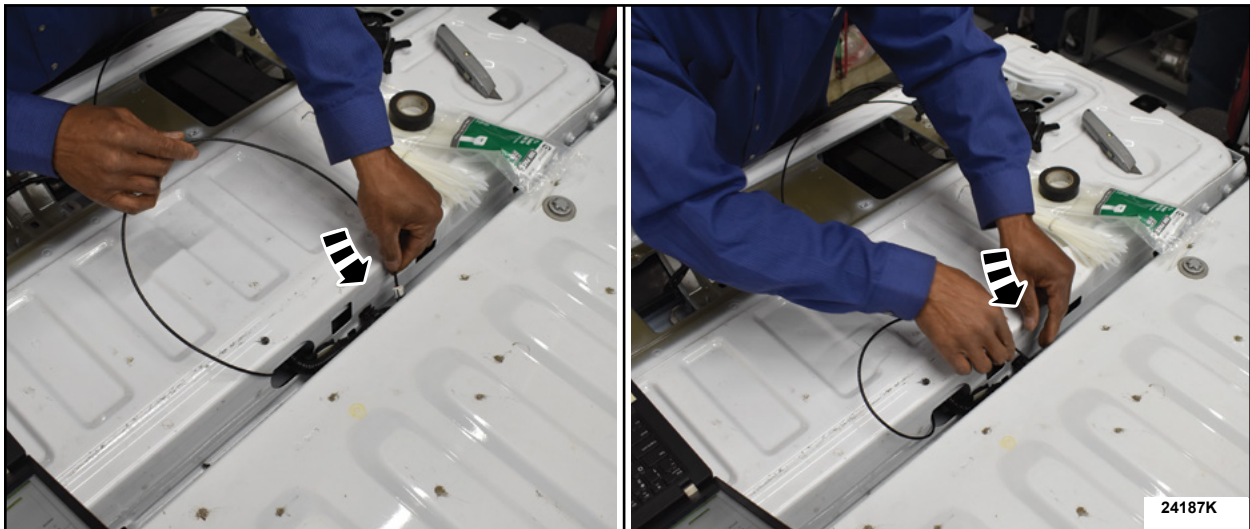
FIGURE 9

8. Guide the connector and wire through the body side wire harness opening, following the existing wire harness. See Figure 9.

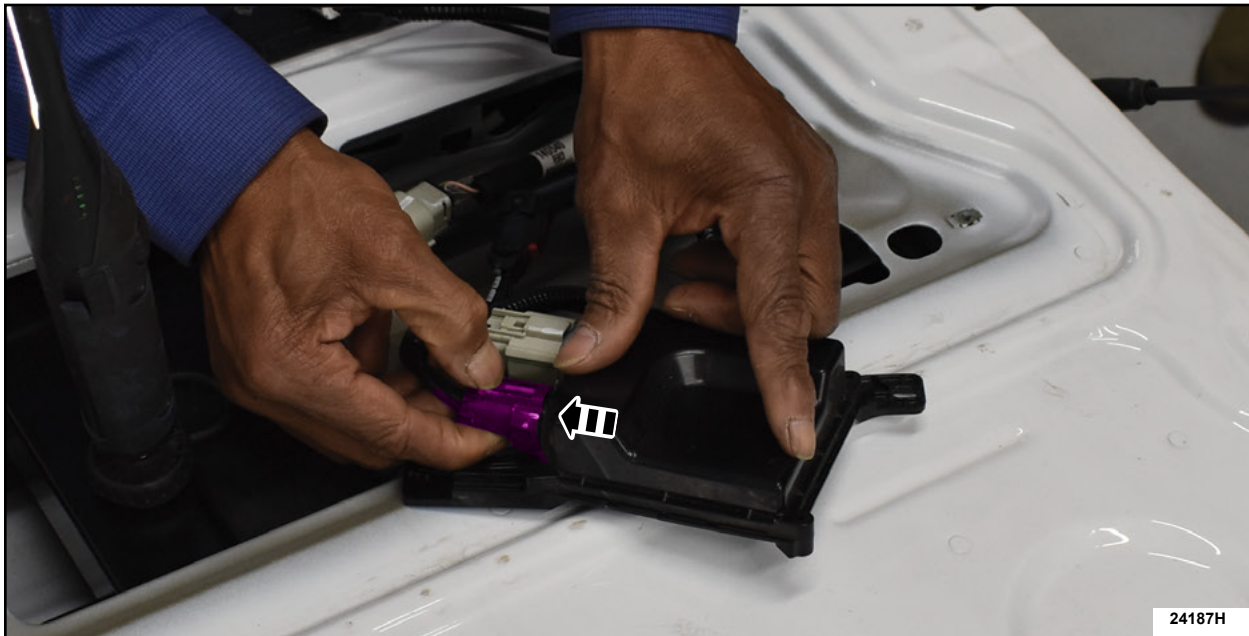
FIGURE 13

14. Release the locking tab and disconnect the black connector on the tailgate park assist sensor interface module as shown in Figure 13. Then, connect the *new* overlay harness wiring connector in that same location on the tailgate park assist sensor interface module and lock the locking tab.
