SAFETY RECALL

Communication #: I-24-03

SUBJECT: ANTI-LOCK BRAKE (ABS) SOFTWARE UPDATE (US ONLY)

I-24-03-AA REPAIR PROCEDURE – FTR MODELS

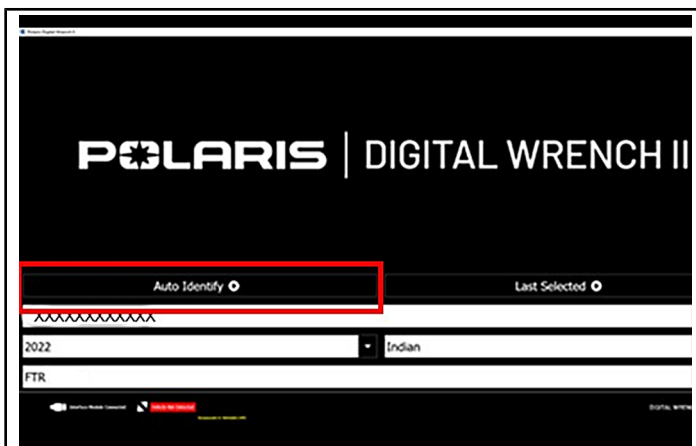
Make sure the VIN, Model Year, Line, and Model are correct.

7. Select “Vehicle Update”.

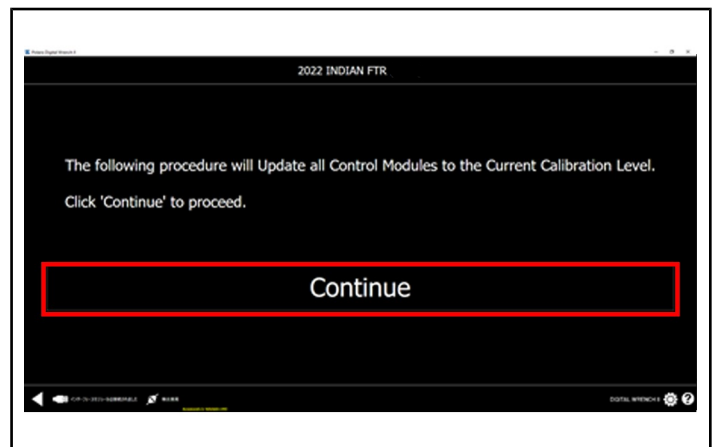
8. Click “Continue”.

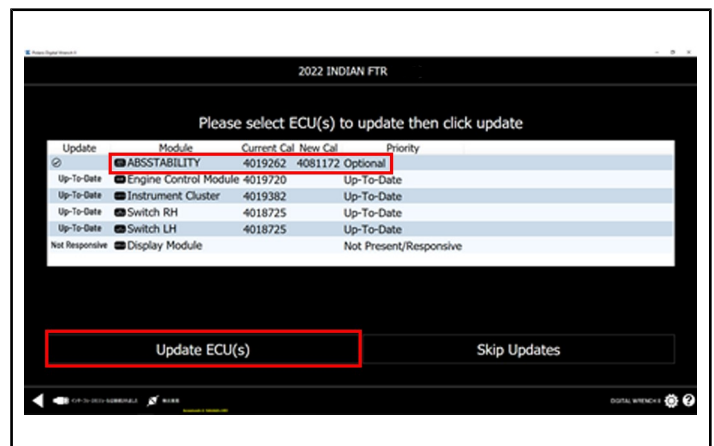
9. Select “ABSSTABILITY”, and then click “Update ECU (s)”.

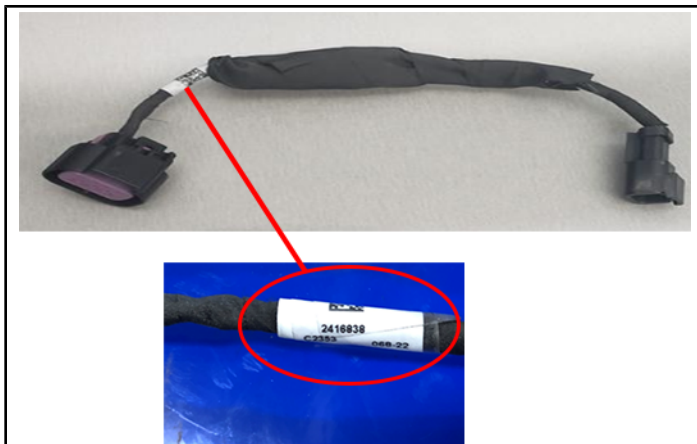
5. Obtain the ABS Reflash Harness (Indian Motorcycle PN 2416838).

This tool was provided by Indian Motorcycle and shipped to the dealer.

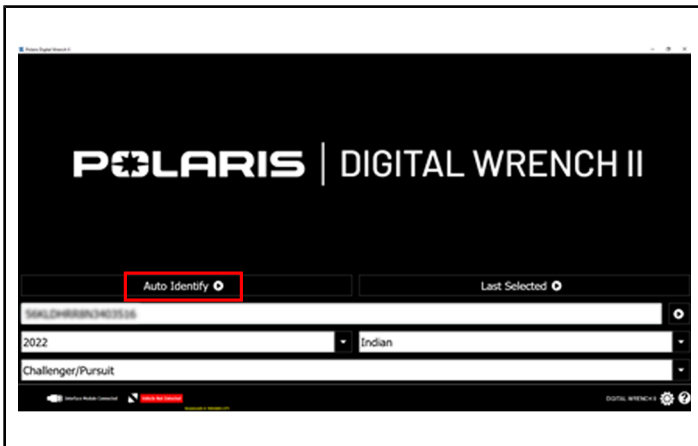
11. Connect the MultiLink XP cable to the PC and motorcycle. Then power on the motorcycle. Do **NOT** start.

12. Open Digital Wrench II and select “Auto Identify”.

Make sure the VIN, Model Year, Line, and Model are correct.

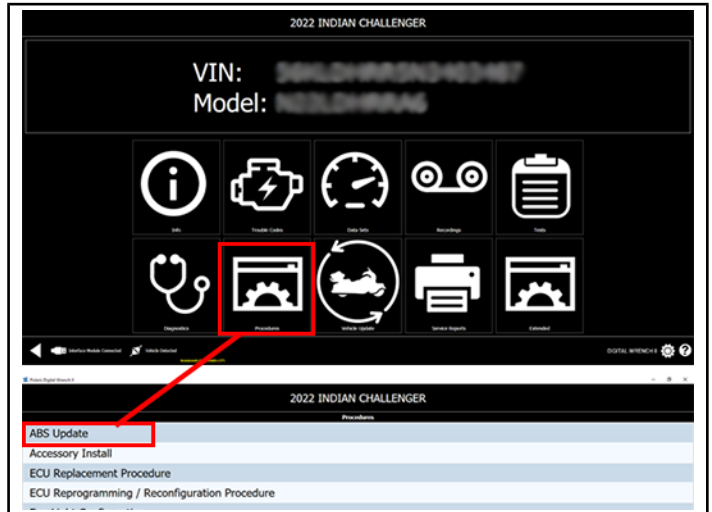
13. Select “Procedures”, and then select “ABS Update”.

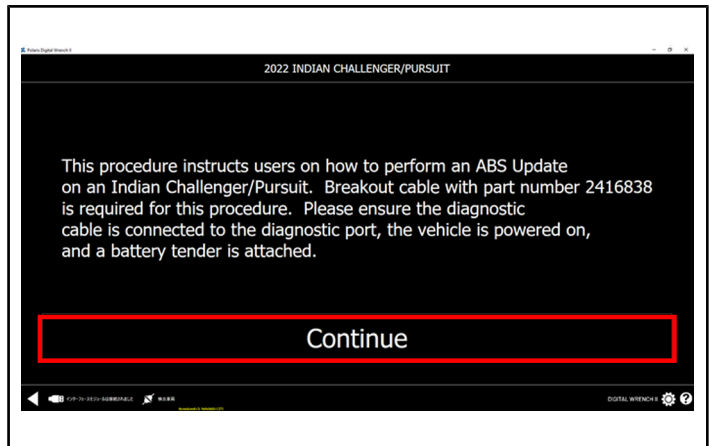
14. Select “Continue”.

Do **NOT** select the next “Continue” until the ABS Reflash Harness is installed.
Instructions to install the ABS Reflash Harness is outlined in steps 15 – 17.

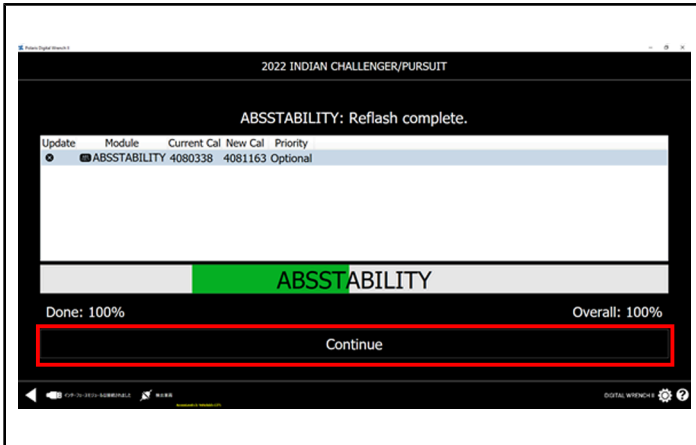
19. The ABS module will now update. Once the update has been successfully completed, select "Continue".

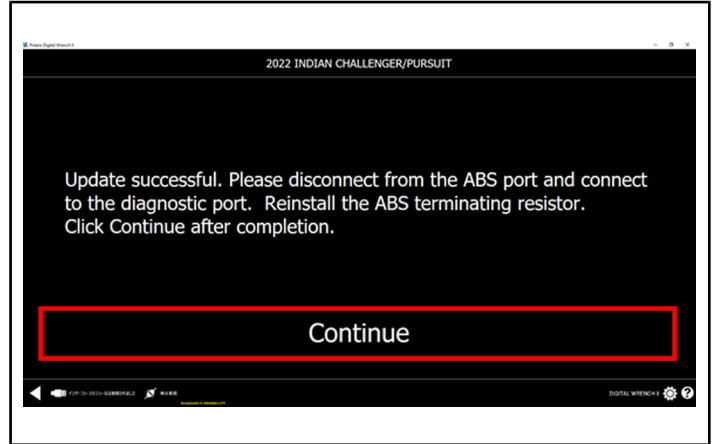
20. Disconnect the ABS Reflash Harness from the ABS harness connector on the motorcycle.

Select "Continue" **AFTER** the following actions have been completed.

An error will be received if this step is not completed as directed below.

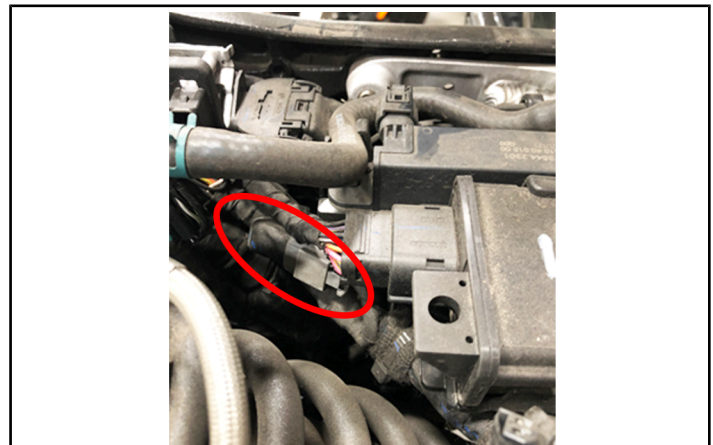
Reconnect the ABS harness connector (terminating resistor) on the motorcycle to the original connector, and reinstall the WCM (if removed previously).

Connect the MultiLink back in to the diagnostic port **before** selecting "Continue".

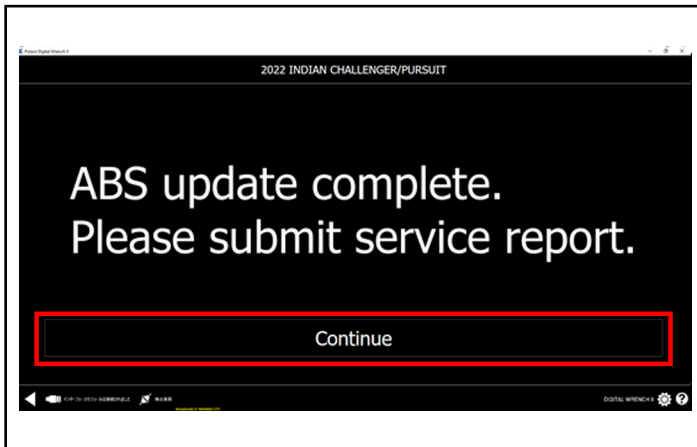
21. Select "Continue" and submit a service report.
