Aftersales Bulletin

A 02 2024 05 – 00 34 68 02 00 - Spectre RR25 – Recall 24V-104 – Integrated Brake Module Replacement

USA - TECHNICAL CAMPAIGN (SAFETY RECALL 24V-104) – Complete as soon as possible, using all available means to recall the vehicle for correction.

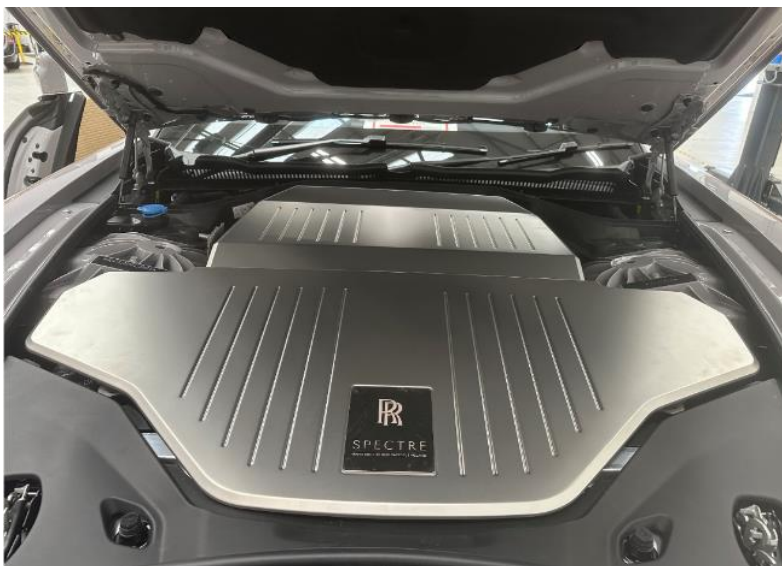
3. Remove design cover.

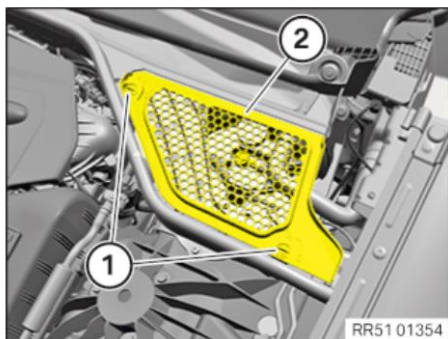
► Removing the cover of the rear engine compartment

- Turn the locks (1) by 90°.
- Remove the cover (2).

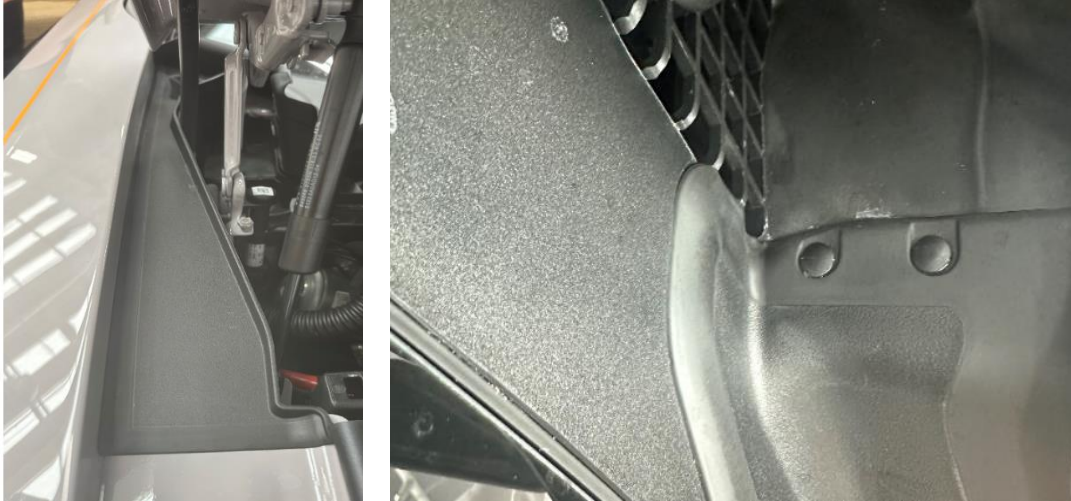
5. Remove fender trim pieces, pay attention to small clips, do not drop.
Note: Picture shown is for RHD. Should be same on driver side for LHD.

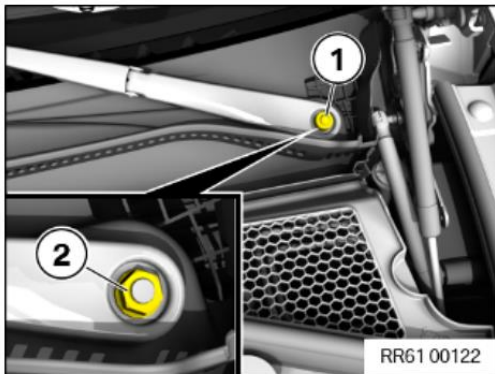
► Remove wiper arm

- Remove the protective cap (1).
- Loosen nut (2).

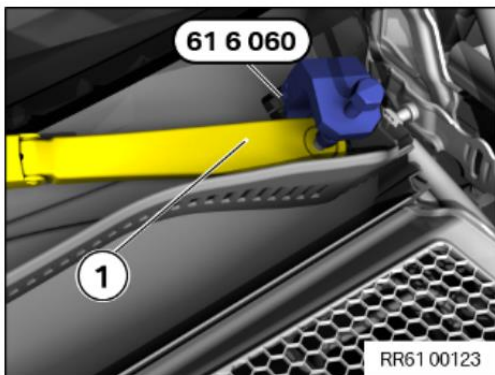
- Pull off the wiper arm (1) using special tool 0 493 441 (61 6 060).

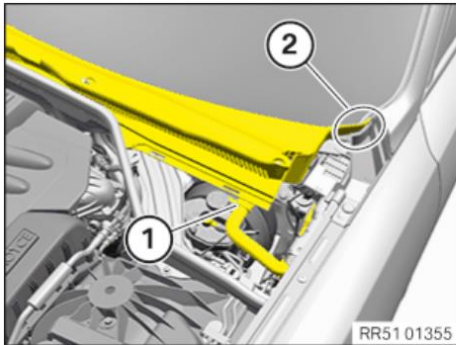
7. Remove scuttle panel trim. (REP-REP-P-5113116-RR21 - V.2)

- Release the water drain hose (1) from the cowl panel cover.
- Release the cowl panel cover in the area (2) from the side cover.

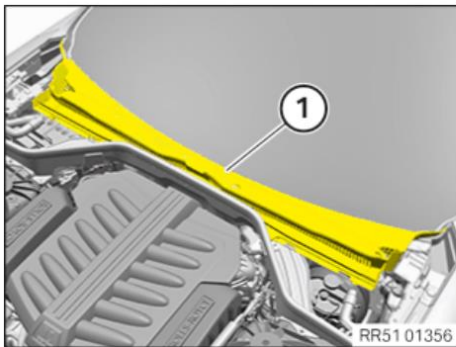
- Pull off the cowl panel cover (1) towards the top, starting from the side.

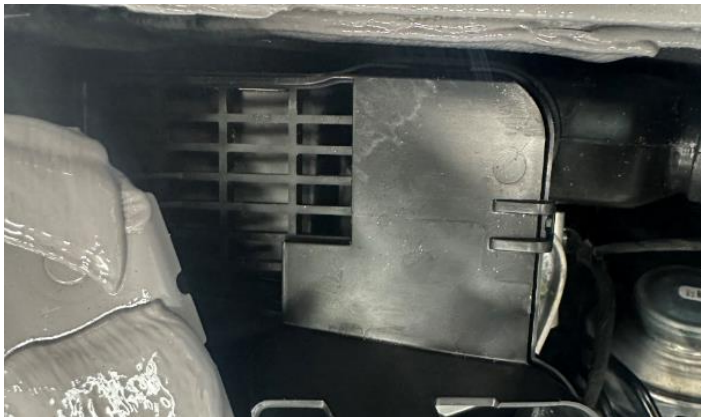
8. Remove drain cover on the DSC unit side (different LHD RHD).

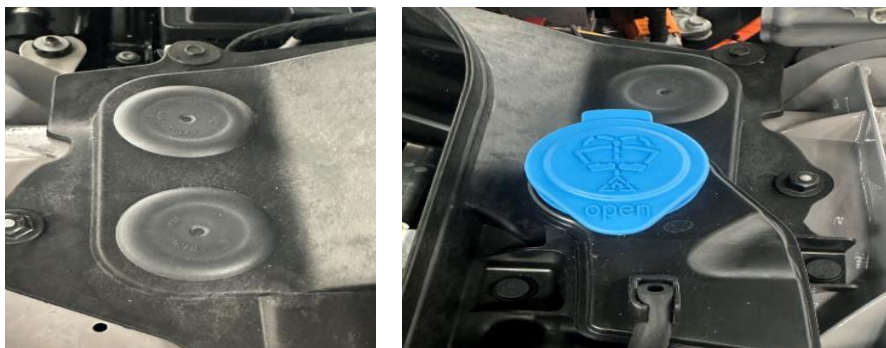
9. Remove grommets for support bolts and the washer bottle filler neck.

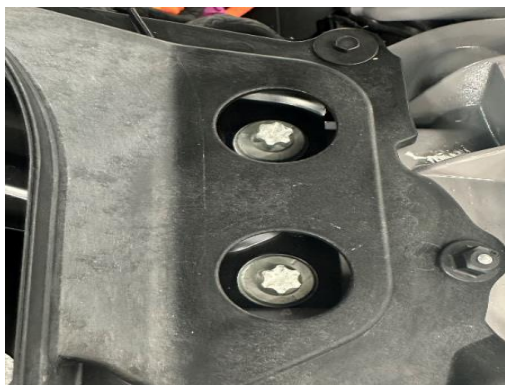
10. Remove lower bolts for support (torque: 56Nm + 90° – Replace bolts)

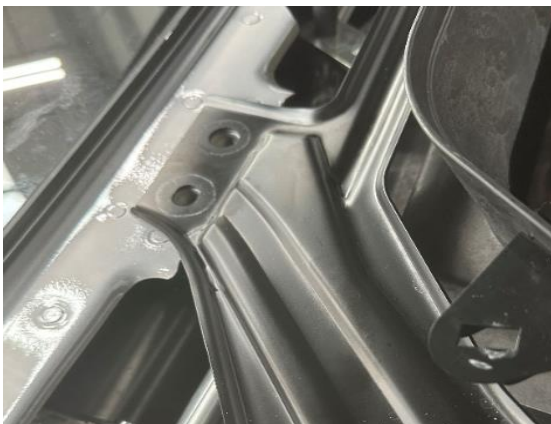
11. Remove upper support bolts (torque 56Nm)

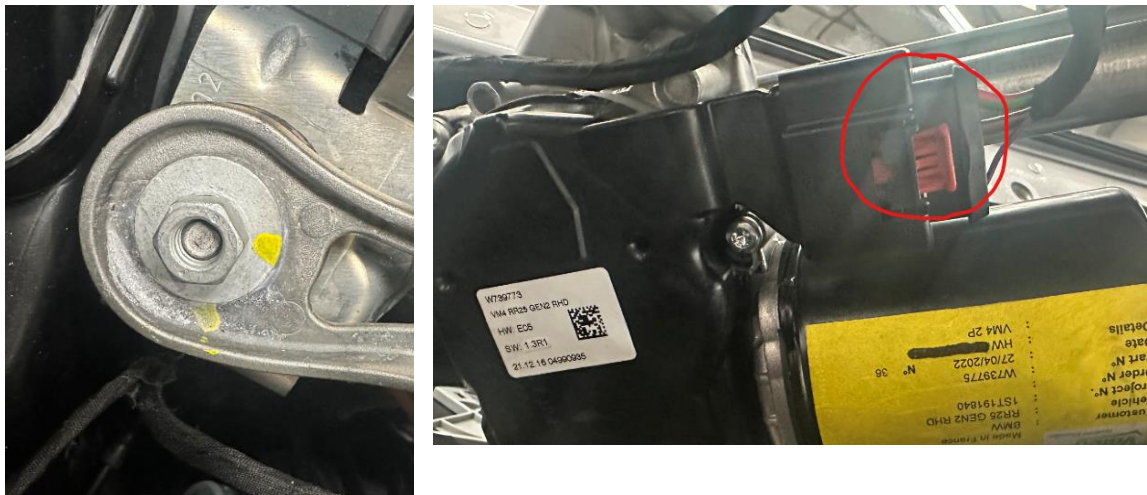
12. Remove wiper motor and linkage (Torque 12nm), pay attention to red lock tab on wiper motor plug.

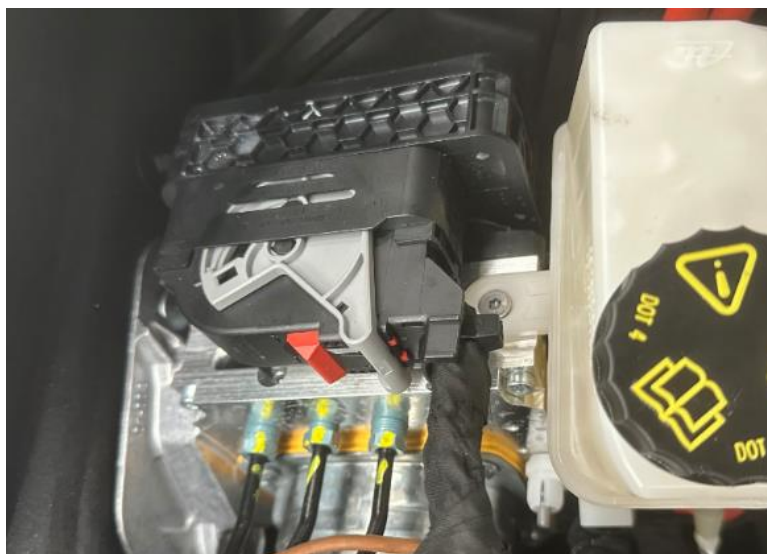
13. Unlock and disconnect/unplug DSCi Hydraulic Unit electrical connection. Red lock tab across, depress black lug, open with grey lever arm, and disconnect.

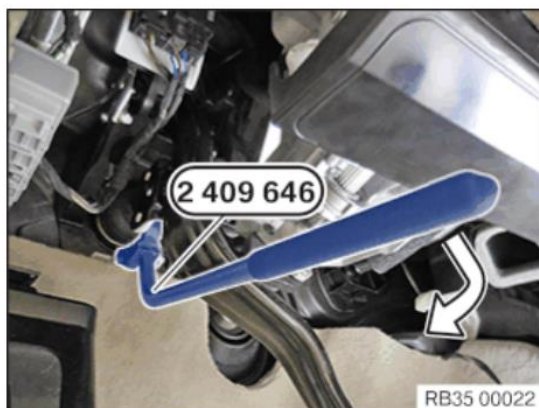
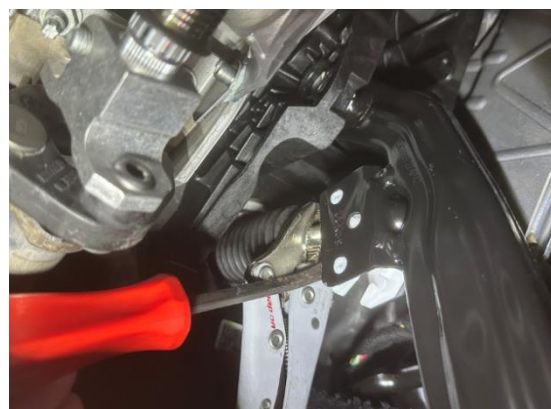
16. Disconnect level sensor on reservoir.
17. Separate the brake pedal from the DSCi Hydraulic unit using special tool 83 30 2 409 646. Insert the tool between the brake pedal and the DSCi Hydraulic Unit ball joint. Please note, if you do not have this tool, it is possible to gently pry the ball joint free using a lever/pry bar and a set of vice grips.
Position the threaded bolt against the bulkhead, and gently lever in the direction of the arrow.
Do not press against the white plastic insert of the brake pedal assembly, risk of damage.

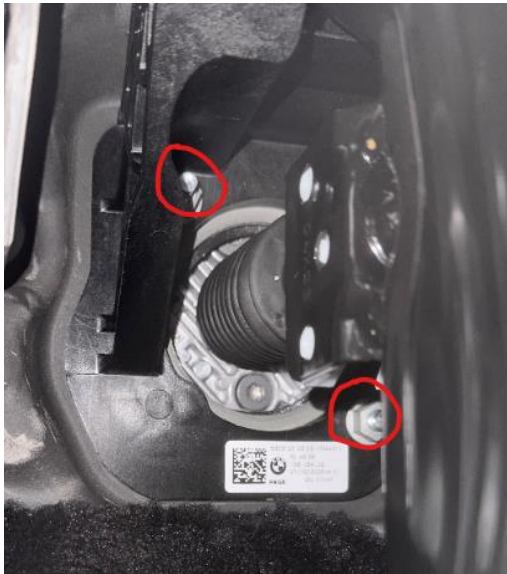
18. Release 2 retaining nuts for hydraulic unit assembly (Torque 21Nm – replace nuts).

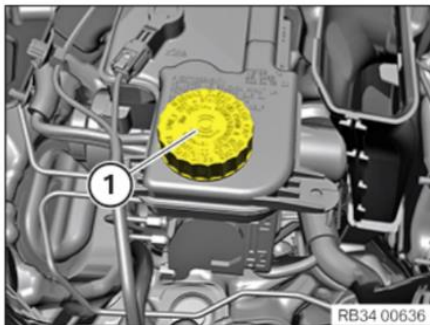
- Open sealing cap (1).

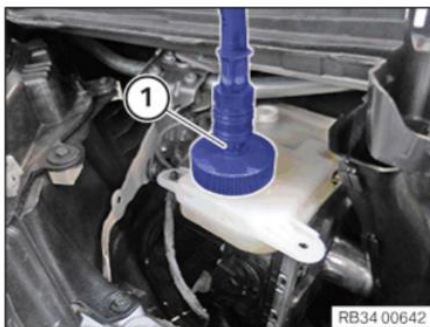
- Connect the bleeder unit (1) to the brake fluid expansion tank and switch it on.
Observe the operating instructions of the corresponding equipment manufacturer.
- Do not exceed the filling pressure of 2 bar.

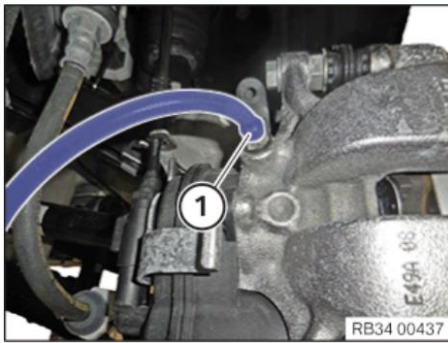
- Work through the instructions in the service function in sequence.
- Start flushing at the rear right.
- Connect the vent hose with the collecting vessel to the vent valve (1) on rear right brake caliper.
- Open the vent valve (1) and purge it until clear, bubble-free brake fluid emerges.
- Close vent valve.

Vent valve	Tightening torque	10Nm
------------	-------------------	------

LHD vehicle: Rear Right, Rear Left, Front Right, Front Left

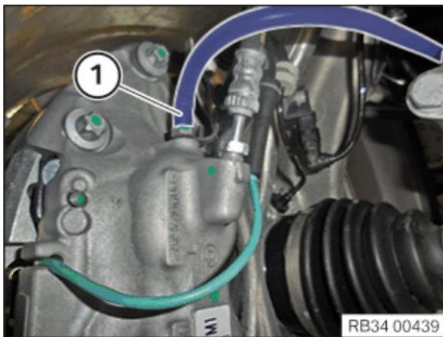
- Start flushing at the front right.
- Connect the vent hose with the collecting vessel to the vent valve (1) on front right brake caliper.
- Open the vent valve (1) and purge it until clear, bubble-free brake fluid emerges.
- Close vent valve (1).

Vent valve	Tightening torque	18Nm
------------	-------------------	------

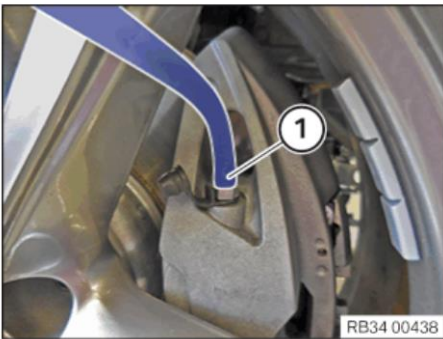
- Connect the vent hose with the collecting vessel to the vent valve (1) on the front right brake caliper.
- Open the vent valve (1) and purge it until clear, bubble-free brake fluid emerges.
- Close vent valve (1).
