**TECHNICAL INSTRUCTIONS**  
**FOR**  
**SAFETY (NONCOMPLIANCE) RECALL 24TA01**  
**UPDATE PARKING ASSIST ECU**  
**CERTAIN 2023 MIRAI VEHICLES**

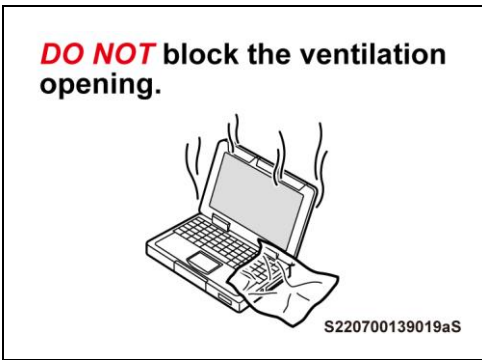
- c) **DO NOT** block the ventilation opening for the cooling fan of the personal computer.

*If the ventilation opening for the cooling fan is blocked with a sheet cover or the like, the personal computer may be heated excessively, causing the operation of the personal computer to stop. Due to the stop of the operation, the communication for reprogramming signals could be stopped, resulting in the damage of the ECU.*

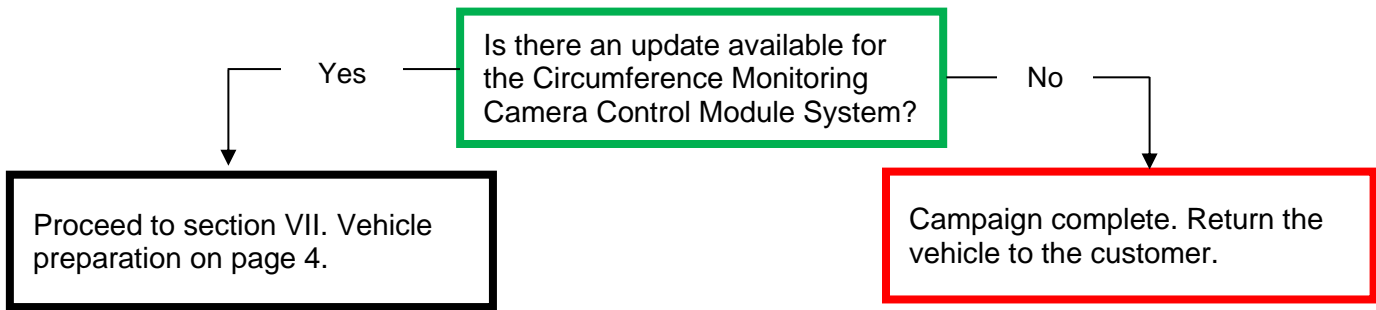
- a) Locate the "Update" column of the "Calibration Information" for the Circumference Monitoring Camera Control Module system on the "Health Check Result" screen.
- b) Determine the status of an available update; indicated by a YES or NO.

*If the CIDs indicate 'Yes', proceed with the update procedure.*

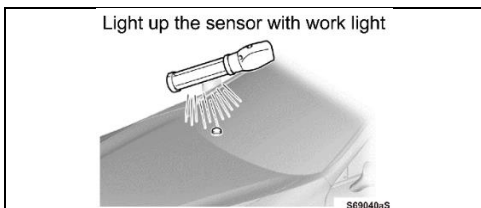
- Vehicle in the IG position (READY OFF).
- Transaxle in Park.
- Parking brake engaged.
- Turn off all electrical accessories (i.e. climate control, audio system, etc.)
- Headlight switch in the DRL OFF position. (w/ DRL OFF position)
- Windshield wiper switch in the OFF position.

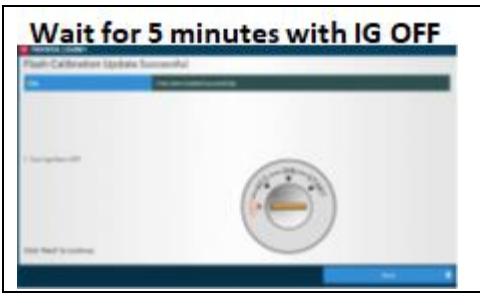
a) Click “Yes” on the “Health Check Results” screen or follow the links on the table above the begin the reflash process.

**Critical** After “Flash Calibration Update Successful” is displayed on the GTS+ screen, turn the IG off and keep with IG OFF for 5 minutes.

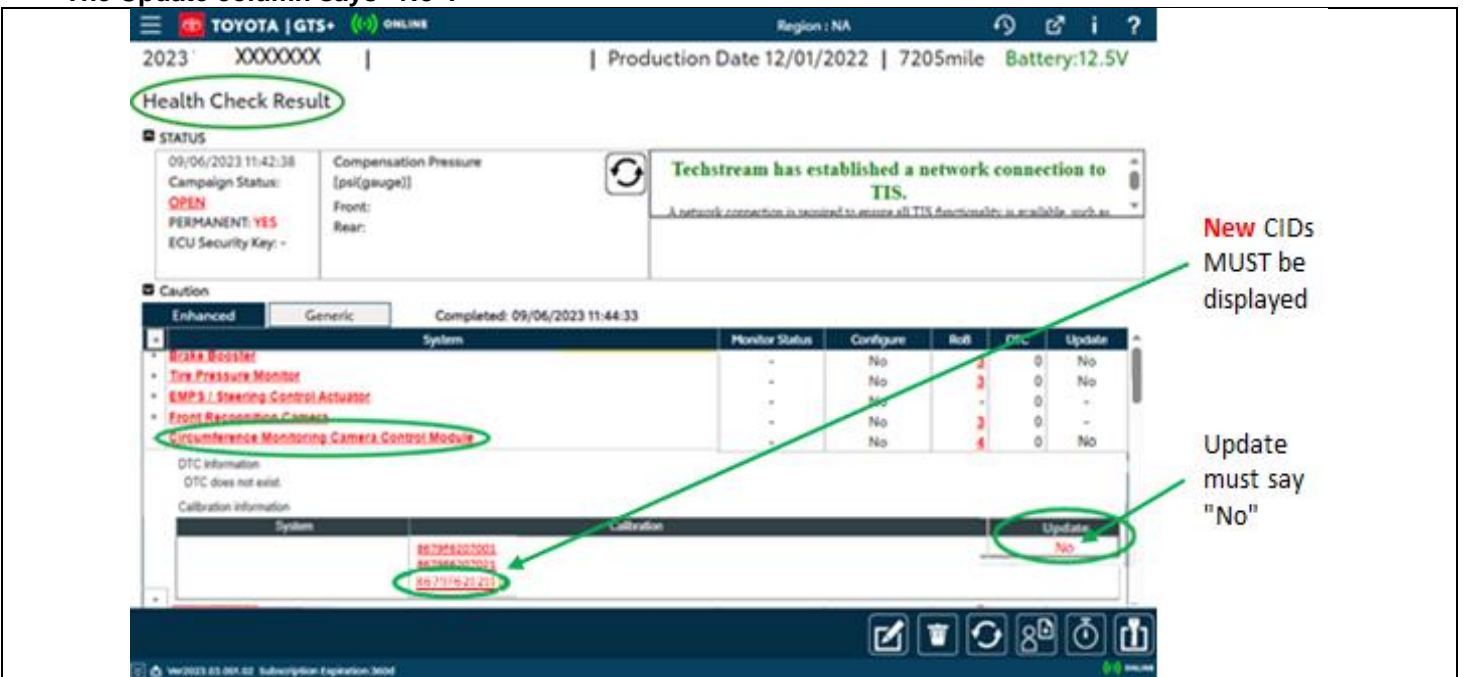
- On the Stored Data tab, confirm the following for the Circumference Monitoring Camera Control Module System:

- The Calibration number has the “New CID” number.
- The Update column says “No”.

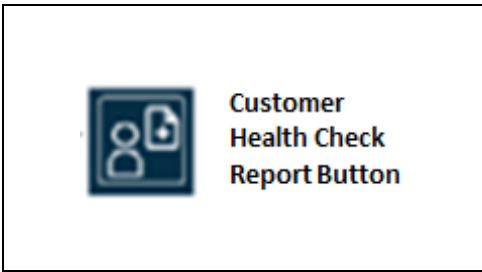
#### 4. PRINT CUSTOMER HEALTH CHECK REPORT

- a) From the Stored Data tab, select the Customer Health Check Report button (TIS will launch when button is pressed).
- b) Log in to TIS.
- c) Input Vehicle Mileage and Repair Order number.
- d) Check the "Performed" campaign button for the applicable campaigns.
- e) Select the Report button.

A screenshot of a web application interface. At the top left, there are two logos: the Toyota logo and the TIS logo. To the right of the logos, the text "Diagnostic Report" is displayed in a large, italicized, grey font. Below the logos, the text "Vehicle Information" is centered. Underneath, there are two input fields: "Mileage: 7787" and "Repair Order: 77888". Below these fields, there is a paragraph of text: "Our systems show the following campaigns are outstanding. Have any of these campaigns been completed? (Check for SSC door label if unsure.)". Below this text, there is a label "XXX:" followed by two radio buttons: "Performed" (which is selected) and "Not Performed". Below the radio buttons, there is a button labeled "Report" which is highlighted with a red rectangular box.
