**24TA02**

**Vehicle May Move While In Neutral Position**

**2022 - 2024 TUNDRA / TUNDRA HV  
2023 AND 2024 SEQUOIA HV**

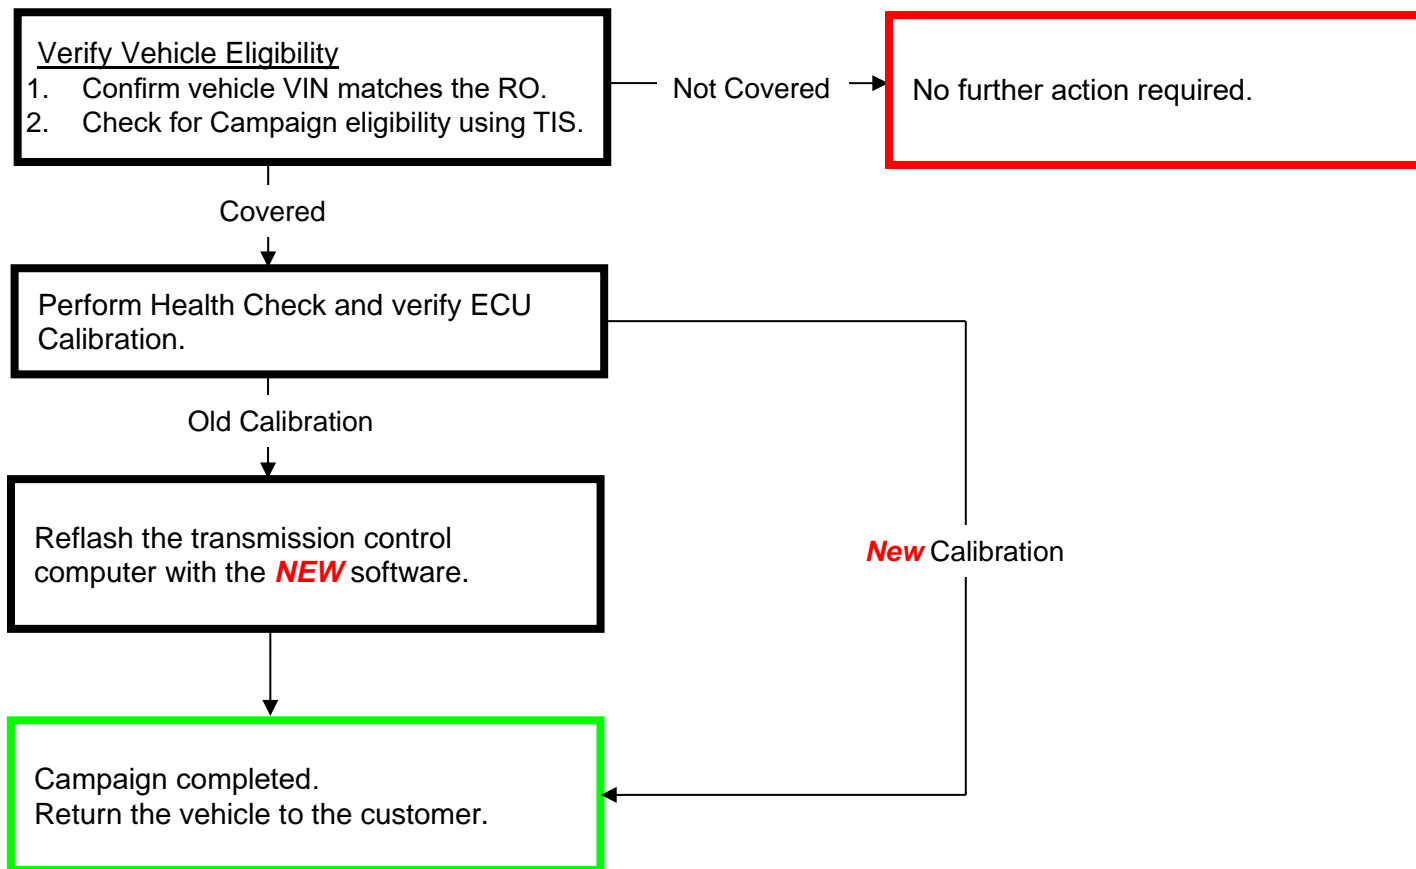
## I. OPERATION FLOW CHART

The flow chart is for reference only. **DO NOT** use it in place of the full technical instructions. Follow **ALL** steps as outlined in the full technical instructions to confirm the campaign is completed correctly.

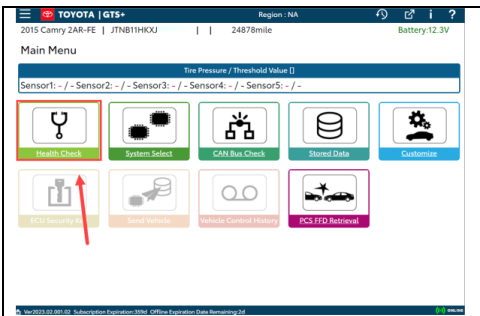
## VI. TRANSMISSION SYSTEM CALIBRATION ID VERIFICATION

**1. CHECK FOR DTC'S**

- ) Using a GTS+, click the "Health Check" button on the Main Menu.

**2. CHECK CURRENT CALIBRATION**

- a) Locate the "Update" column of the "Calibration Information" for the Transmission system on the "Health Check Result" screen.
- b) Determine the status of an available update; indicated by a YES or NO.

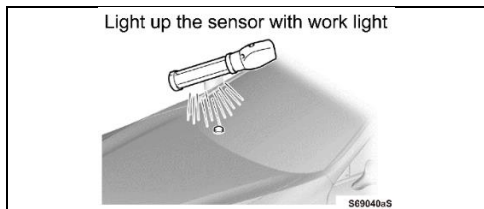
- Vehicle in the IG position (READY OFF).
- Transaxle in Park.
- Parking brake engaged.
- Turn off all electrical accessories (i.e. climate control, audio system, etc.)
- Headlight switch in the DRL OFF position. (w/ DRL OFF position)
- Windshield wiper switch in the OFF position.

- ) When the vehicle has no "OFF position" in the light control switch:
- 1) Turn the IG ON.
  - 2) Set the light control switch to the AUTO position and make sure that the exterior lights are turned on.
  - 3) Light up the automatic light control sensor with work light to keep the exterior lights turned off.

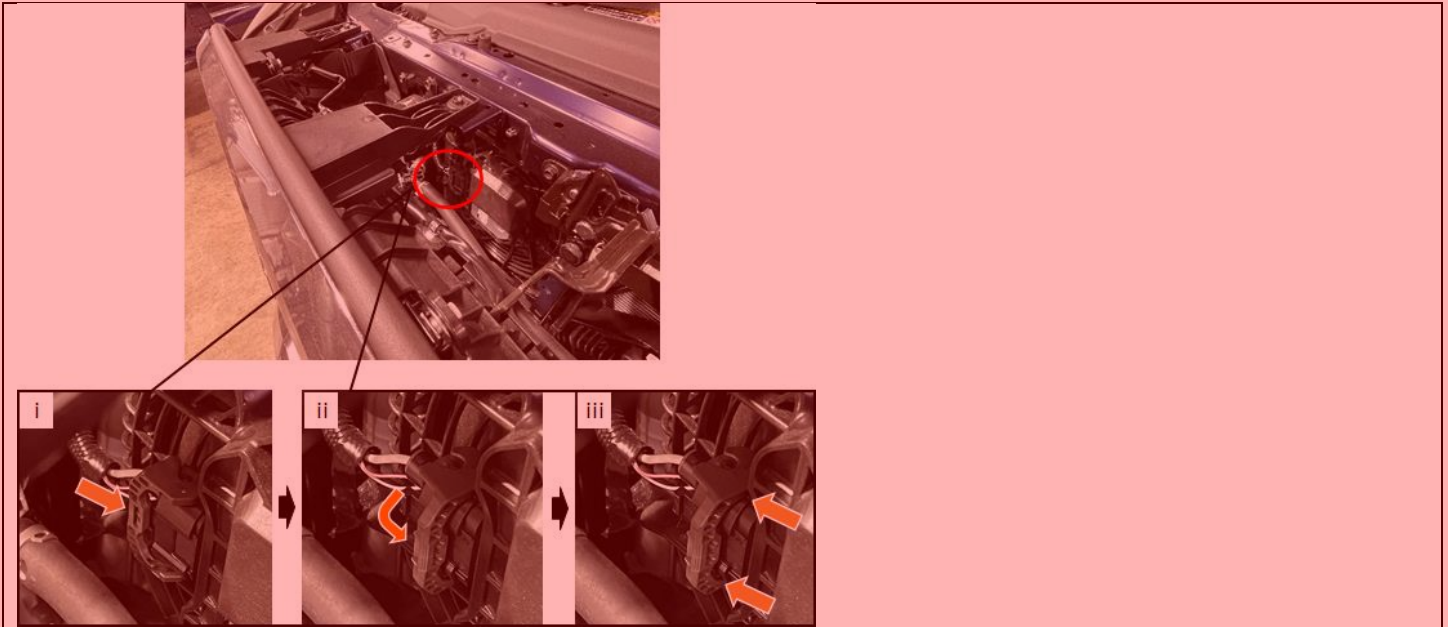
## 2. STOP THE OPERATION OF THE ELECTRIC FAN

- a. Disconnect the connector from the cooling fan.

- **DO NOT** pull from the wire side.

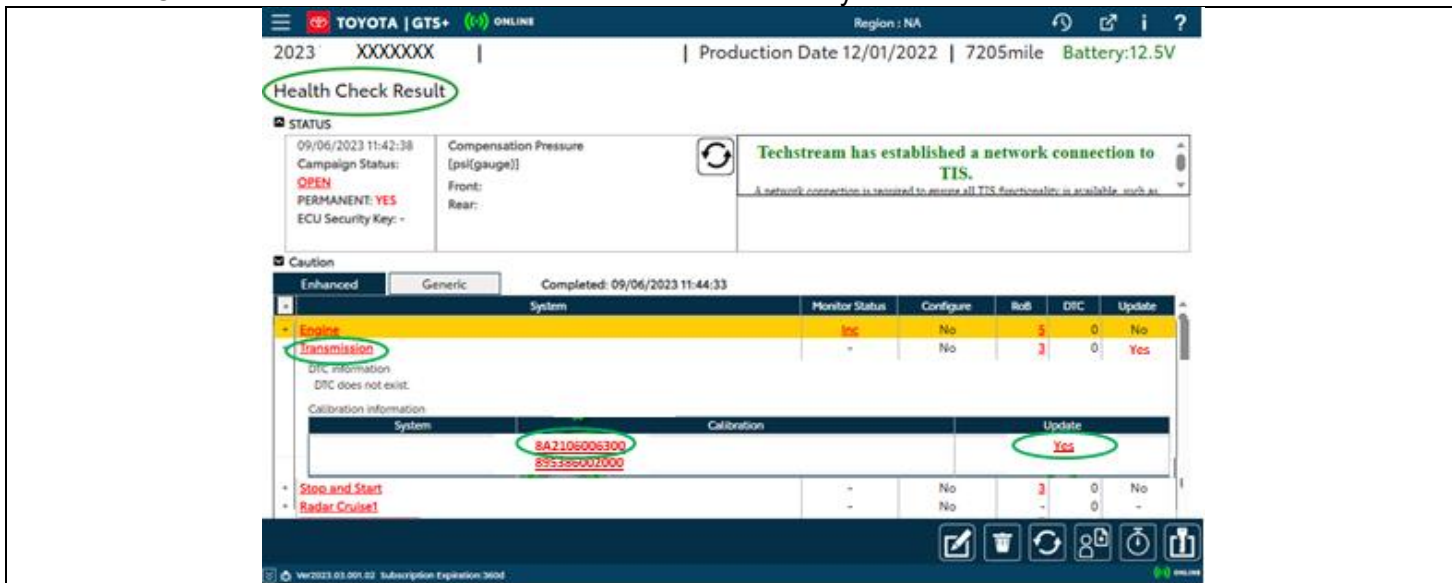
### 1. CONFIRM THE CALIBRATION ID

Confirm the current calibration ID in the Transmission System.

The calibration IDs to re-flash in this campaign are as shown in the table below.

Transmission Control Computer Calibrations				
System	Vehicle Model	Current Calibration ID	<b>New</b> Calibration ID	
Transmission	Tundra (2WD)	<u>8A2100C01200</u> 895386002000	<u>8A2100C01500</u> 895386002000	
		<u>8A2100C01300</u> 895386002000		
		<u>8A2100C01400</u> 895386002000		
		<u>8A2100C09000</u> 895386002000		
	Tundra (4WD)	<u>8A2100C03200</u> 895386002000	<u>8A2100C03500</u> 895386002000	
		<u>8A2100C03300</u> 895386002000		
		<u>8A2100C03400</u> 895386002000		
		<u>8A2100C10000</u> 895386002000		
	Tundra Hybrid (2WD)	<u>8A2100C02200</u> 895383401000	<u>8A2100C02300</u> 895383401000	
	Tundra Hybrid (4WD)	<u>8A2100C06200</u> 895383401000	<u>8A2100C06300</u> 895383401000	
	System	Vehicle Model	Current Calibration ID	<b>New</b> Calibration ID
	Transmission	Sequoia HV (2WD)	<u>8A2100C02200</u> 895383401000	<u>8A2100C02300</u> 895383401000
	Sequoia HV (4WD)	<u>8A2100C06200</u> 895383401000	<u>8A2100C06300</u> 895383401000

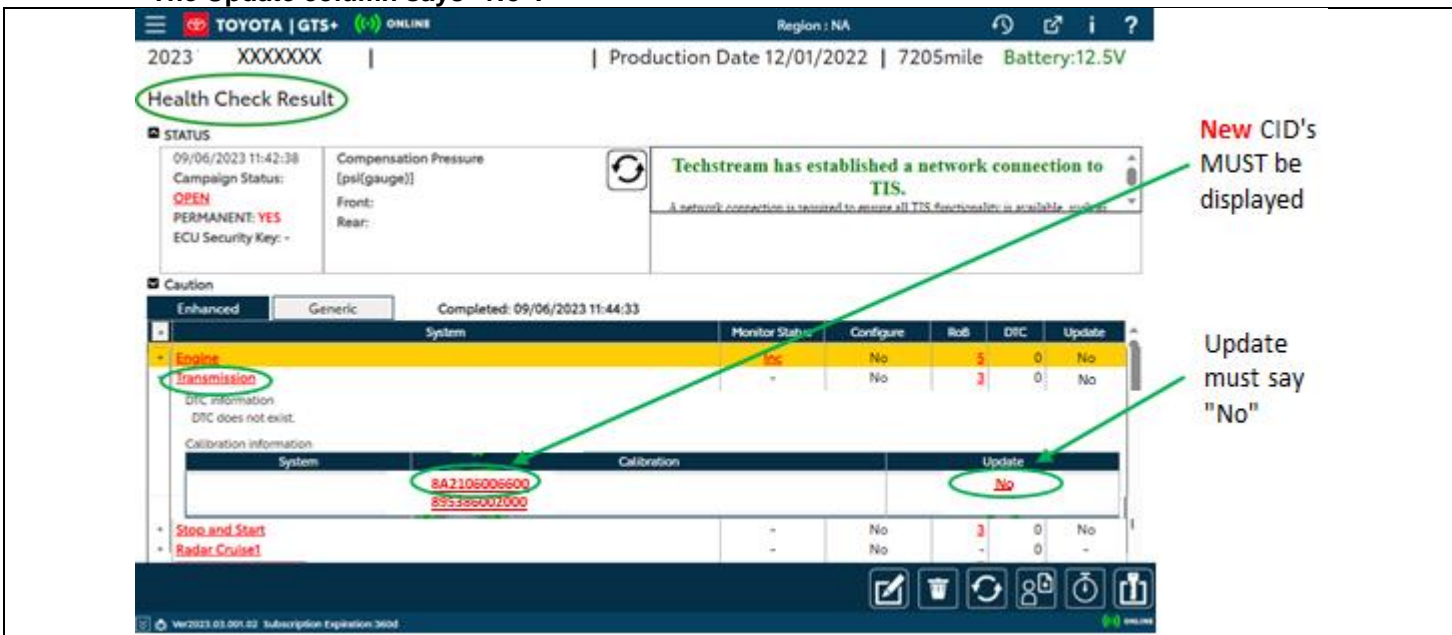
### 3. CONFIRM CID UPDATE

- a) On the Stored Data tab, confirm the following for the Transmission System:
  - The Calibration number has the “New CID” number.
  - The Update column says “No”.

**Critical** Confirm the CID's has been updated successfully to the **NEW** CID's by someone other than the individual who performed the repair. Refer to page 5.

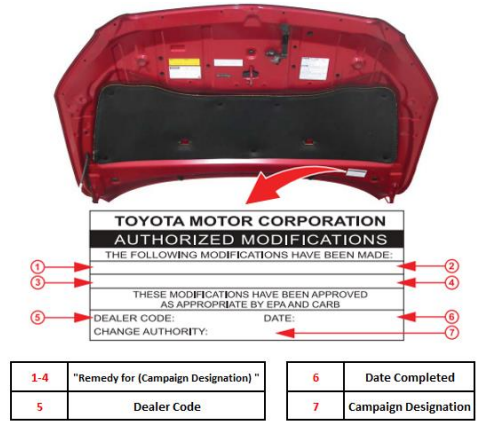
Install the Authorized Modifications Label after the repairs have been completed. Using a permanent marker, fill out the label and affix it to the location under the hood as indicated.

As this Safety Recall includes emission related parts, California dealers are requested to fill out the Vehicle Emissions Recall – Proof of Correction form and affix an Authorized Modification Label to the vehicle after repairs have been completed.
