TECHNICAL INSTRUCTIONS

24TA02

Vehicle May Move While In Neutral Position

**2022 - 2024 TUNDRA / TUNDRA HV
2023 AND 2024 SEQUOIA HV**

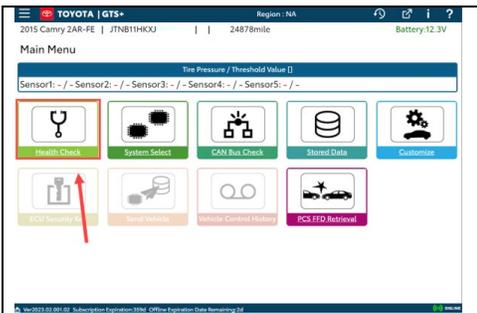
1. CHECK FOR DTC'S

-) Using a GTS+, click the "Health Check" button on the Main Menu.

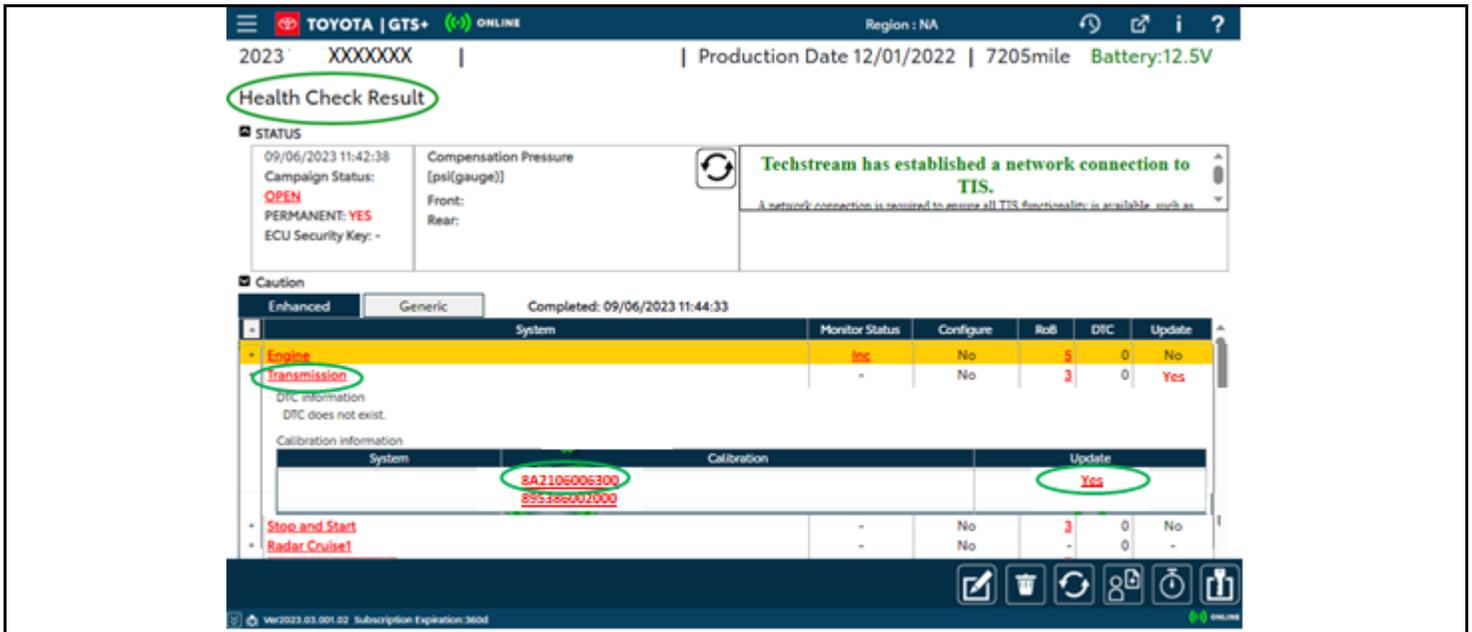
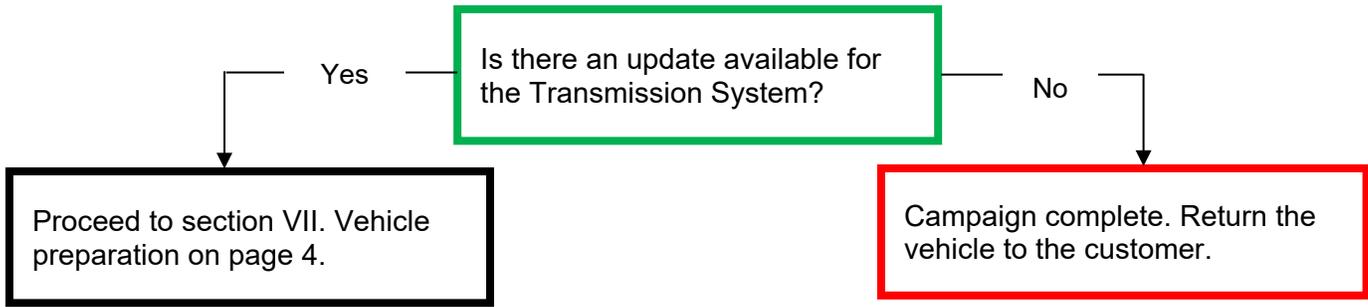
- a) Locate the "Update" column of the "Calibration Information" for the Transmission system on the "Health Check Result" screen.
- b) Determine the status of an available update; indicated by a YES or NO.

If the CID's indicate 'Yes', proceed with the update procedure.

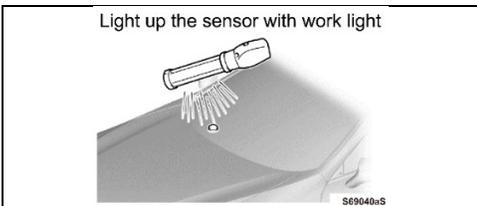
- a) When the vehicle has no “OFF position” in the light control switch:
- 1) Turn the IG ON.
 - 2) Set the light control switch to the AUTO position and make sure that the exterior lights are turned on.
 - 3) Light up the automatic light control sensor with work light to keep the exterior lights turned off.

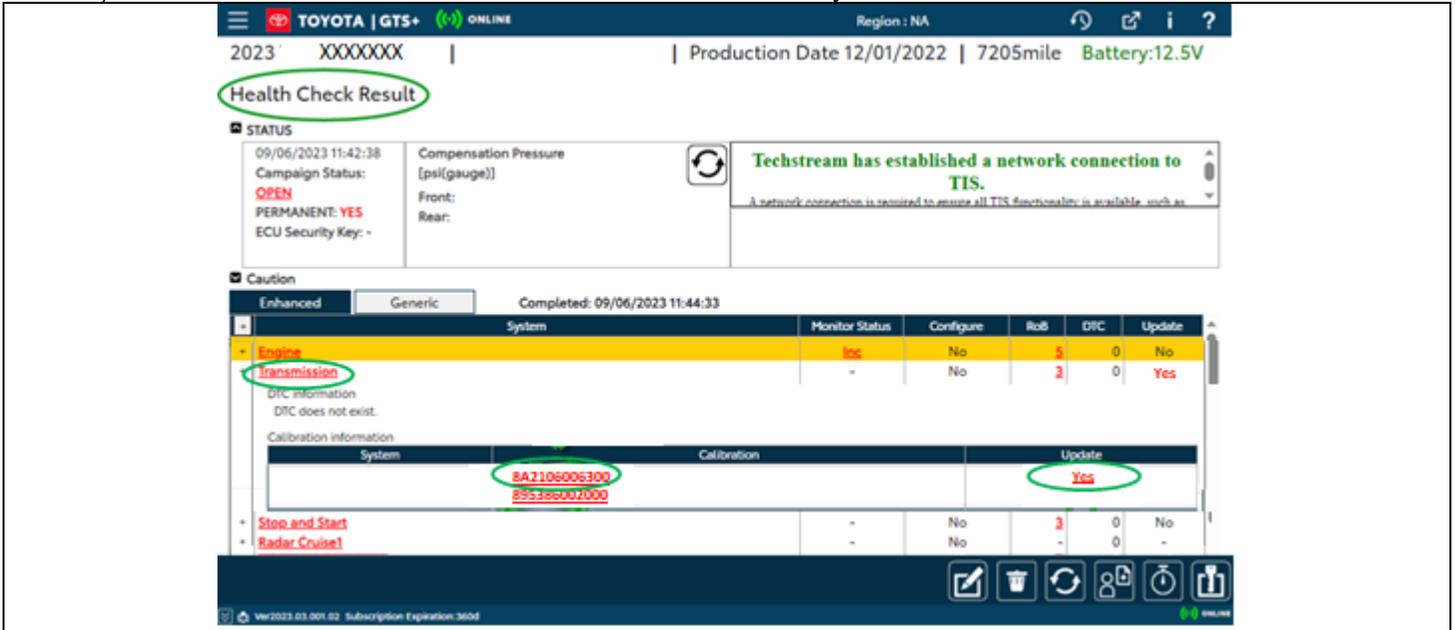
) Confirm the current calibration ID in the Transmission System.

The calibration IDs to re-flash in this campaign are as shown in the table below.

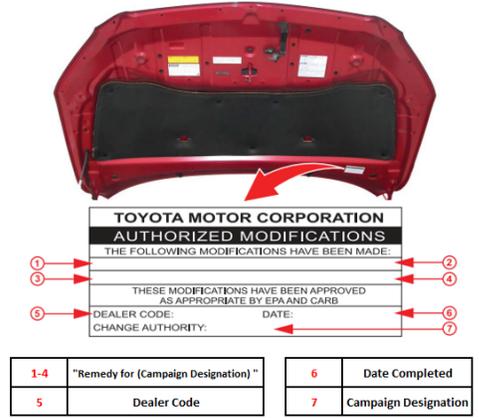
Install the Authorized Modifications Label after the repairs have been completed. Using a permanent marker, fill out the label and affix it to the location under the hood as indicated.
