TECHNICAL INSTRUCTIONS
FOR
24LA02
Vehicle May Move While Neutral In Motion
2022 - 2024 LX600 VEHICLES

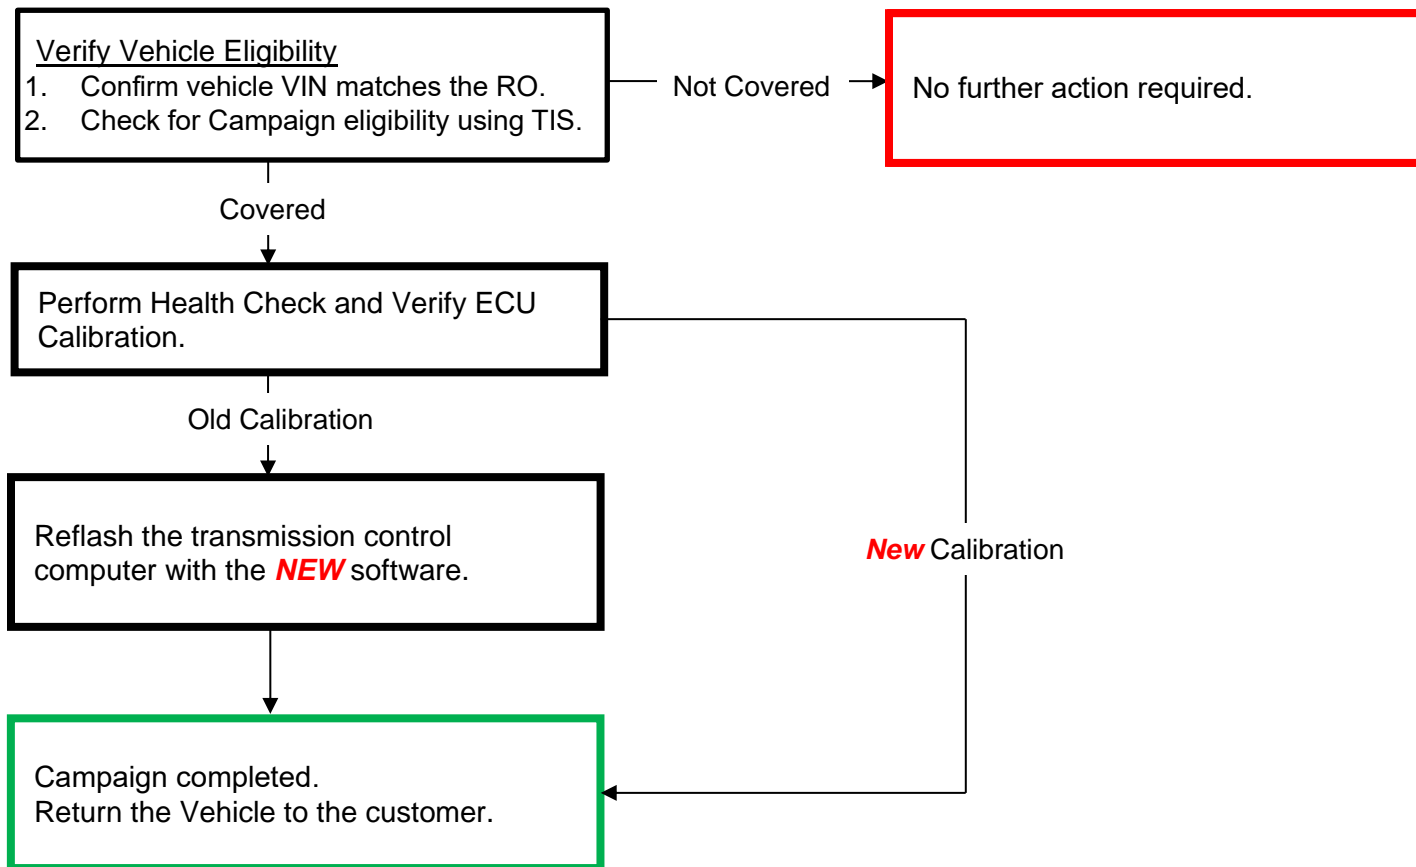
I. OPERATION FLOW CHART

The flow chart is for reference only. **DO NOT** use it in place of the full technical instructions. Follow **ALL** steps as outlined in the full technical instructions to confirm the campaign is completed correctly.

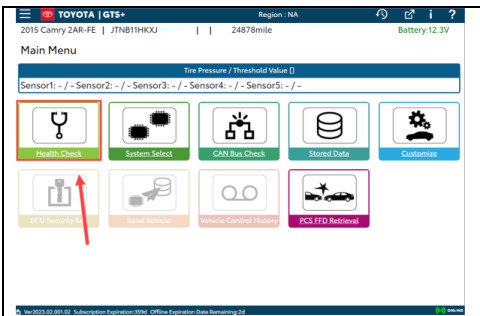
1. CHECK FOR DTC'S

-) Using a GTS+, click the "Health Check" button on the Main Menu.

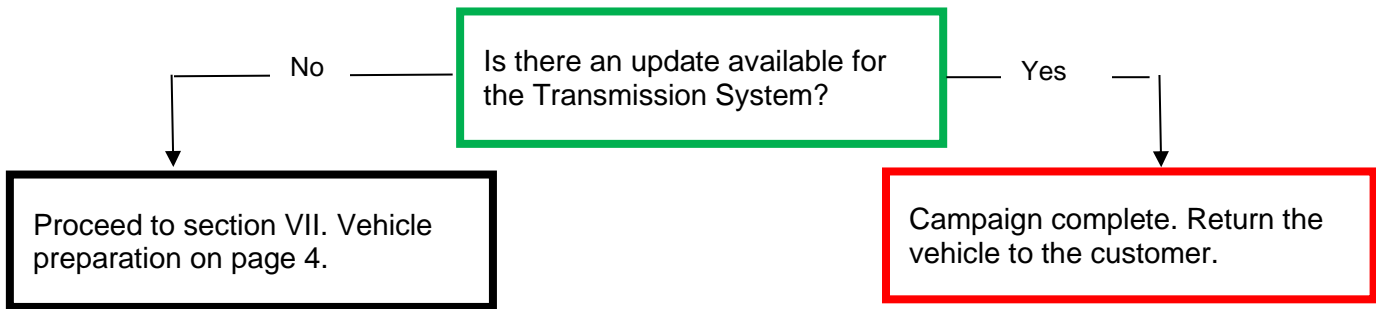
- a) Locate the "Update" column of the "Calibration Information" for the Transmission system on the "Health Check Result" screen.
- b) Determine the status of an available update; indicated by a YES or NO.

If the CID's indicate 'Yes', proceed with the update procedure.

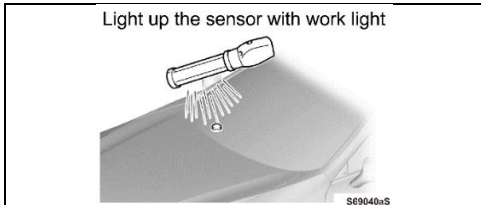
- Vehicle in the IG position (READY OFF).
- Transaxle in Park.
- Parking brake engaged.
- Turn off all electrical accessories (i.e. climate control, audio system, etc.)
- Headlight switch in the DRL OFF position. (w/ DRL OFF position)
- Windshield wiper switch in the OFF position.

- a) When the vehicle has no “OFF position” in the light control switch:
- 1) Turn the IG ON.
 - 2) Set the light control switch to the AUTO position and make sure that the exterior lights are turned on.
 - 3) Light up the automatic light control sensor with work light to keep the exterior lights turned off.

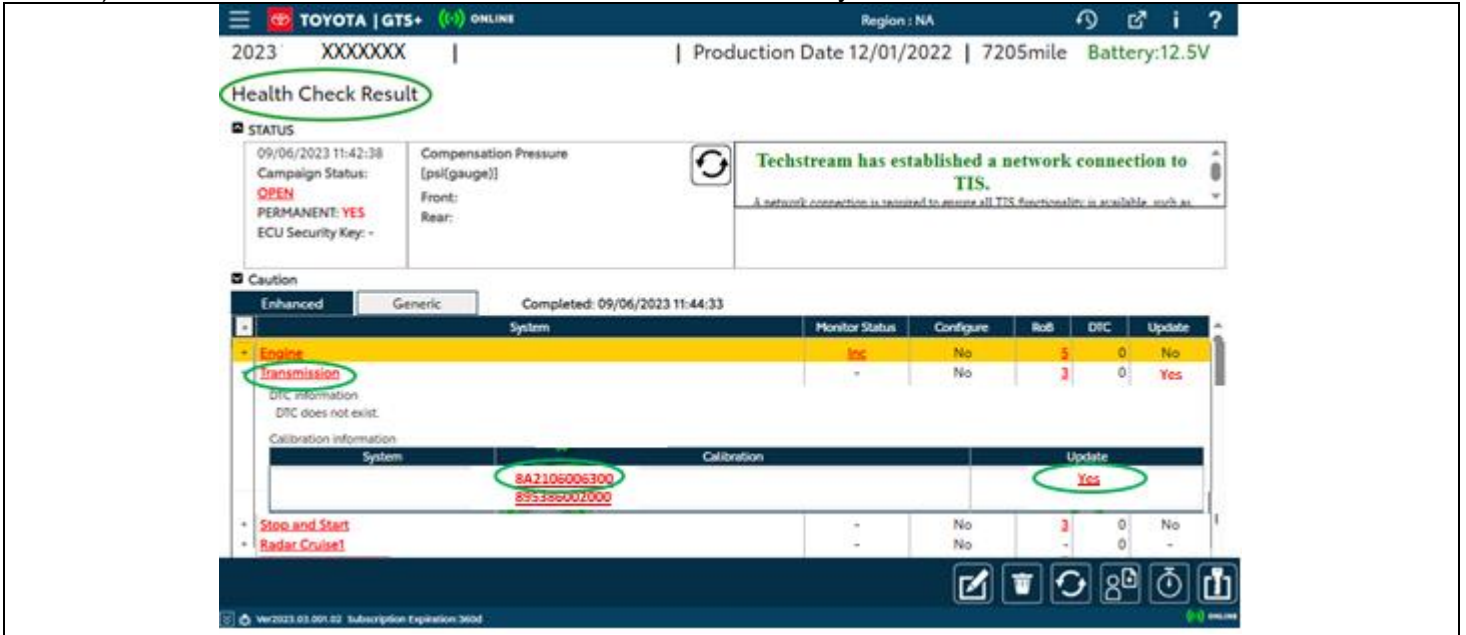
1. CONFIRM THE CALIBRATION ID

) Confirm the current calibration ID in the Transmission System.

The calibration IDs to re-flash in this campaign are as shown in the table below.

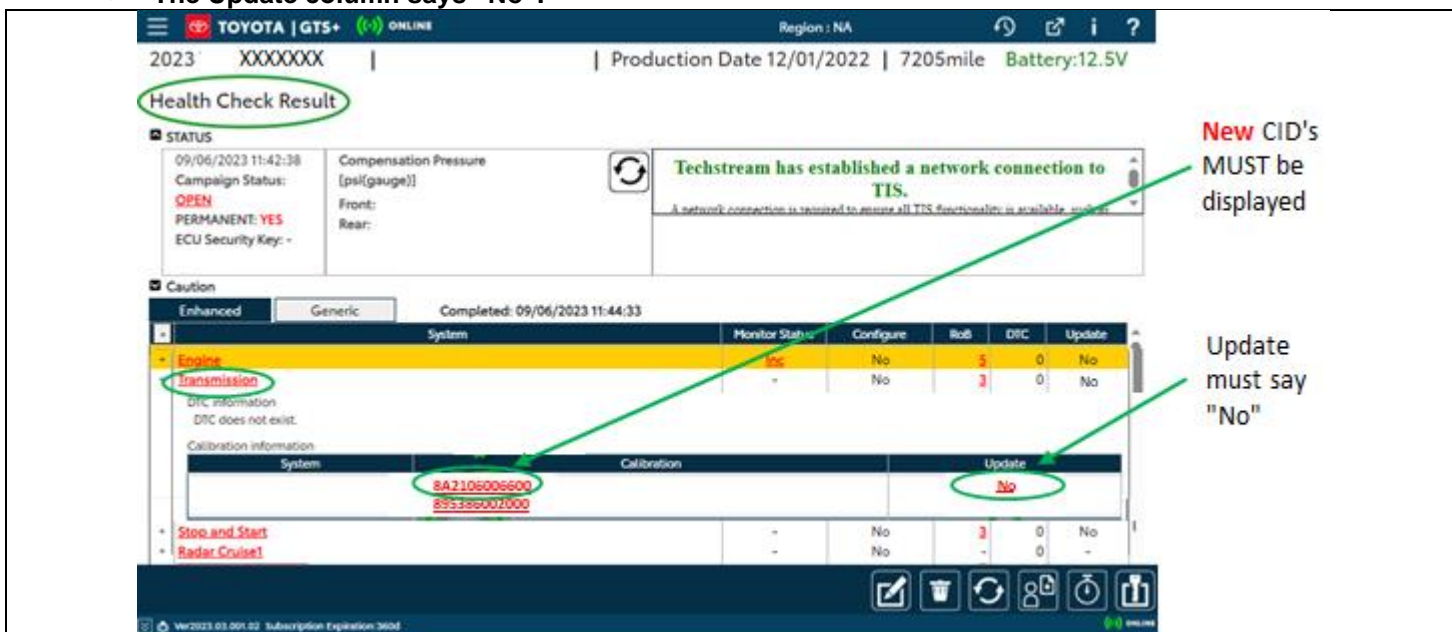
3. CONFIRM CID UPDATE

- On the Stored Data tab, confirm the following for the Transmission System:
 - The Calibration number has the “New CID” number.
 - The Update column says “No”.

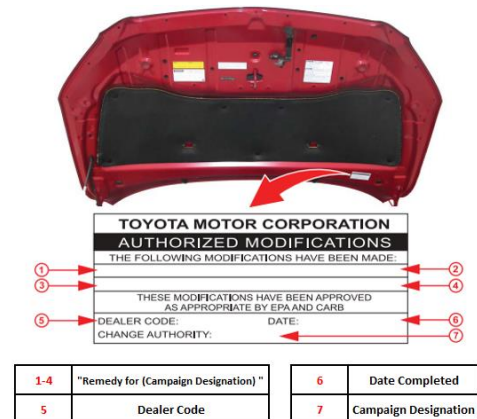
Install the Authorized Modifications Label after the repairs have been completed. Using a permanent marker, fill out the label and affix it to the location under the hood as indicted.
