**SAFETY RECALL**  
NORTH AMERICA  
**Airbag Clockspring**

Reference: 27B / NHTSA 24V-196

Remedy available for  
2016 (JK) Jeep® Wrangler

## **A. Airbag Clockspring Replacement**

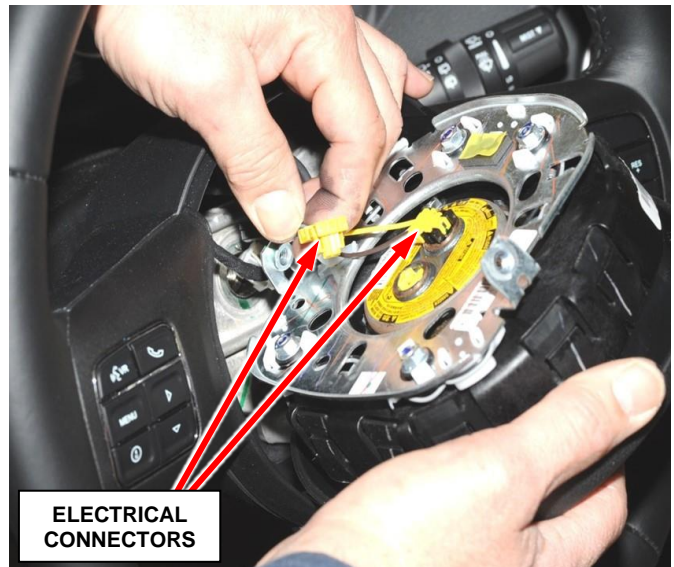
**Figure 1 – Airbag Module Electrical Connectors**

3. Remove and save the driver airbag module retaining screws.
4. Separate the driver airbag module from the steering wheel and disconnect the two airbag electrical connectors (Figure 1) and the one horn electrical connector. Then set the driver airbag module aside.
5. Remove and discard the steering wheel retaining bolt from the steering shaft (Figure 2).
6. Remove and save the steering wheel assembly.
7. Move the steering column to the fully lowered position and leave the tilt release lever in the released (down) position.

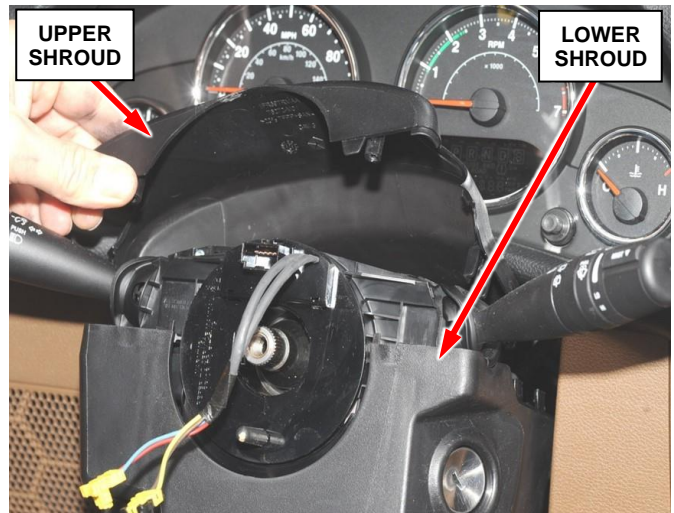
8. Remove and discard the upper and lower steering column shrouds from the steering column (Figure 3).

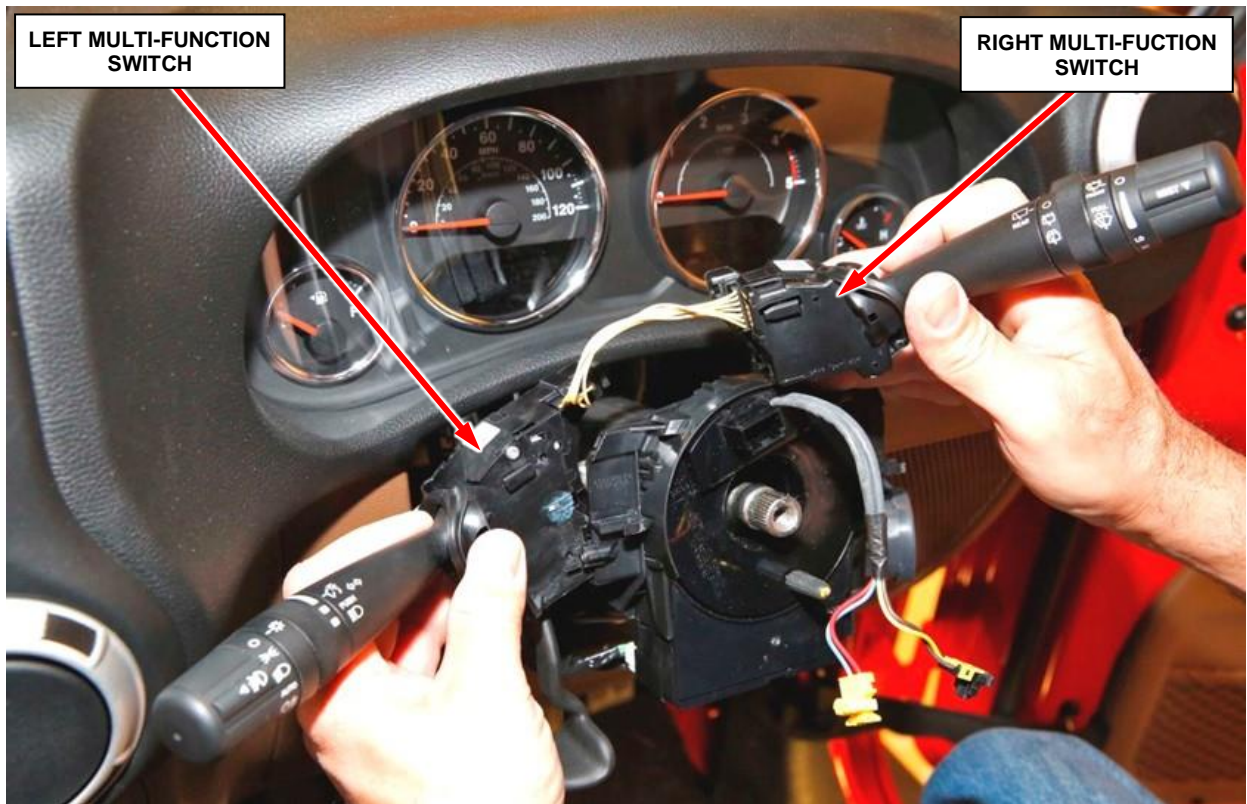
**Figure 4 – Right and Left Multi-Function Switches**

9. Remove and save the right and left multi-function switches (Figure 4).

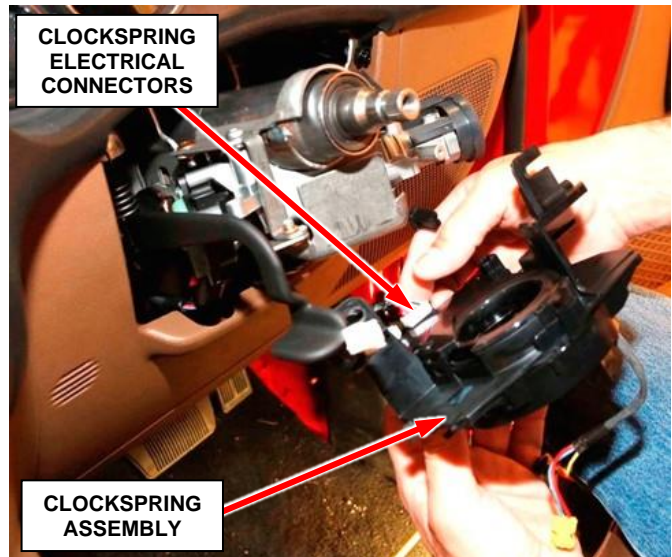
**Figure 5 – Clockspring Electrical Connections**

11. Pull the clockspring away from the steering column lock housing enough to access and disconnect the three instrument panel wire harness electrical connectors from the receptacles on the back of the clockspring (Figure 5).

14. Connect the three instrument panel wire harness electrical connectors to the receptacles on the back of the clockspring (Figure 5).

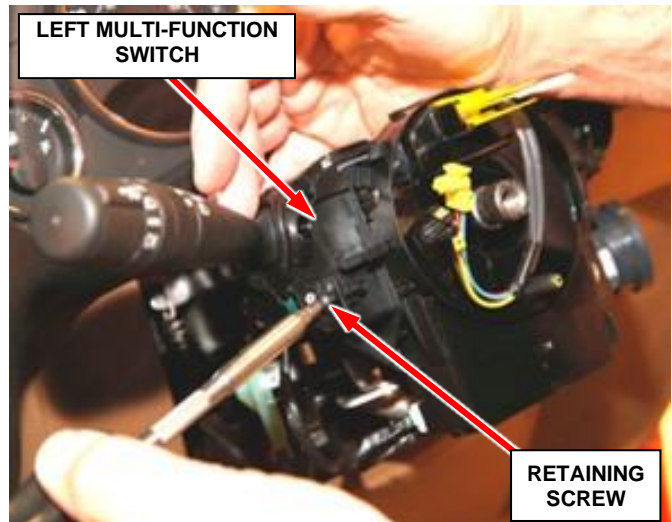
**Figure 6 – Multi-Function Switch Retaining Screw (left side switch shown)**

18. Install the left multi-function switch retaining screw. Tighten the screw to 10 in. lbs. (1 N·m) (Figure 6).

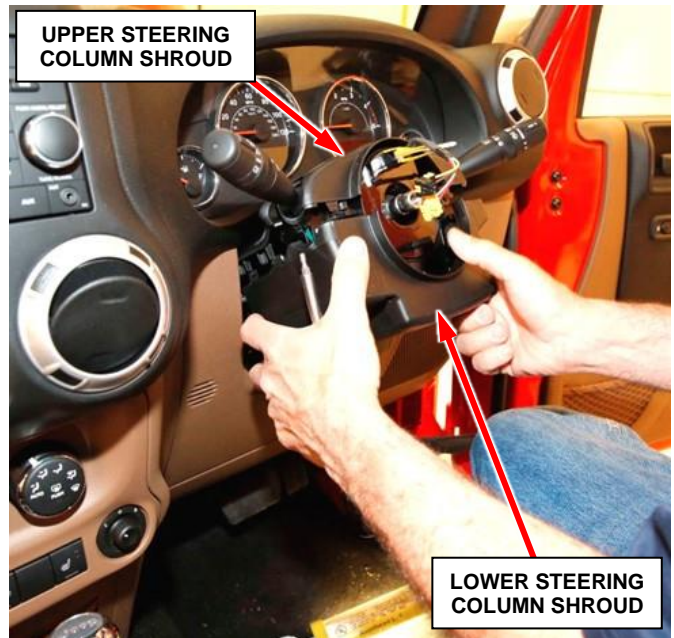
**Figure 7 – Install Steering Column Shrouds**

20. Install the new upper and lower steering column shrouds onto the steering column (Figure 7).

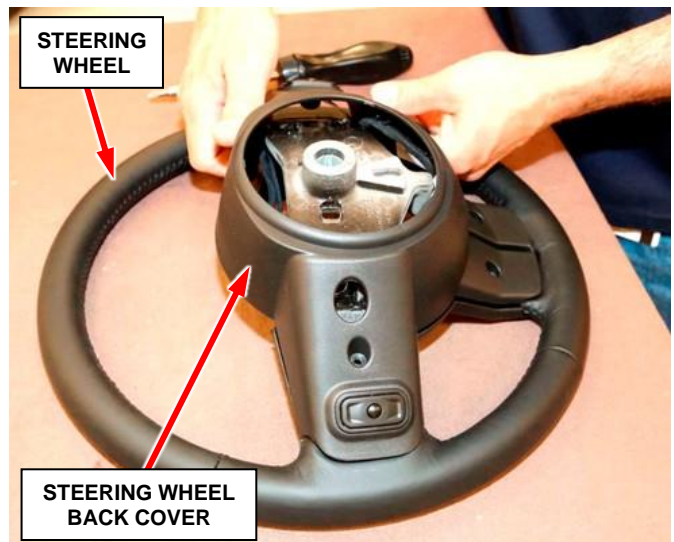
**Figure 8 – Steering Wheel Back Cover**

22. Remove and discard the original steering wheel back cover (Figure 8).

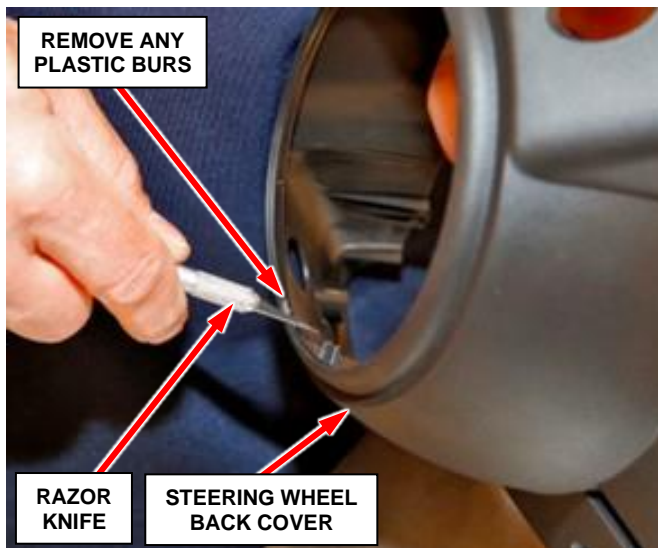
**Figure 9 – Remove any Burs from Opening**

23. Remove any burrs from the new steering wheel back cover (Figures 9 and 10).

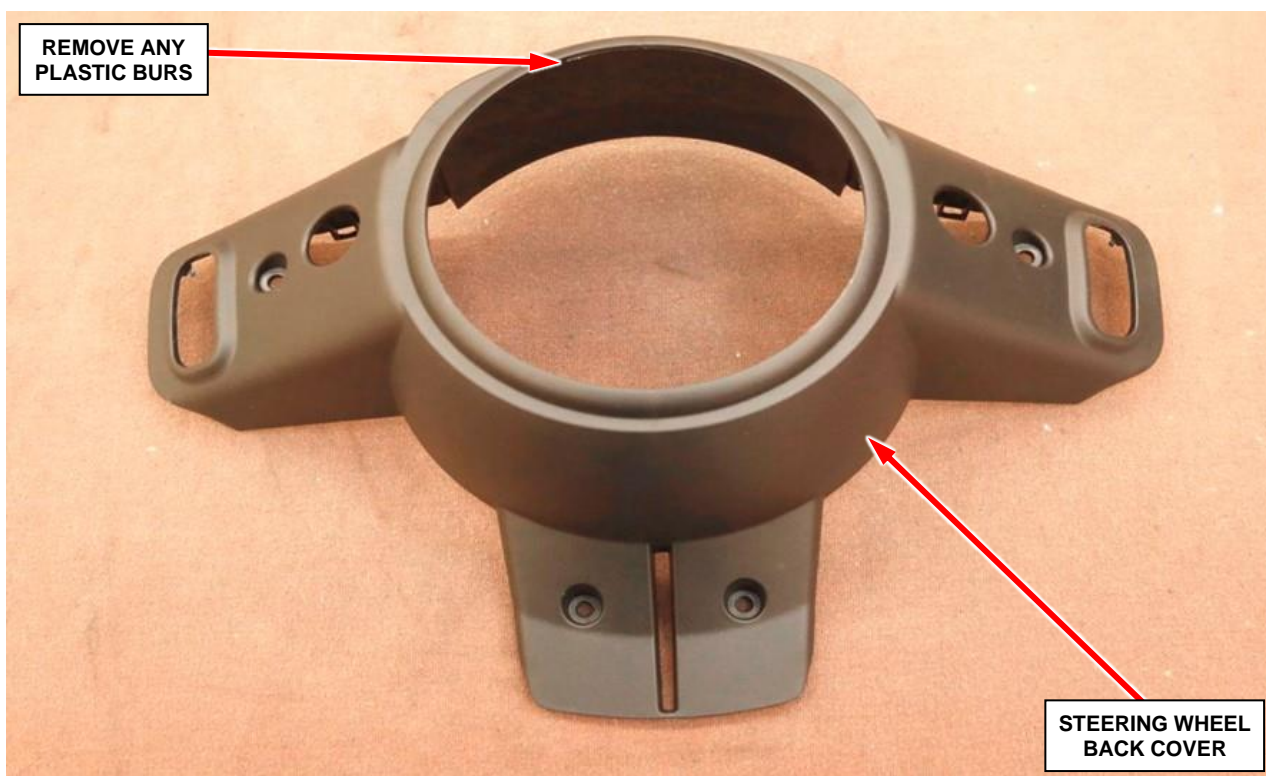
**Figure 10 – Steering Wheel Back Cover**

24. Install the new steering wheel back cover to the original steering wheel (Figure 10).

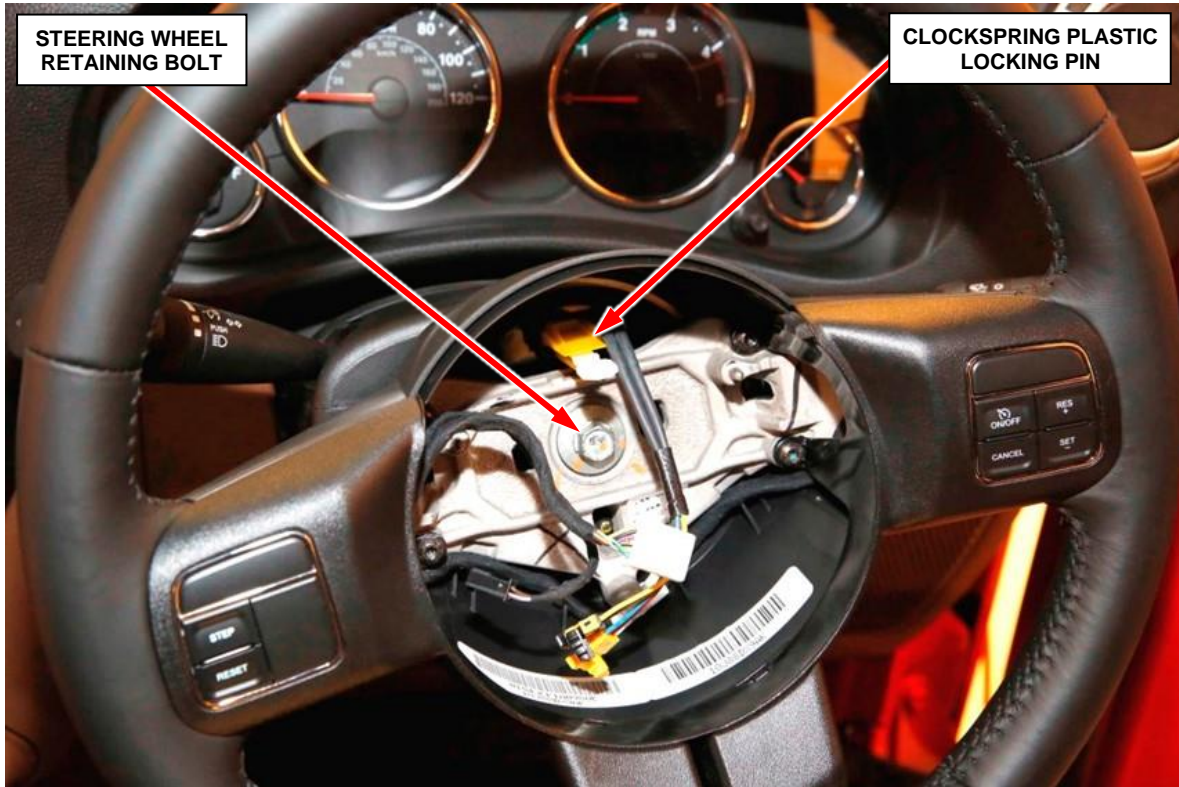
**Figure 11 – Install New Steering Wheel Retaining Bolt**

25. Install the steering wheel assembly onto the steering column.
26. Install a new steering wheel retaining bolt finger tight (Figure 11).
27. Remove and discard the plastic locking pin that secures the clockspring rotor (Figure 11 and 12).

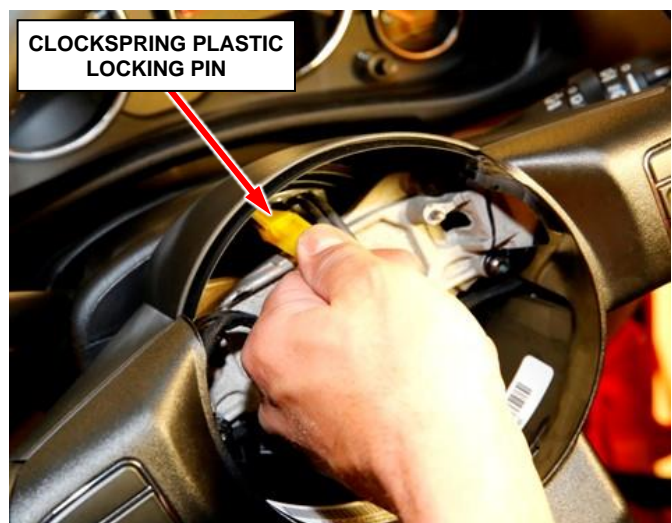
**Figure 12 – Remove Clockspring Locking Pin**

**NOTE: A service replacement clockspring is shipped with the clockspring pre centered and with a molded plastic locking pin installed. This locking pin should not be removed until the steering wheel has been installed on the steering column. If the locking pin is removed before the steering wheel is installed, the clockspring centering procedure must be performed.**

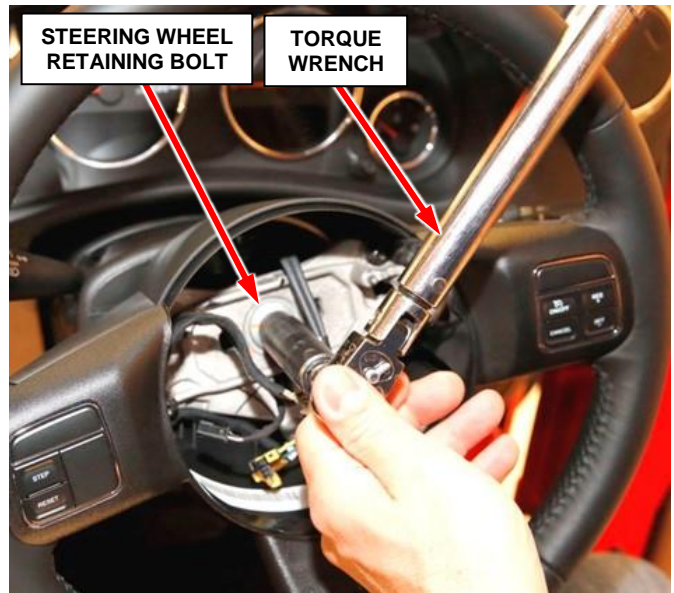
**Figure 13 – Tighten Steering Wheel Retaining Bolt to 40 ft. lbs. (54 N·m)**

28. Tighten the new steering wheel retaining bolt to 40 ft. lbs. (54 N·m) (Figure 13).
