RAM

- Remedy available for
- 2023 (DS) Ram 1500 Classic Pickup
 - 2023-2024 (D2) Ram 3500 Pickup
 - 2023-2024 (DD) Ram 3500 Cab Chassis
 - 2023 (DF) Ram 3500 10k Lb. Cab Chassis
 - 2023-2024 (DJ) Ram 2500 Pickup
 - 2023-2024 (DP) Ram 4500/5500 Cab Chassis

SAFETY RECALL
NORTH AMERICA
SCCM Internal Failure

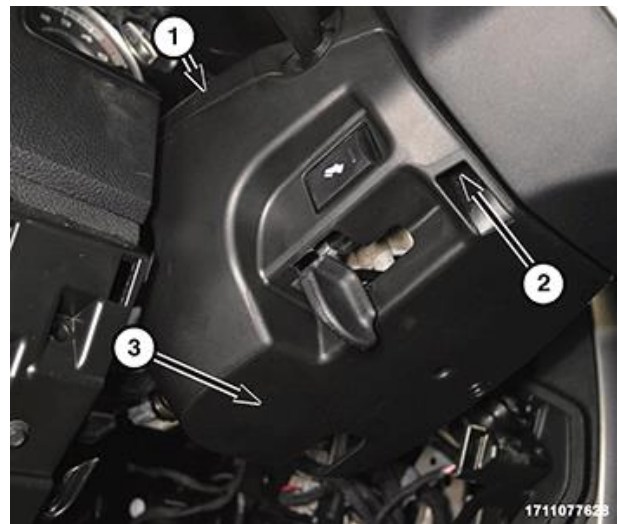
Figure 1 – Steering Column Upper Shroud

1. Place the front wheels in the straight-ahead position.
2. Disconnect and isolate the negative battery cable. If equipped with an Intelligent Battery Sensor (IBS), disconnect the IBS connector first before disconnecting the negative battery cable.
3. Wait 2 minutes for capacitor discharge.
4. From below the steering column, remove the two outboard screws within the recess areas (2) that secure the upper shroud (1) to the lower shroud (3) (Figure 1).

5. Remove the upper shroud (1) by pushing gently inward and upward on both sides of the upper shroud above the parting line of the lower shroud to release the snap features that secure the two shroud halves to each other (Figure 1).
6. Release the steering column tilt lever and lower the column to its most downward position for easiest driver airbag removal access.

21. Position the upper shroud (1) onto the steering column over the lower shroud (3) (Figure 1).
22. Align the snaps features on the upper and lower shroud halves and apply hand pressure to snap together.
23. From below the steering column, install the two outboard screws within the recess areas (2) that secure the upper shroud (1) to the lower shroud (3) (Figure 1).

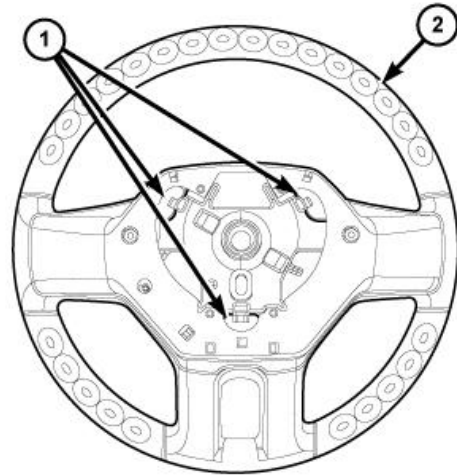
Figure 2 – Airbag Retainer Access Holes

7. There are three airbag retainer access holes (1) on the instrument panel side of the hub of the steering wheel (2), located at the two o'clock, six o'clock and ten o'clock positions. The steering wheel must be rotated to bring each of these access holes up to the twelve o'clock position of the steering column one at a time for removal access (Figure 2).

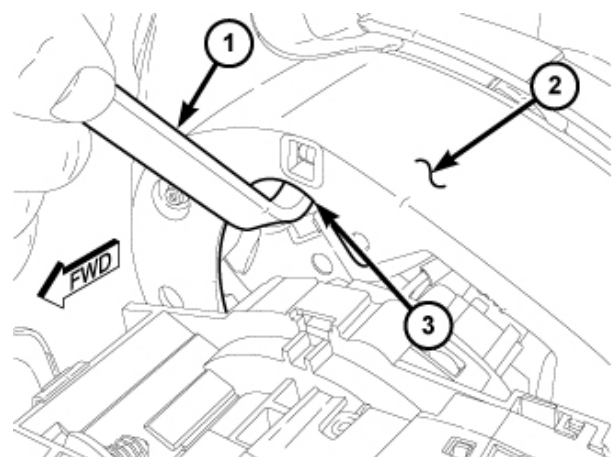
Figure 3 – DAB Removal Tool 10187

8. Insert the short blade (Tip A) of the DAB Removal Tool (Special Tool Number 10187) (1) or the blade of an equivalent prying tool into either of the upper (two o'clock or ten o'clock) access holes (3) of the steering wheel hub rear trim cover (2), being certain to place the blade of the tool on the inboard (steering wheel hub) side of the airbag snap retainer wire loop (Figure 3).

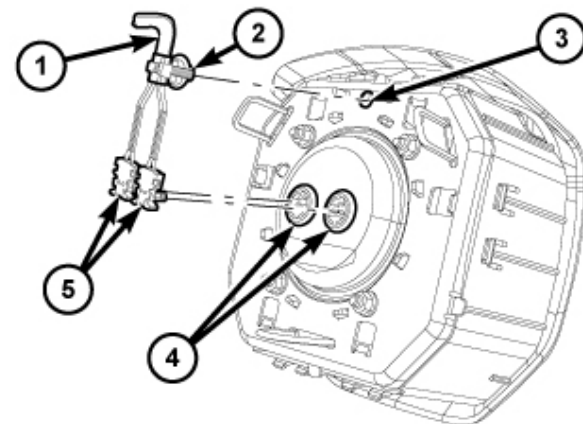
Figure 5 – Pigtail Wiring Harness Retainer

12. Pull the DAB away from the steering wheel far enough to access and disengage the plastic push-in retainer (2) of the clockspring pigtail wire harness (1) from the locator hole (3) at the 12 o'clock position on the back of the airbag housing (Figure 5).

15. Position the Driver AirBag (DAB) close enough to the steering wheel to reconnect the two clockspring DAB pigtail wire (1) electrical connections (5) to the inflator connector receptacles (4) on the back of the airbag housing (Figure 5).

17. Be certain to fully engage the plastic push-in retainer (2) of the clockspring pigtail wires into the locator hole (3) at the 12 o'clock position on the back of the airbag housing (Figure 5).

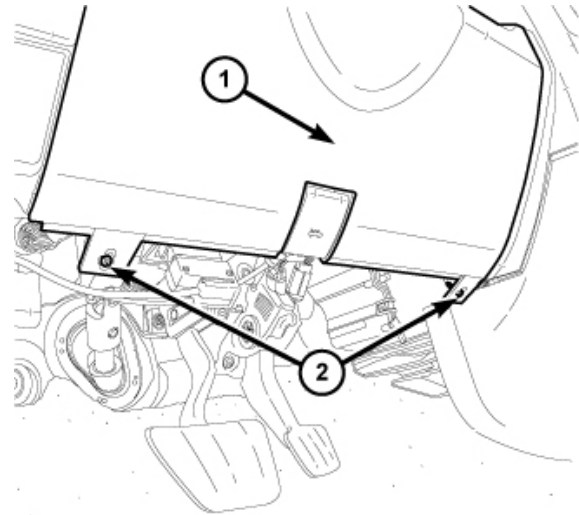
Figure 8 – Steering Column Opening Cover

18. Using a trim stick C-4755 or equivalent, disengage the retainer clip that secures the hood release to the steering column opening cover, and remove the hood release handle from the cover (Figure 8).
19. Remove the two fasteners (2) that secure the bottom of the steering column opening cover (1) to the instrument panel (Figure 8).

7. Lift the steering column opening cover into position. Connect necessary wire harness connectors.
8. Align the retainer clips that secure the steering column opening cover (1) to the instrument panel and install the cover (Figure 10).
9. Install the Data Link Connector (3) to the steering column opening cover (2) through the opening on the back side of the cover (Figure 9).
10. Install the two fasteners (2) that secure the bottom of the steering column opening cover (1) to the instrument panel and tighten securely (Figure 8).
11. Engage the retainer clip that secures the hood release to the steering column opening cover (Figure 8).

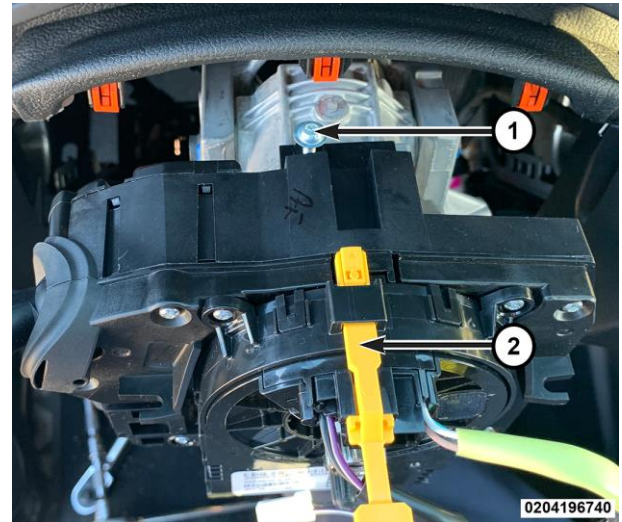
Figure 12 – SCCM Screw

24. Remove the screw (1) (Figure 12).

1. Connect the wire harness connectors (2&3) (Figure 14).
2. Secure the wire harness routing clip (1) (Figure 14).
3. While sliding the SCCM over the steering column connect the pedal adjustment wire harness connector, if equipped.
4. Install and securely tighten the screws (1) (Figures 12 & 13).
5. Remove the lock tab or any other device that is being used to secure the SCCM rotor to the SCCM case to maintain SCCM centering.

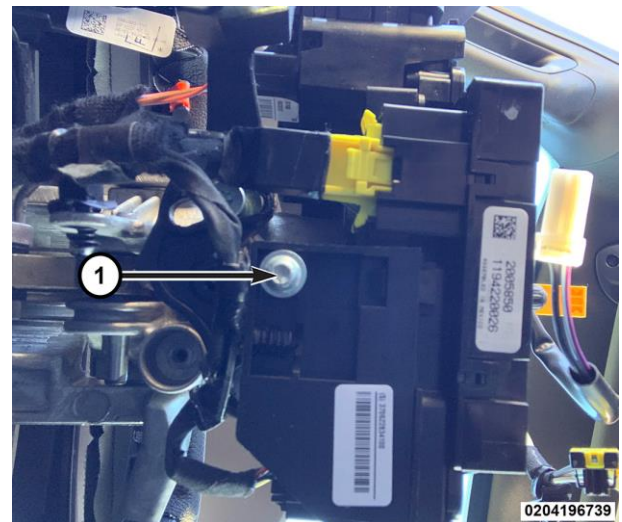
Figure 13 – SCCM Screw

25. Remove the screw (1) (Figure 13).

26. Pull the SCCM slightly away from the steering column and disconnect the pedal adjustment wire harness connector, if equipped.

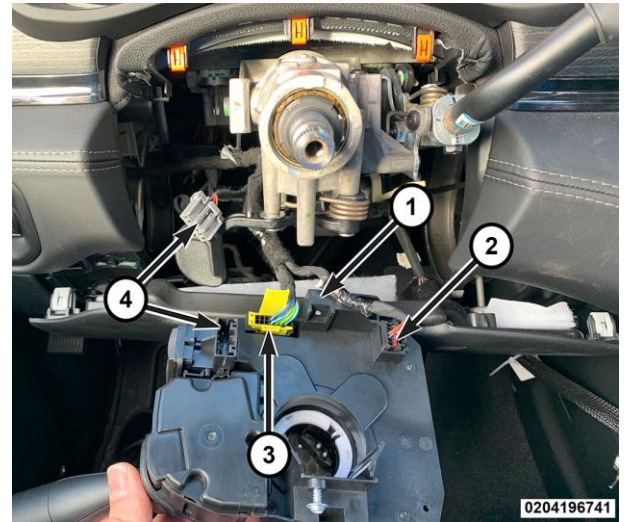
Figure 14 – SCCM Removal

27. Remove the SCCM from the steering column (Figure 14).
28. Disengage the wire harness routing clip (1) (Figure 14).
29. Disconnect the wire harness connectors (2 & 3) (Figure 14).
30. Remove and DISCARD the SCCM from the vehicle.

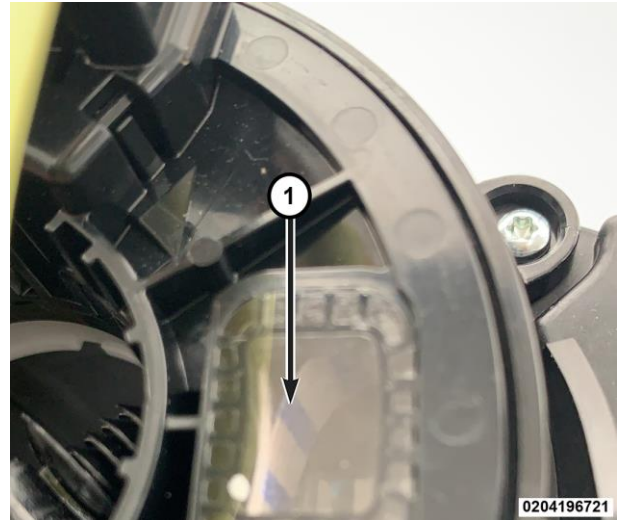
Figure 15 – Blue Stripe Ribbon

NOTE: The Steering Column Control Module (SCCM) centering can be verified by visually confirming the blue striped ribbon is present in the sight glass (Figure 15).

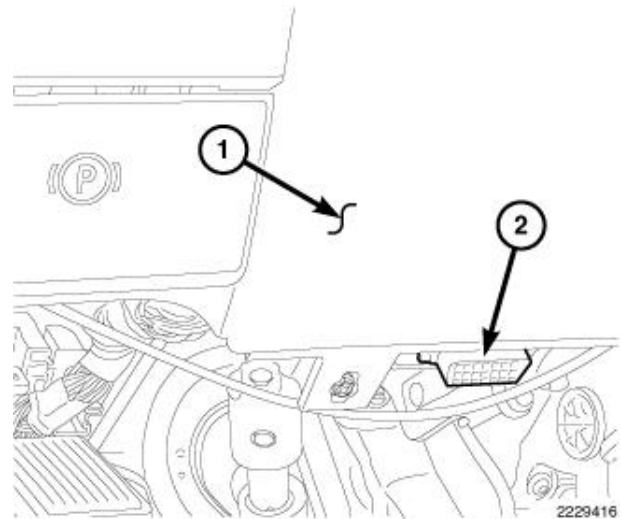
Figure 16 – DLC

25. Be certain that the diagnostic scan tool contains the latest version of the proper diagnostic software. Connect the scan tool to the 16-way Data Link Connector (DLC) (2). The DLC is located on the driver side lower edge of the instrument panel, near the steering column opening cover (1) and outboard of the steering column (Figure 16).

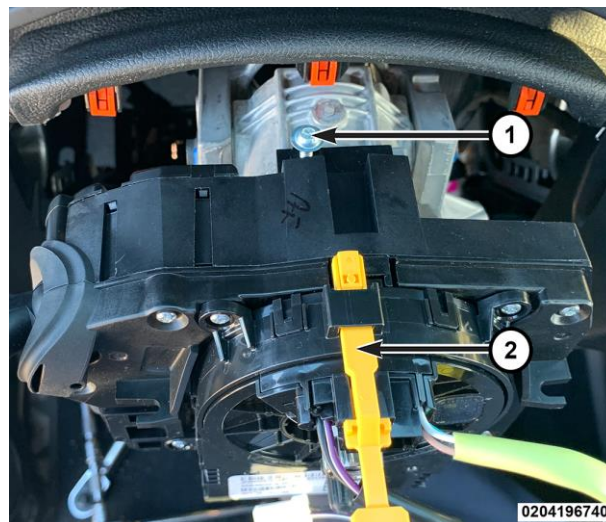
Figure 25 – SCCM

22. Secure the SCCM in the straight-ahead position.
23. Remove the screws (1) (Figure 25 and 26).

4. Install and securely tighten the SCCM screws (1) (Figure 25 and 26).
5. Position the lower steering column (1) shroud to the steering column (Figure 24).

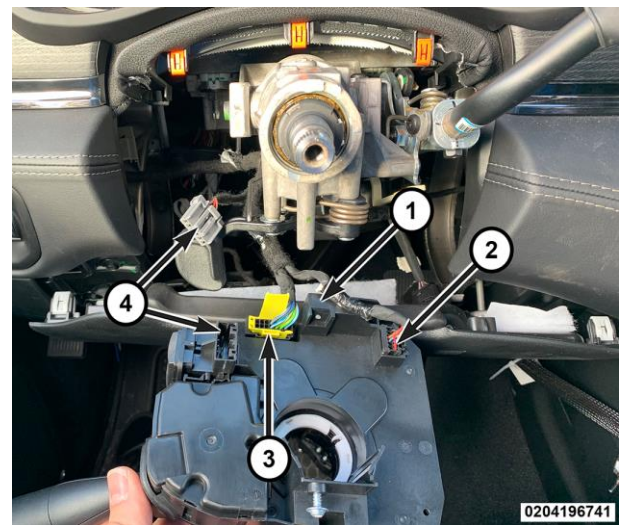
Figure 27 – SCCM

24. Pull the SCCM slightly away from the steering column and disconnect the pedal adjustment wire harness connector (4), if equipped (Figure 27).
25. Remove the SCCM from the steering column.
26. Disengage the wire harness routing clip (1) (Figure 27).
27. Disconnect the wire harness connectors (2 & 3) (Figure 27).

1. Connect the wire harness connectors (2 & 3) (Figure 27).
2. Secure the wire harness routing clip (1) (Figure 27).
3. While sliding the **NEW** SCCM over the steering column connect the pedal adjustment wire harness connector.
