GROUP	MODEL
Safety Recall Campaign	2022-2024MY EV6, EV6 GT (CV)
NUMBER	DATE
SC302 (Rev 2, 06/20/2024)	May 2024

ICCU AND FUSE INSPECTION/REPLACEMENT AND ICCU SOFTWARE UPGRADE (SC302)

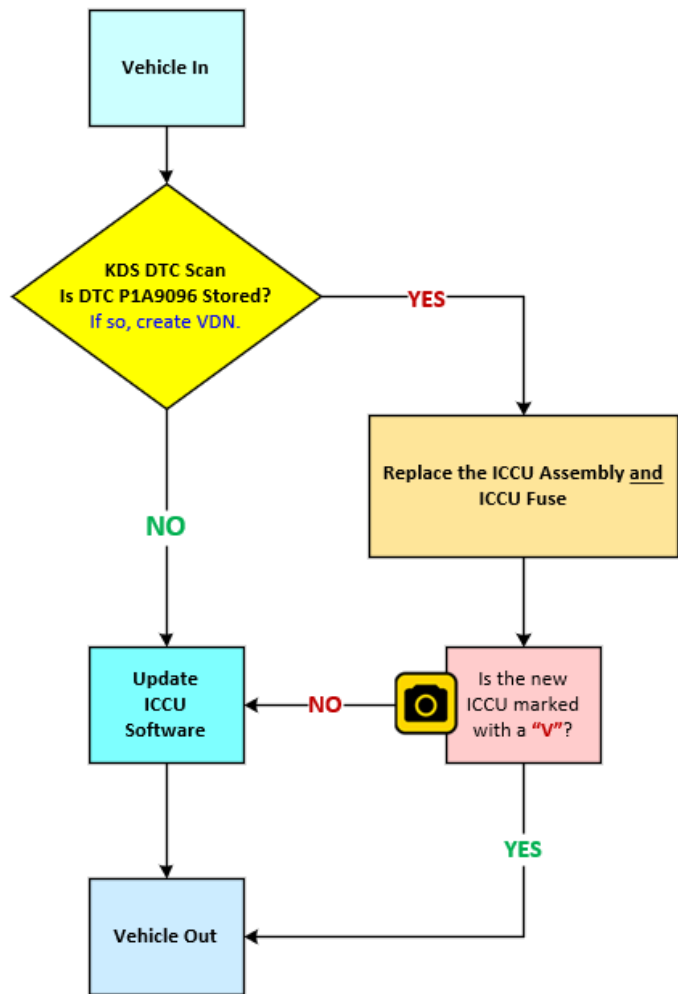
Flowchart:

Using KDS, scan the vehicle for DTC P1A9096 - Is DTC stored?

- If DTC is not stored, update the ICCU software (Pages 3-4).
- If DTC is stored, replace the ICCU Assembly + ICCU Fuse (Page 5)

DTC P1A9096 Stored + ICCU Assembly and ICCU Fuse Replacement

Is the 'new' ICCU Assy marked with a letter "V"?

- No - Take a KVID photo of ICCU marked "V" + Update the ICCU software (Pages 3-4)
- Yes - Vehicle Out

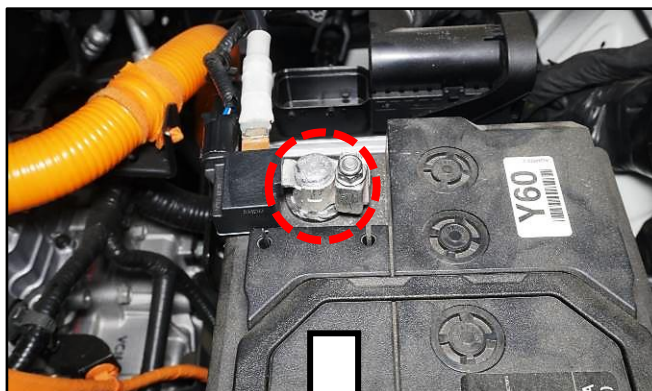
2. Open the hood and disconnect the battery negative (-) post cable.

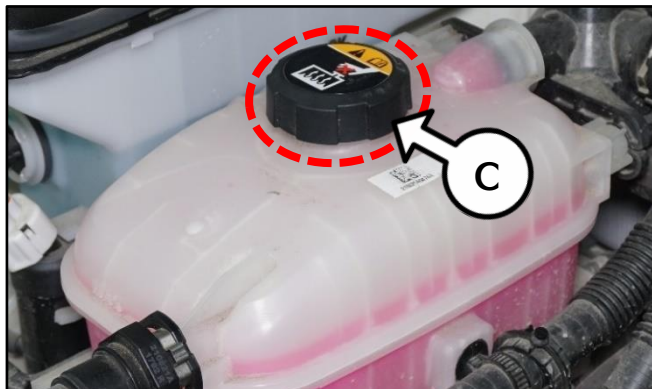
4. Open the coolant reservoir tank pressure cap (C) to release pressure.

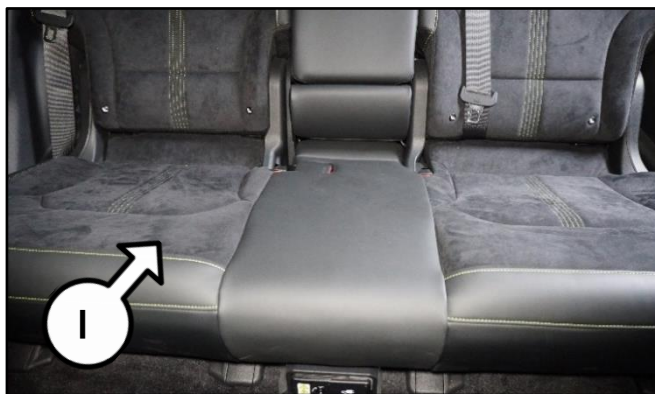
11. Remove the rear seat assembly (I) by referring to "Body Interior and Exterior → Rear Seat Assembly → Removal and Installation" in the applicable Shop Manual on KGIS.

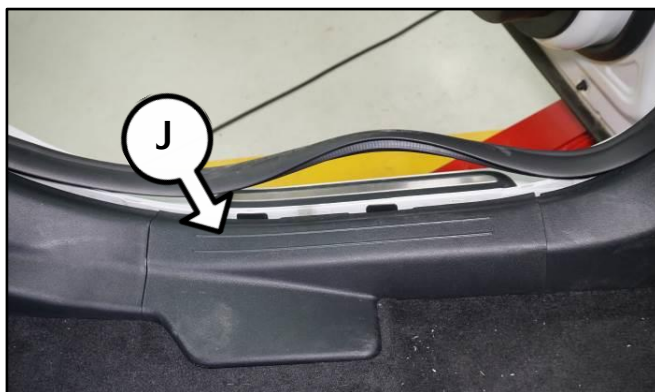
12. Remove the left (LH) and right (RH) side rear door scuff trim (J).

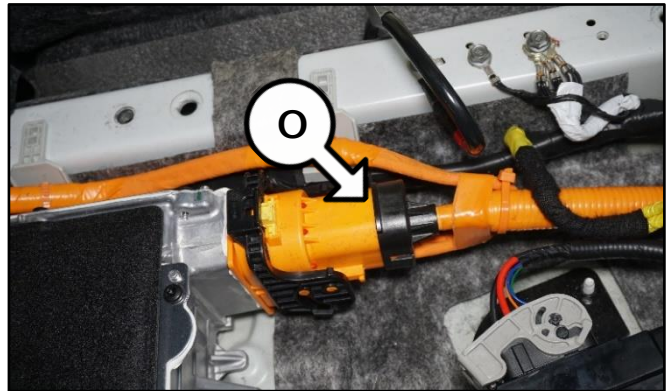
- 17. Disconnect the combo charge inlet wire harness connector (O).

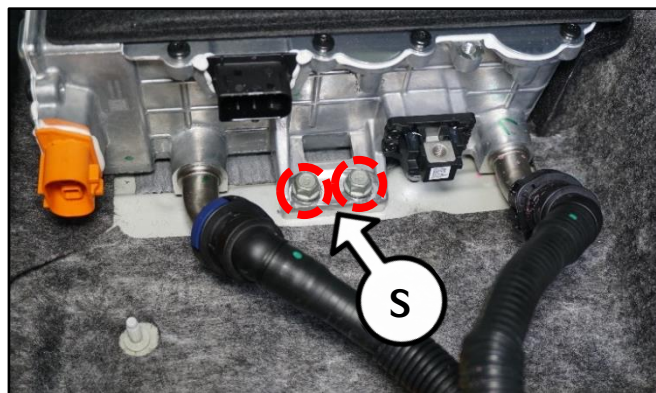
19. Remove the two (2) ICCU assembly retaining bolts (S).

Tightening torque for bolts (V):
5.8 - 8.7 lb.ft (7.8 - 11.8 N.m)
