## PRODUCT CAMPAIGN BULLETIN

**APPLICABILITY:** 2020-2022 MY Legacy  
2020-2022 MY Outback

**NUMBER:** WRA-24R

**SUBJECT:** Safety Recall – ODS Sensor Replacement

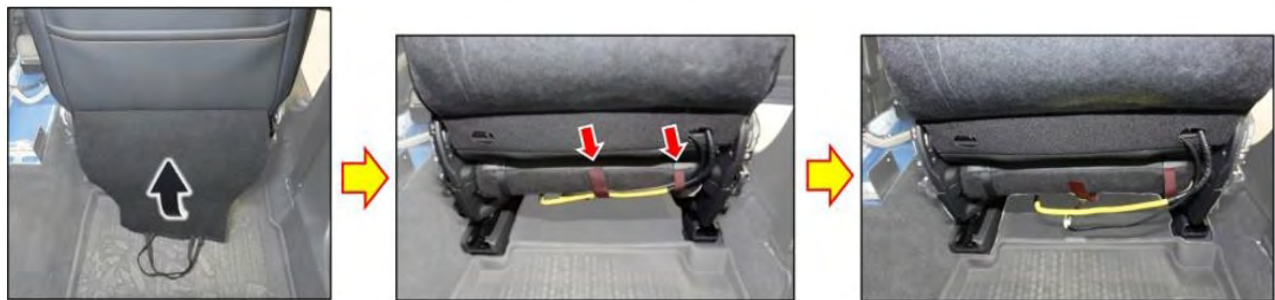
**STEP 12:** Tuck the hanging section of the cover into the rear pocket of the seat. Release the two Velcro straps and free the two harness sections.

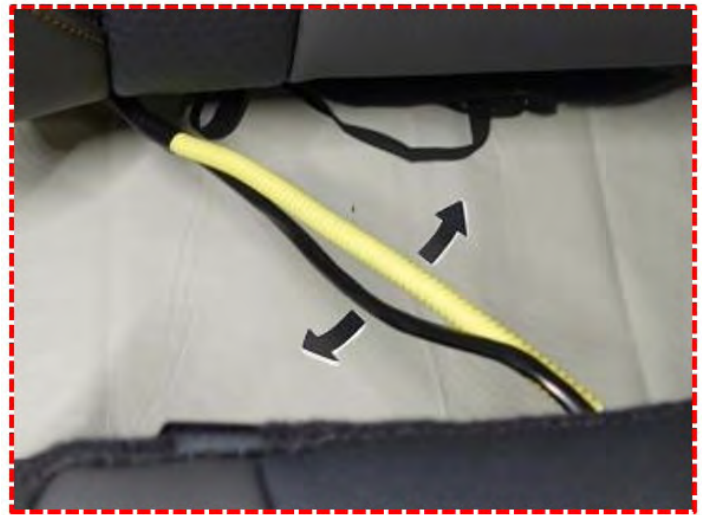
**CAUTION:** Confirm the harness section does not have any excessive tension and is free from pinching of any kind.

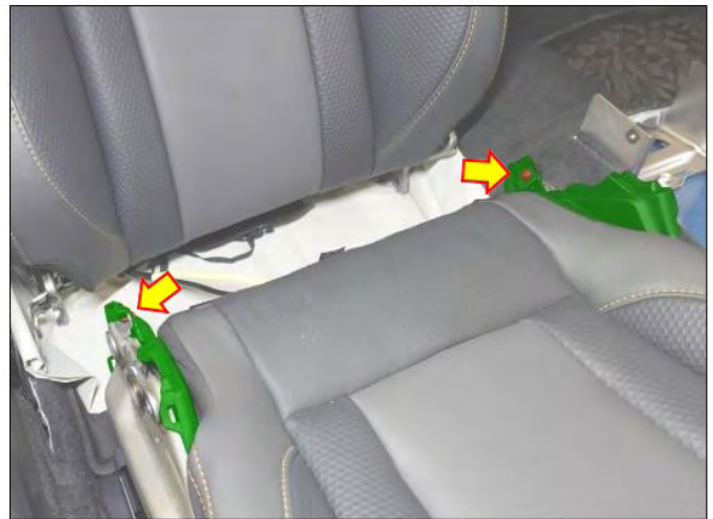
**STEP 14:** Remove both mounting screws for the inner cushion covers.

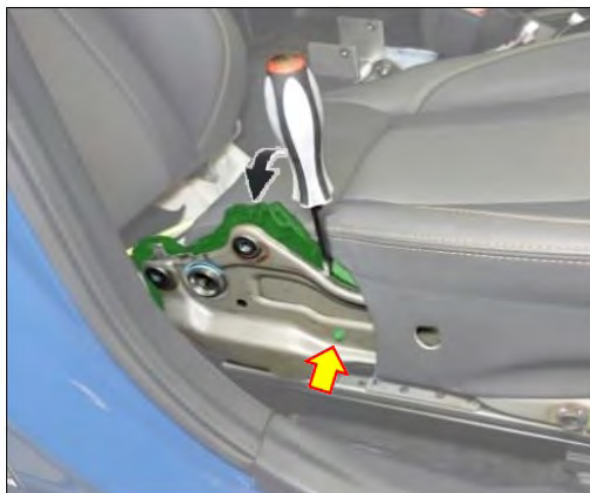
**STEP 15:** Starting with the outside cover, release the mounting clip using a large flat blade screwdriver or suitable plastic trim tool.

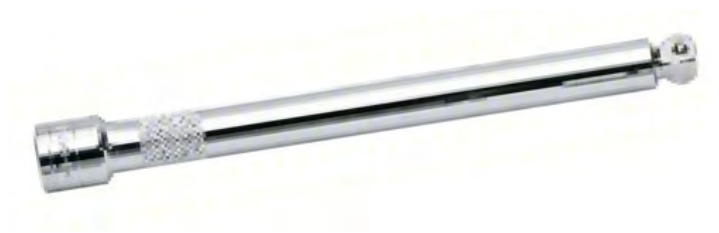
**STEP 18:** Remove the four 14mm (M10) nuts securing the cushion frame. The front nuts can be removed using an offset boxed wrench. The rear nuts can be removed with a 14mm socket, 3/8 in drive ratchet, and 3/8 in drive wobble extension. The nuts can be discarded after removal.

**CAUTION:** Avoid touching the seat adjustment lever with mounting nuts removed. This may cause the left and right rails to become misaligned and difficult to reassemble.

**NOTE:** Snap-on® tool # **FXWK8** is an example of a wobble extension suitable for usage.

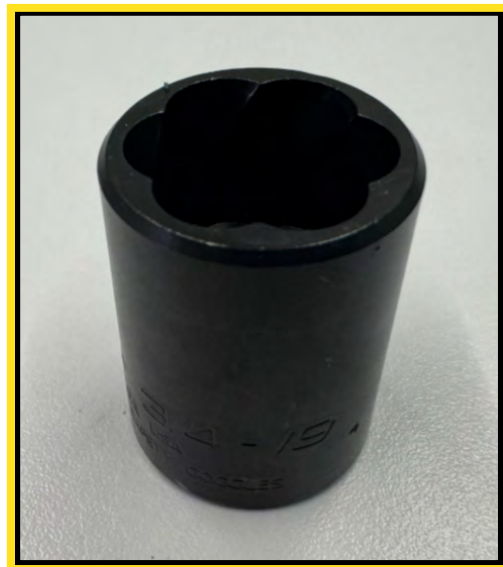
Attach a 19mm twist socket and ratchet to the bottom portion of the stud to prevent it from spinning, then remove the nut securing the ODS sensor to the seat bottom.

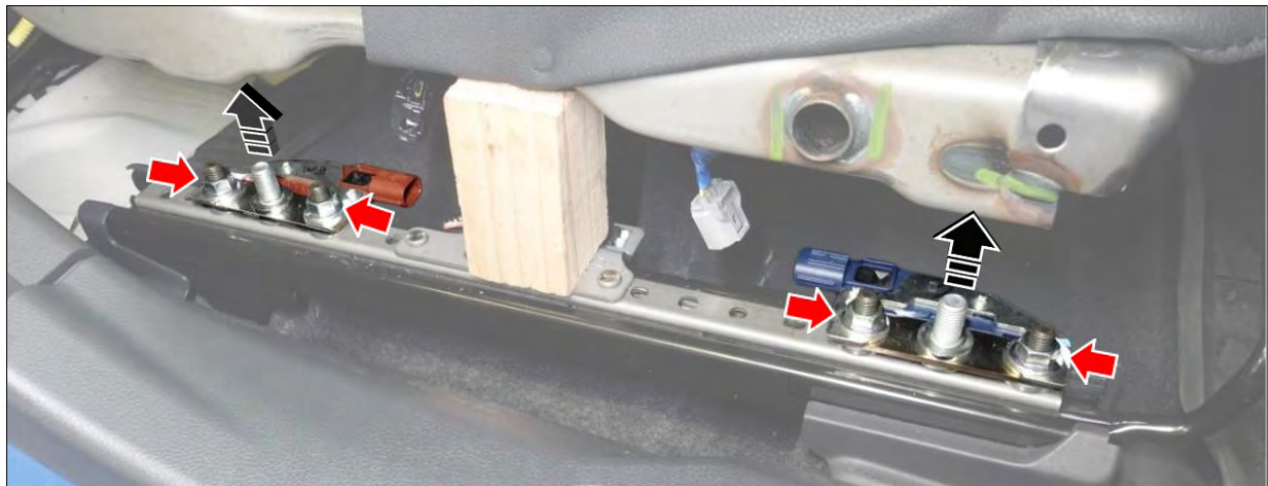
**STEP 20:** Remove and discard the four 12mm (M8) sensor mounting nuts. The two sensors can then be removed and discarded.

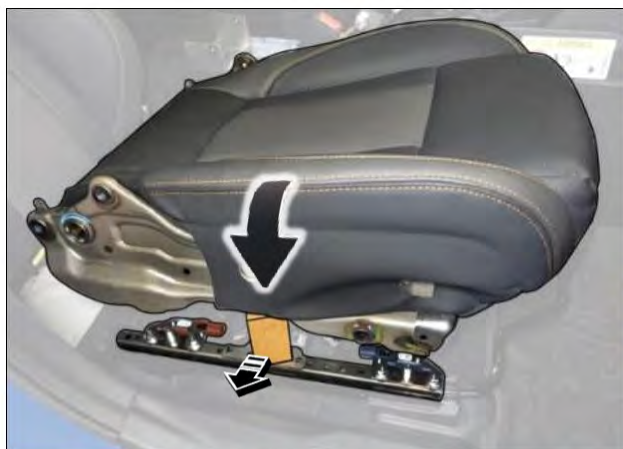
**STEP 22:** Remove the block and CAREFULLY lower the cushion frame.

**NOTES:**

- Slowly lower the cushion while monitoring the bolt of the sensor and the insertion hole of the cushion frame.
- Do not secure the seat until the inner sensor has been replaced.

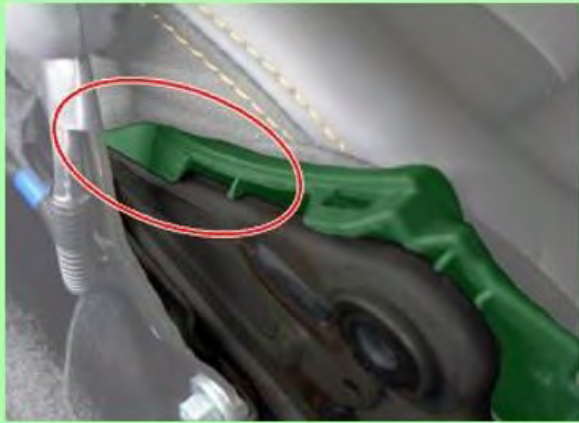
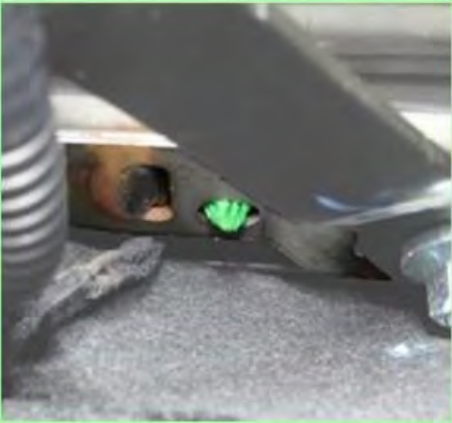
| | Mounting condition of the cover | Clip Position |
|---|---|---|
| ✓ | A close-up photograph showing a green plastic cover being mounted onto a metal frame. A red oval highlights the correct placement of the cover's edge against the frame. | A close-up photograph of a green plastic clip being inserted into a slot on a metal frame. The clip is shown in its correct, seated position. |

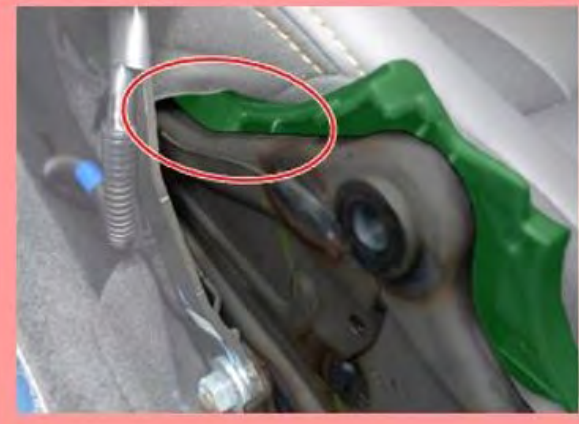
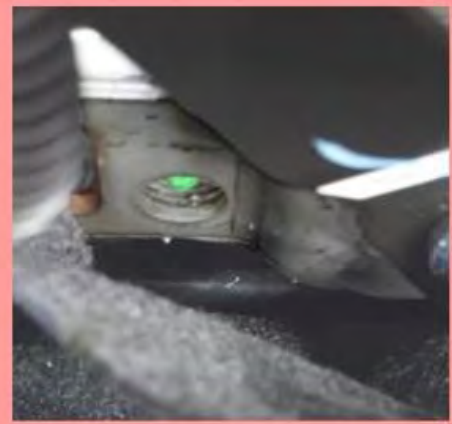
| | Mounting condition of the cover | Clip Position |
|---|---|---|
| X | A close-up photograph showing a green plastic cover being mounted onto a metal frame. A red oval highlights the incorrect placement of the cover's edge, which is not fully seated against the frame. | A close-up photograph of a green plastic clip being inserted into a slot on a metal frame. The clip is shown in an incorrect position, not fully seated in the slot. |

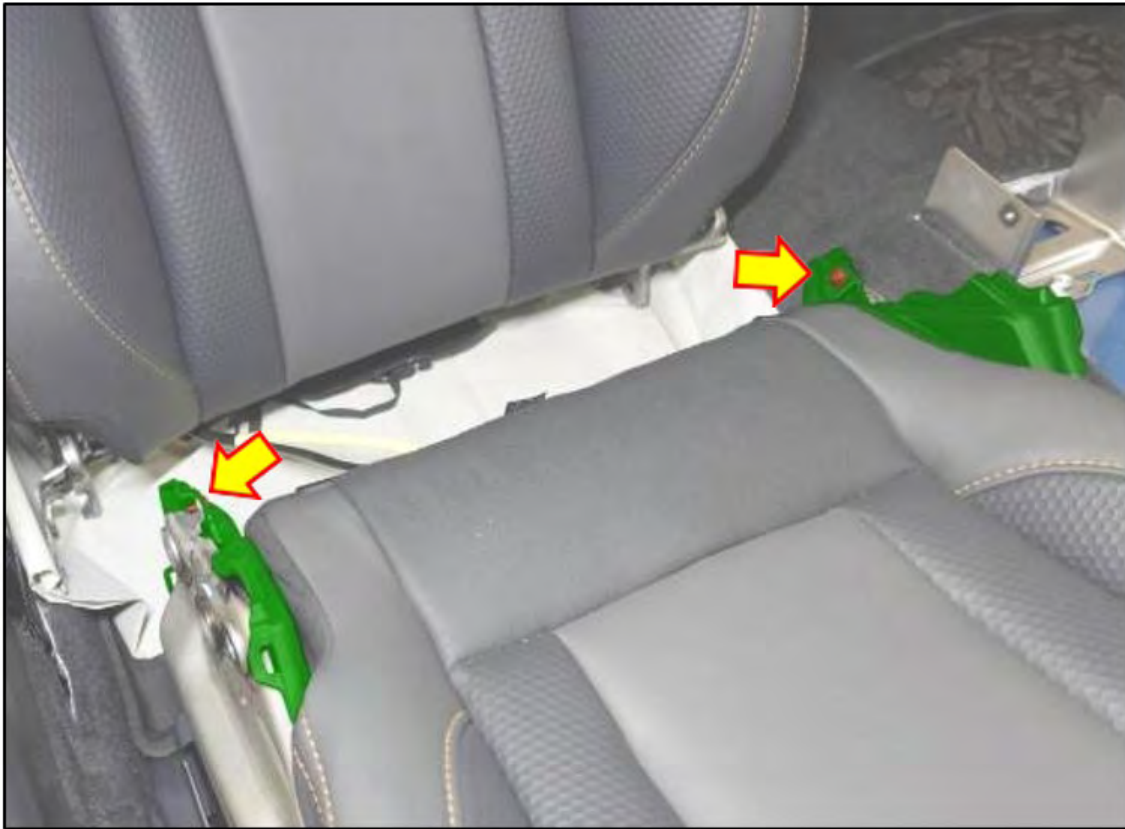
**STEP 31:** Reinstall the two mounting screws for the inner cushion covers.

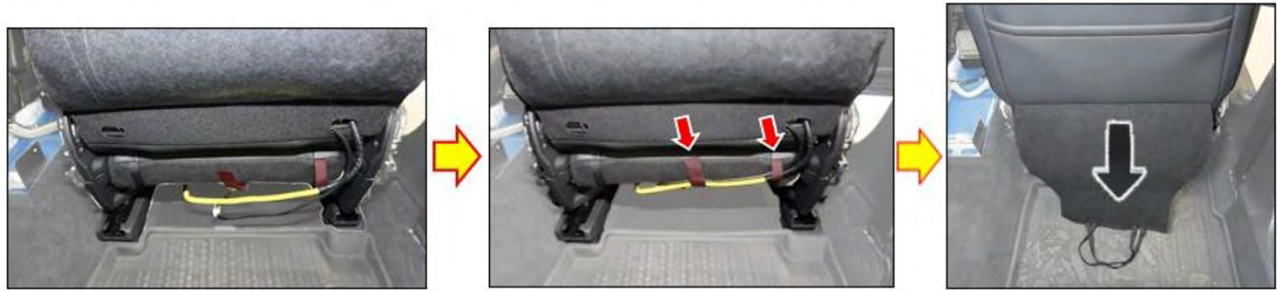
**STEP 33:** Secure the two Velcro straps and harness sections. Untuck the hanging section of the cover from the rear pocket of the seat.

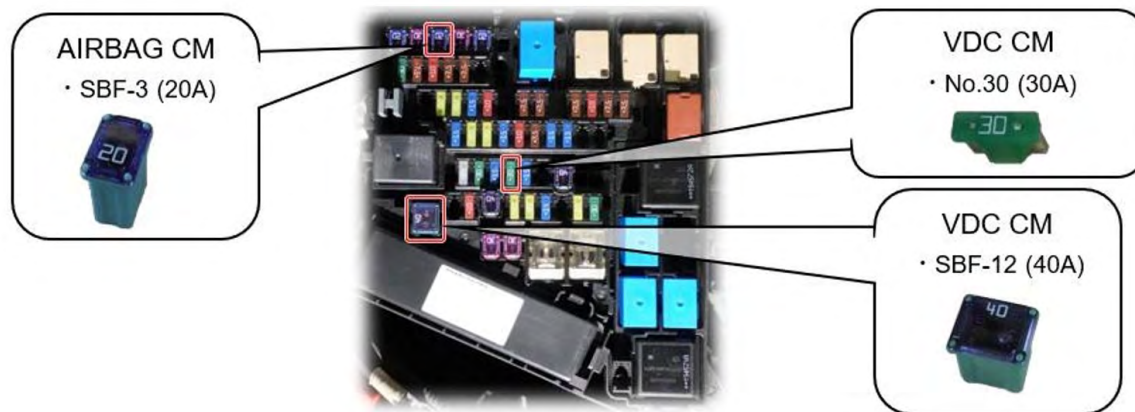
**STEP 36:** Reinstall the center console and gear selector cover.

**STEP 37:** Reinstall the fuses.

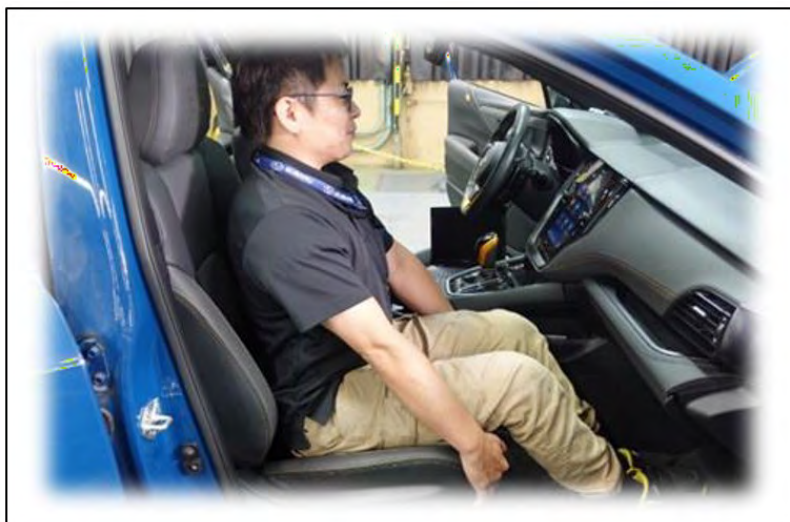
**STEP 38:** Sit on the front passenger seat and slightly move around while adjusting the positions.

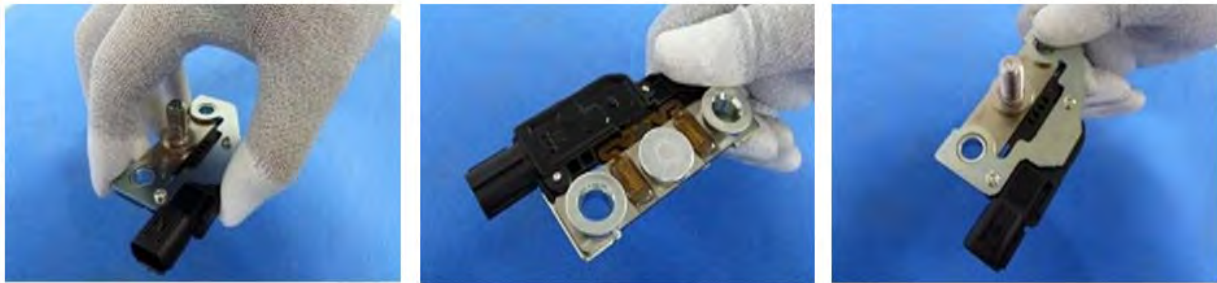
### EXAMPLES OF PROPER SENSOR HANDLING:

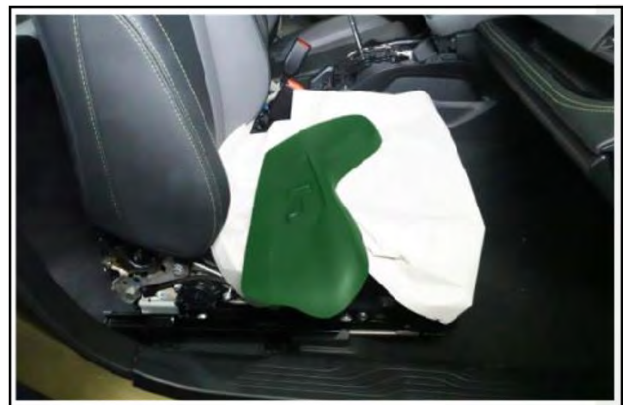
**STEP 10:** Release the rear section of the seat side cover. With all the holding clips released, the cover can then be removed by pulling towards the front of the vehicle. There is no need to disconnect the switch/harness. The cover can be placed on top of the seat. A clean fender cover or cloth can be used for seat protection.

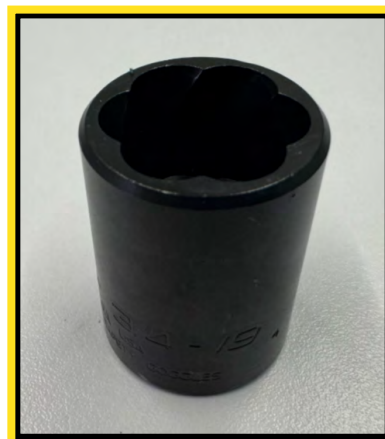
Attach a 19mm twist socket and ratchet to the bottom portion of the stud to prevent it from spinning, then remove the nut securing the ODS sensor to the seat bottom.

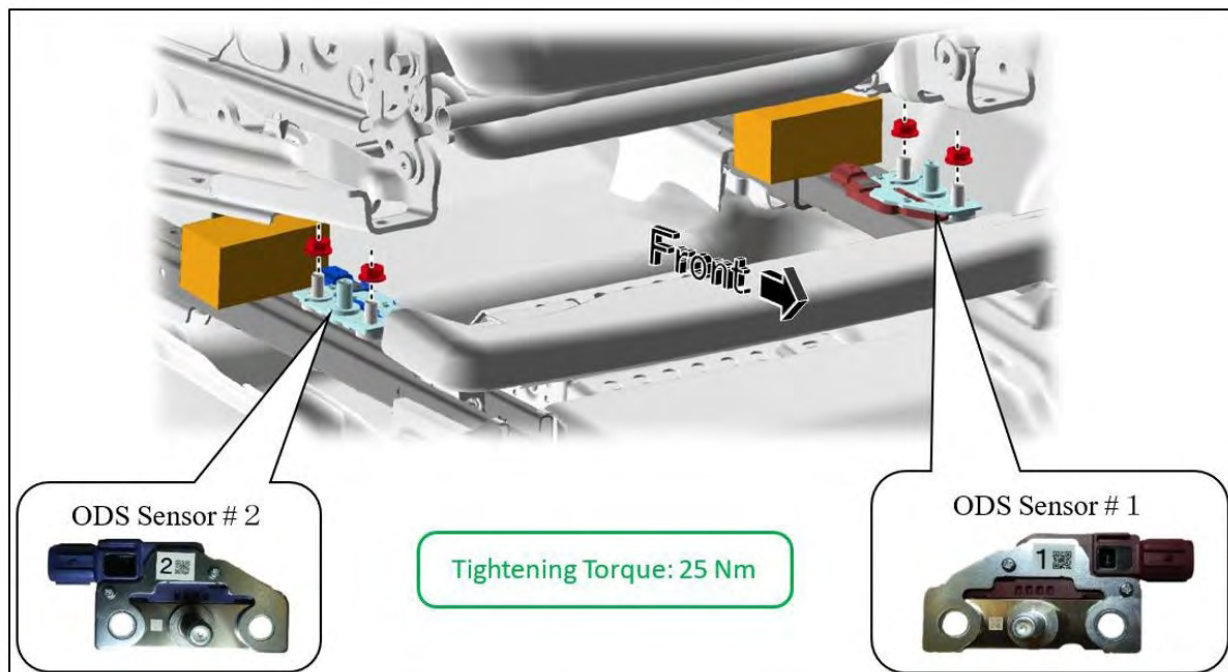
**STEP 17:** Confirm the identification numbers of the NEW Occupant Detection Sensors are #1 and #2. Mount the #1 (**Brown**) sensor to the inner front position and the #2 (**Blue**) sensor to the outer front position. Torque the NEW sensor mounting nuts (p.n. 64157AN02A) to 25Nm (18.5ft-lbs).

**NOTE:** Take special care in handling the new sensors.

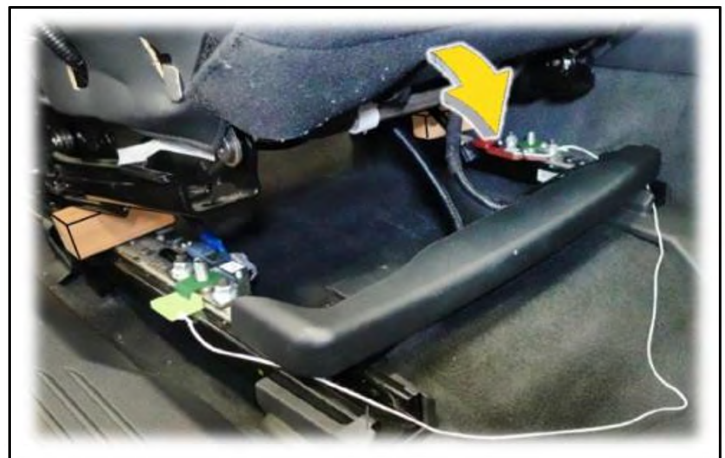
**STEP 19:** Tuck the connector of sensor sensors into the cushion frame. Remove the blocks and CAREFULLY lower the cushion frame.

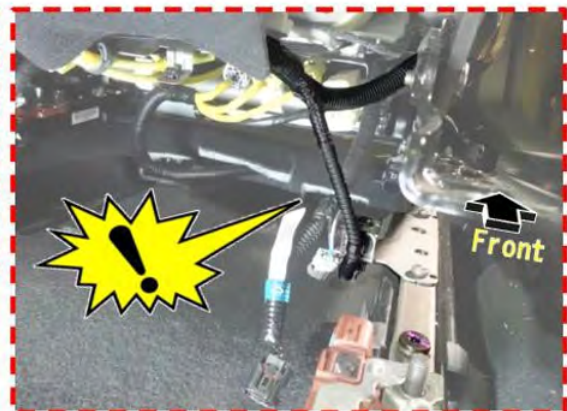
**STEP 21:** CAREFULLY raise the rear of the seat assembly 35-40mm (1.4 to 1.6 inch). Insert both of the pre-prepared blocks between the cushion frame and the seat rail.

- DO NOT damage the slide sensor when inserting the block into the outer rail.
- Pay close attention to the seat harness when lifting the cushion frame. Excessive tension may cause damage to the harness.

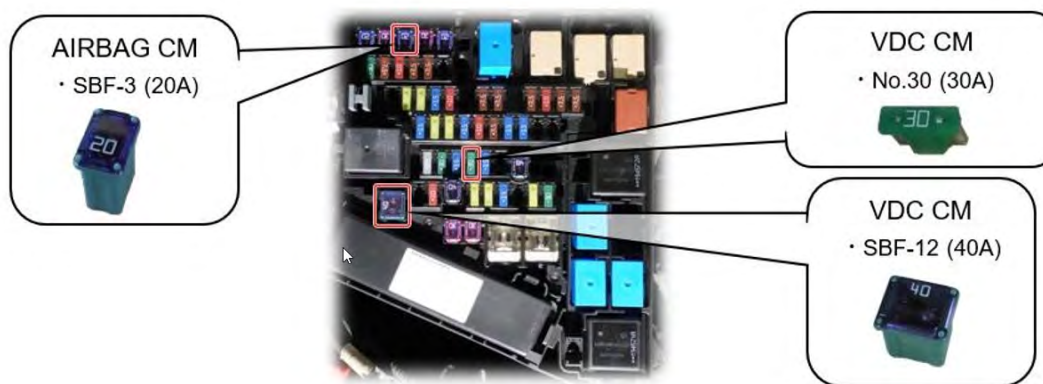
**STEP 34:** Reinstall the fuses.

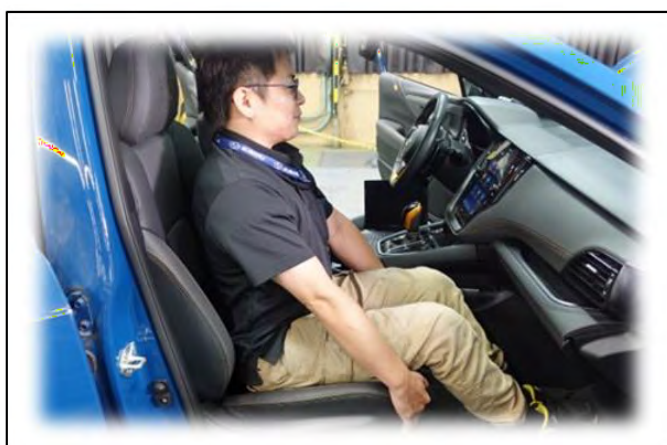
**STEP 35:** Sit on the front passenger seat and slightly move around while adjusting the positions.
