PRODUCT CAMPAIGN BULLETIN

NUMBER: WRA-24

SUBJECT: Safety Recall – ODS Sensor Replacement

Subaru of America, Inc. (Subaru) has initiated a safety recall for certain 2020-2022 model year Legacy and Outback vehicles to replace all (four) of the Occupant Detection System (ODS) sensors on the front passenger seat.

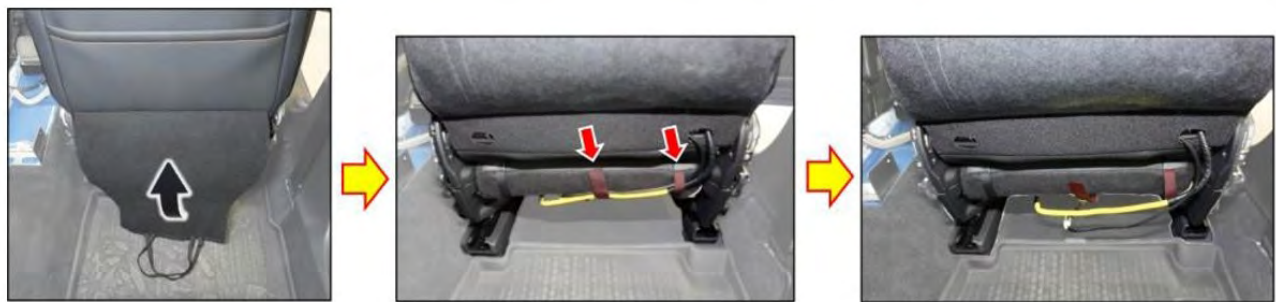
STEP 12: Tuck the hanging section of the cover into the rear pocket of the seat. Release the two Velcro straps and free the two harness sections.

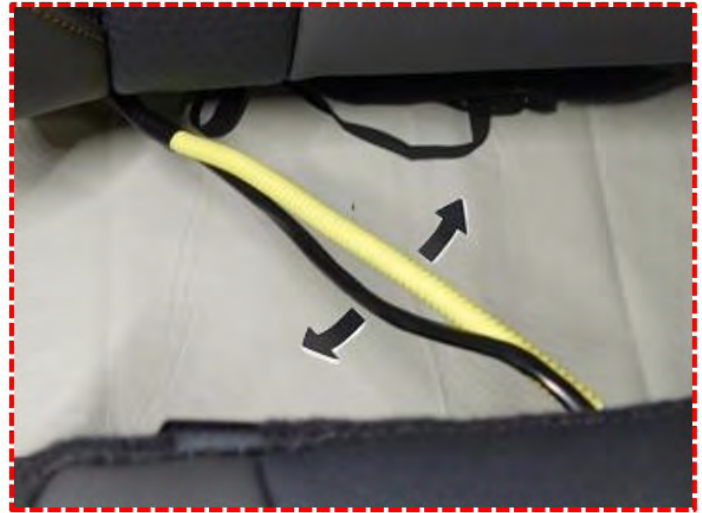
CAUTION: Confirm the harness section does not have any excessive tension and is free from pinching of any kind.

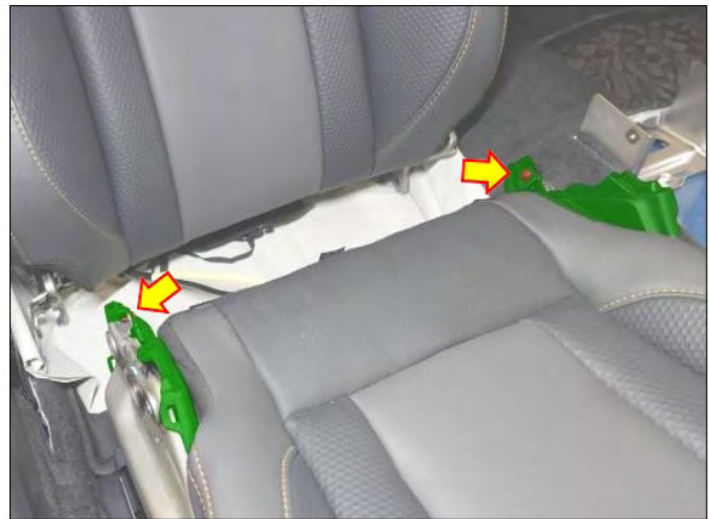
STEP 14: Remove both mounting screws for the inner cushion covers.

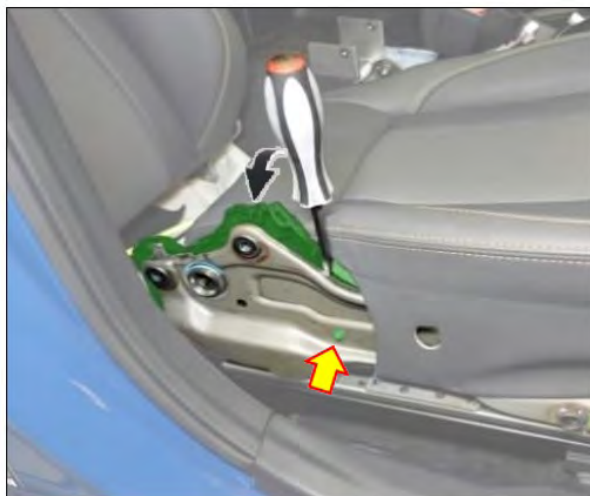
STEP 15: Starting with the outside cover, release the mounting clip using a large flat blade screwdriver or suitable plastic trim tool.

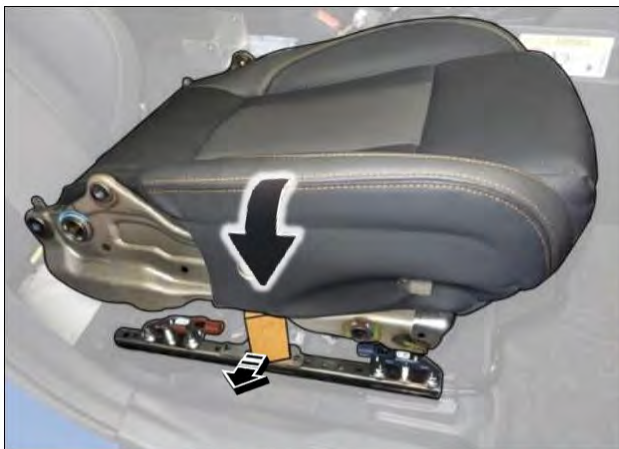
STEP 22: Remove the block and CAREFULLY lower the cushion frame.

- Slowly lower the cushion while monitoring the bolt of the sensor and the insertion hole of the cushion frame.
- Do not secure the seat until the inner sensor has been replaced.

BE CAREFUL not to pinch the connectors when lowering the cushion.

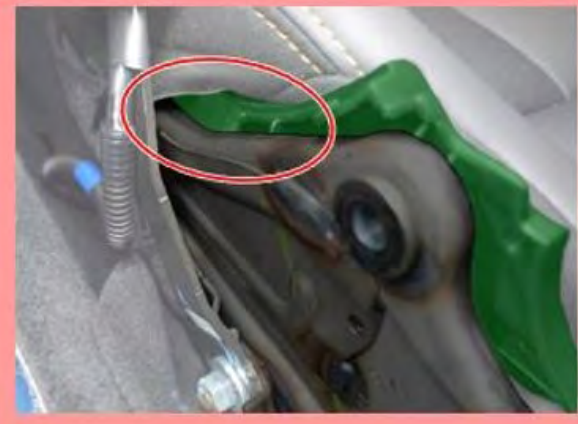
<p>A close-up photograph showing the green clip from the cover correctly engaged with a metal component. The clip is fully seated, and a green light is visible, indicating a proper connection.</p>
✗

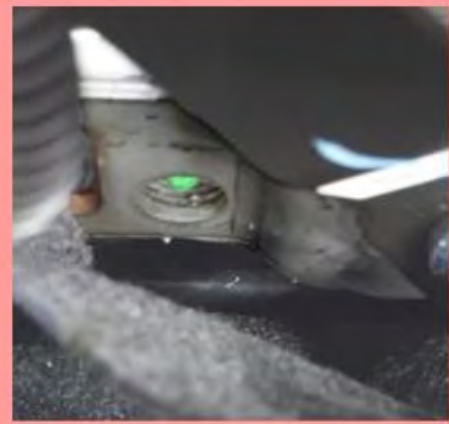
<p>A close-up photograph showing the green plastic cover incorrectly mounted. A red oval highlights the green clip, which is not properly engaged with the metal component.</p>

<p>A close-up photograph showing the green clip from the cover not properly engaged with the metal component. The clip is partially seated, and a green light is visible, indicating an incorrect connection.</p>

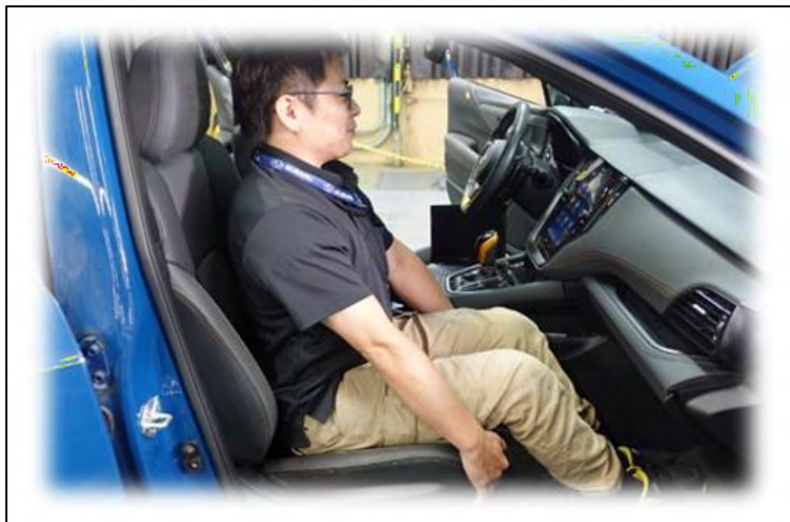
STEP 38: Sit on the front passenger seat and slightly move around while adjusting the positions.

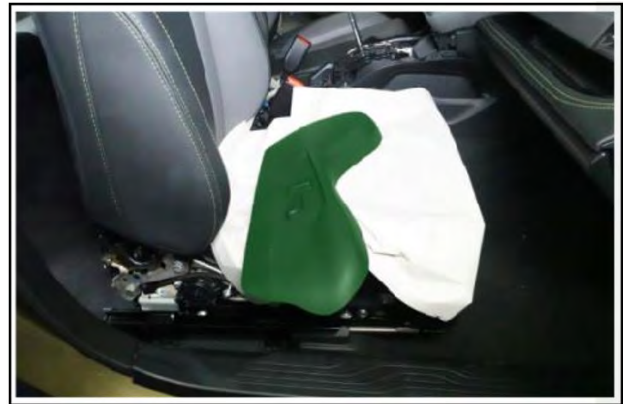
STEP 10: Release the rear section of the seat side cover. With all the holding clips released, the cover can then be removed by pulling towards the front of the vehicle. There is no need to disconnect the switch/harness. The cover can be placed on top of the seat. A clean fender cover or cloth can be used for seat protection.

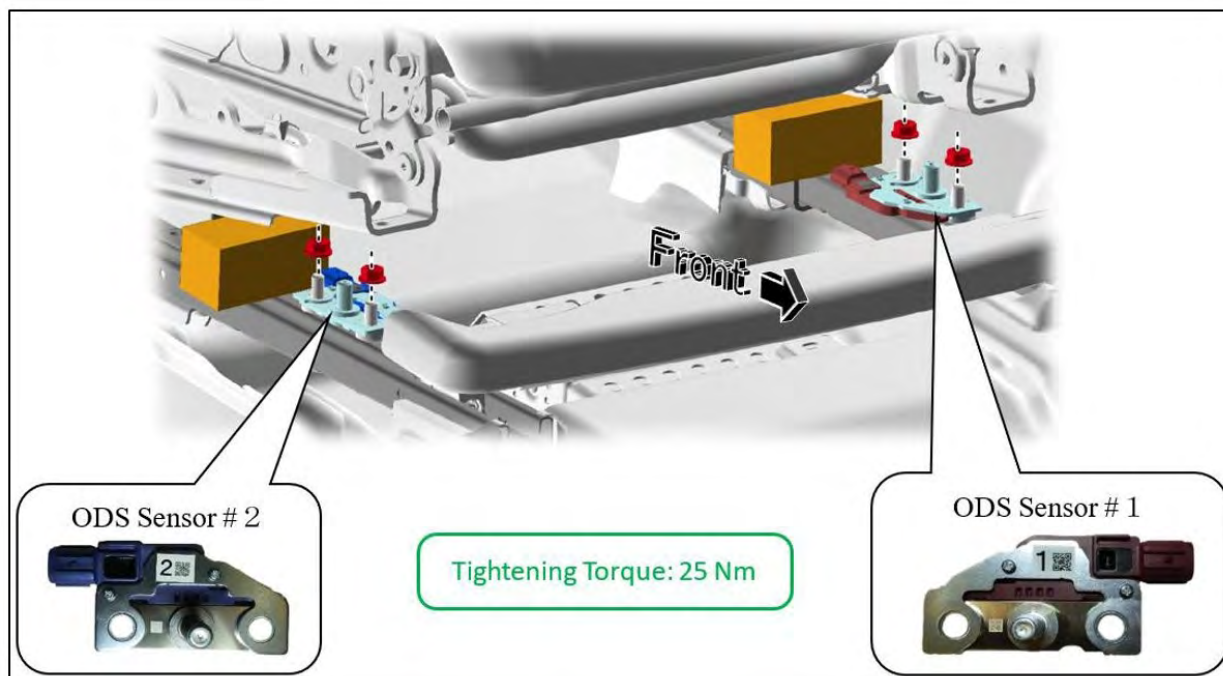
STEP 17: Confirm the identification numbers of the NEW Occupant Detection Sensors are #1 and #2. Mount the #1 (**Brown**) sensor to the inner front position and the #2 (**Blue**) sensor to the outer front position. Torque the NEW sensor mounting nuts (p.n. 64157AN02A) to 25Nm (18.5ft-lbs).

NOTE: Take special care in handling the new sensors.

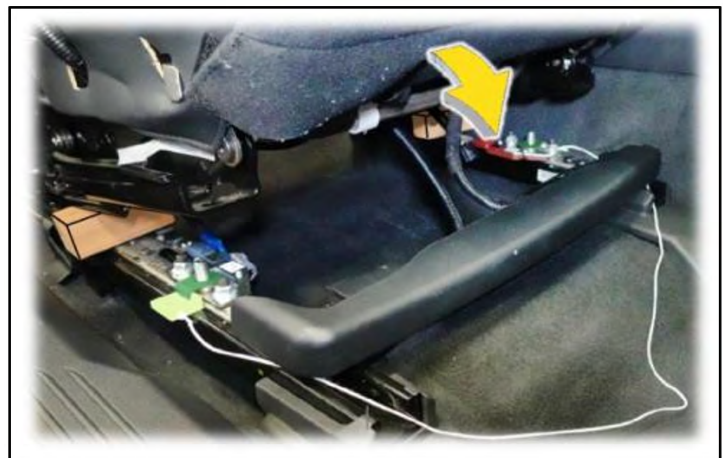
STEP 19: Tuck the connector of sensor sensors into the cushion frame. Remove the blocks and CAREFULLY lower the cushion frame.

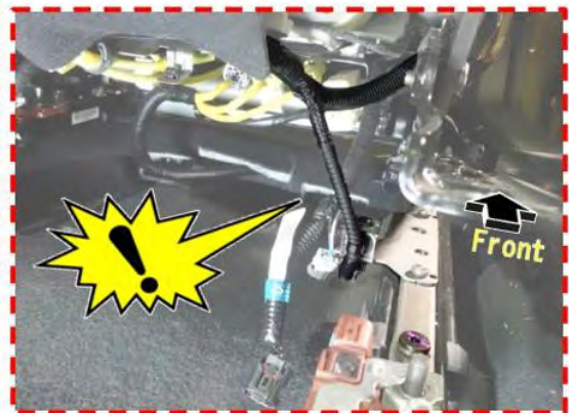
STEP 21: CAREFULLY raise the rear of the seat assembly 35-40mm (1.4 to 1.6 inch). Insert both of the pre-prepared blocks between the cushion frame and the seat rail.

- DO NOT damage the slide sensor when inserting the block into the outer rail.
- Pay close attention to the seat harness when lifting the cushion frame. Excessive tension may cause damage to the harness.

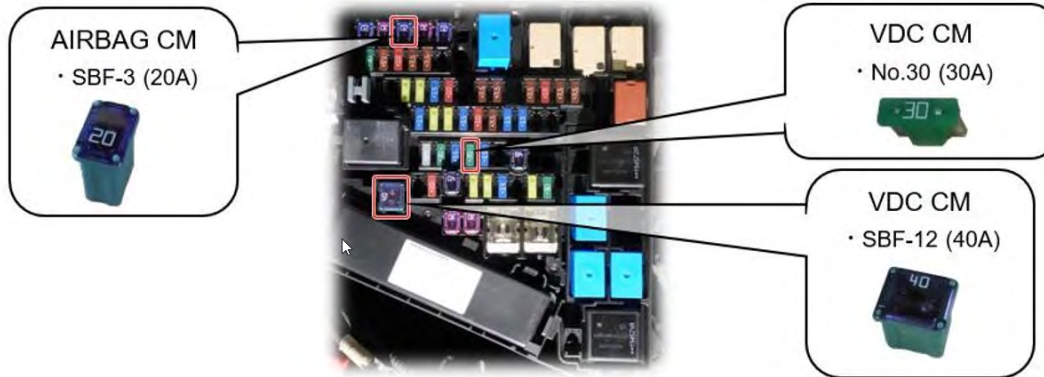
STEP 33: Reinstall the center console and gear selector cover.

STEP 34: Reinstall the fuses.

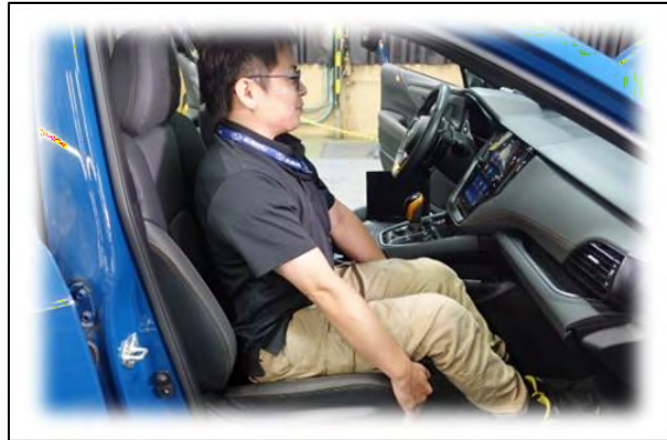
STEP 35: Sit on the front passenger seat and slightly move around while adjusting the positions.
