Safety Recall

N242447080 Drive Unit Loss of Propulsion

Release Date: May 2024

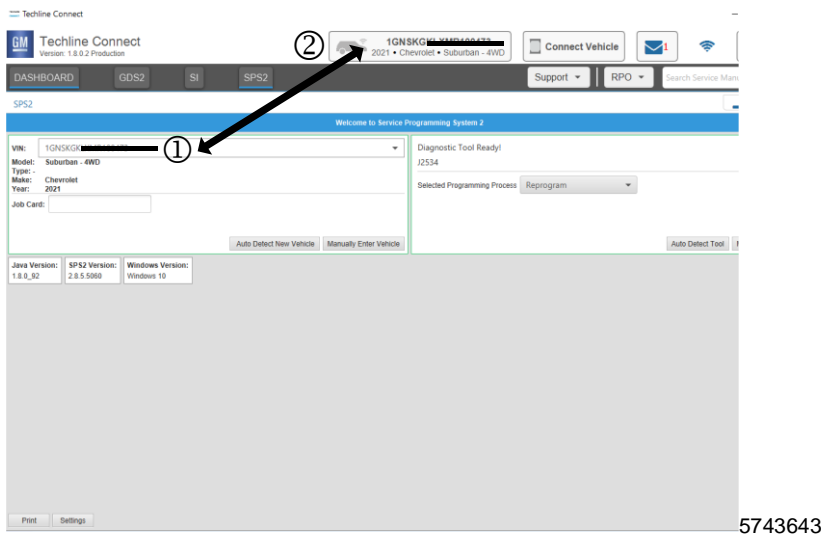
Caution: Be sure the VIN selected in the drop down menu (1) is the same as the vehicle connected (2) before beginning programming.

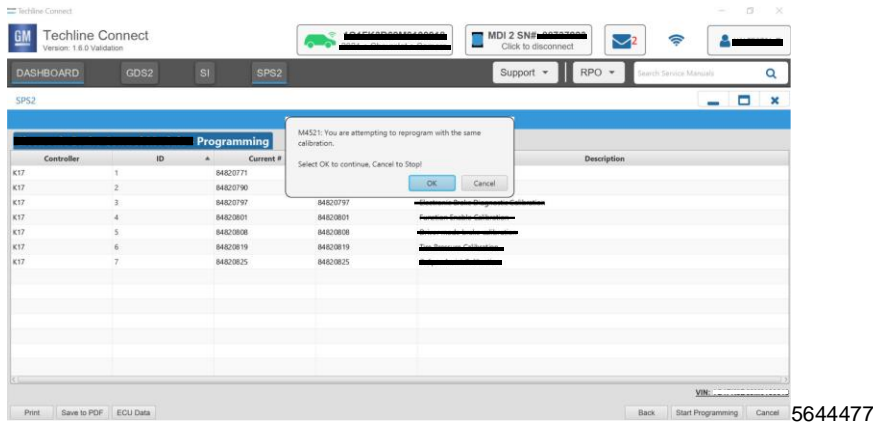
Important: If the vehicle VIN DOES NOT match, the message below will be shown.

Important: Techline Connect screens shown above.

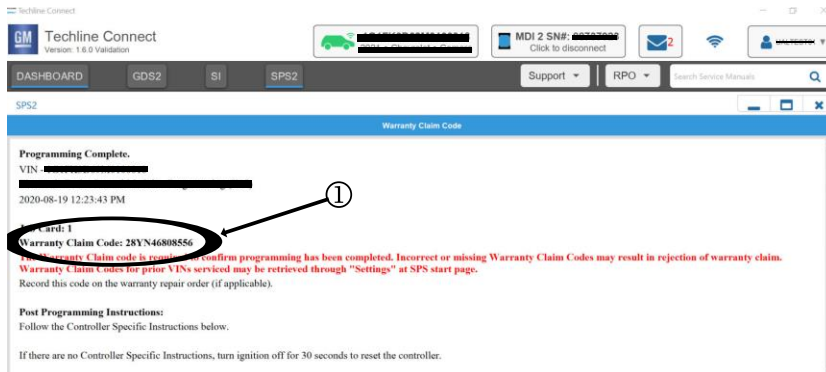
5644478

2. Reprogram the Drive Motor Control Module. Refer to *K107 Drive Motor Control Module: Programming and Setup* in SI.

Note: The screenshot above is an example of module programming and may not be indicative of the specific module that is being programmed. Module selection and VIN information have been blacked out.
