Compliance Recall

Code: 919A

Subject Vehicle Software

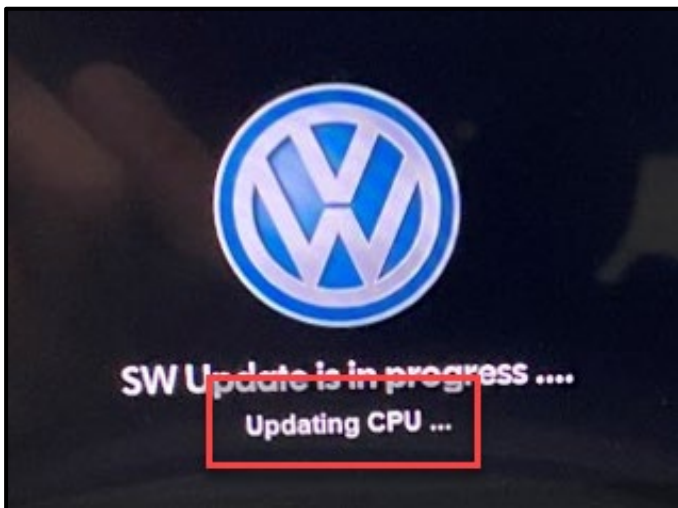
- The update will start on its own after about two minutes.
- During the update, the instrument cluster display will change multiple times.

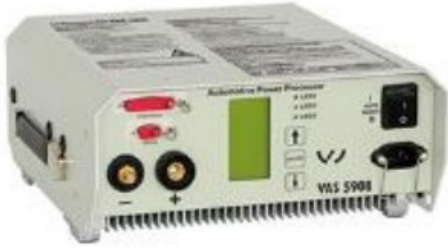
- Turn battery charger OFF, then back ON.
- Connect battery charger.
- **Cycle the ignition OFF, then back ON.**
- Confirm that scan tool is communicating with the diagnostic head by USB <Green Arrow>.
 - If the Bluetooth symbol is shown <Red Arrow> then disconnect the diagnostic head from the vehicle and reconnect the USB cable to the diagnostic head and then reattach to the vehicle.
- Upon ODIS startup, verify the “Diagnosis” operating mode is selected <as shown>.
- Turn the hazards on.
